# **Assessment of Juvenile Salmonid Passage at the Young's Dam Fish Ladder, Scott River, Siskiyou County, CA**

Siskiyou County Resource Conservation District

Dr. Christopher Adams, Fish Wiz LLC

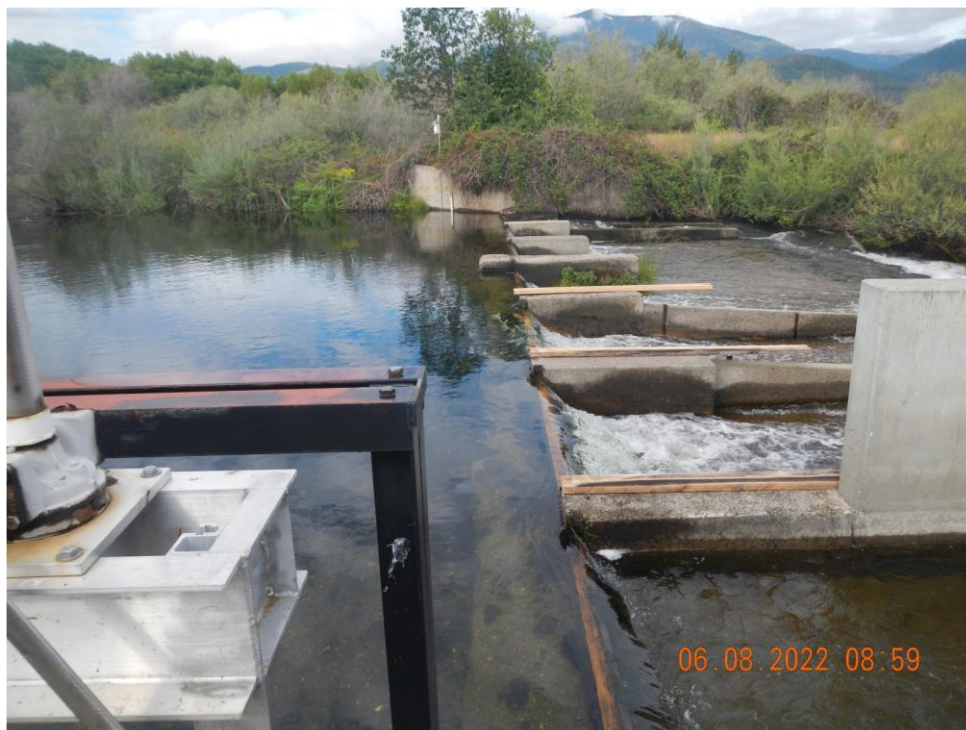
Photo 1. Young's dam with the headgate to the Scott Valley Irrigation District ditch in the left foreground, upstream end of fish ladder in the right foreground, and concrete apron with dam board slotst extending across the main channel.

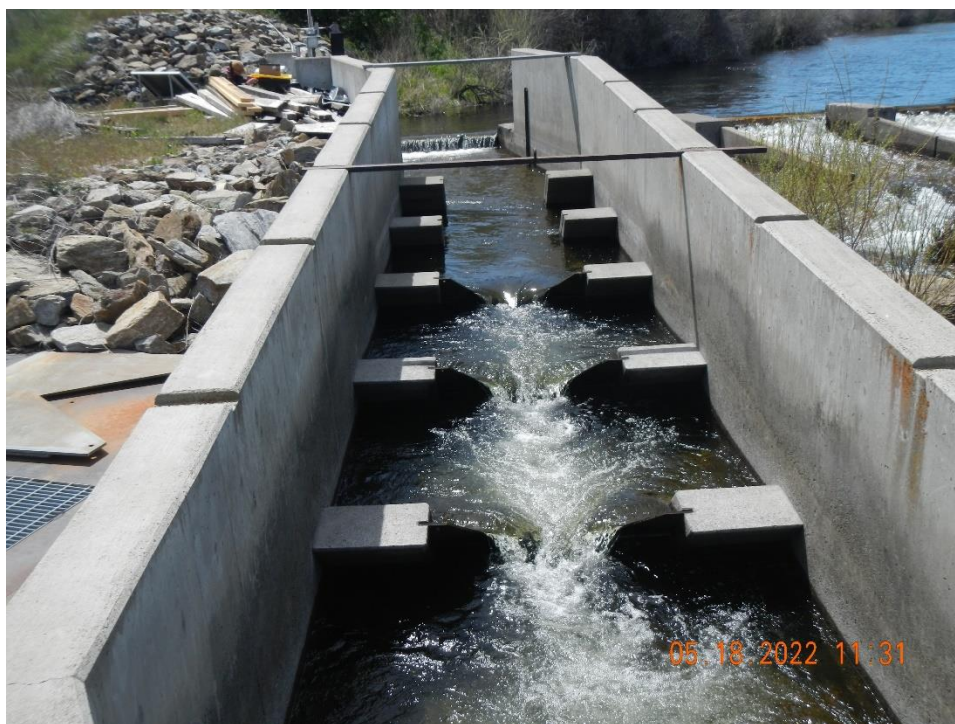
Photo 2. Looking upstream at the Young's Dam fish ladder.

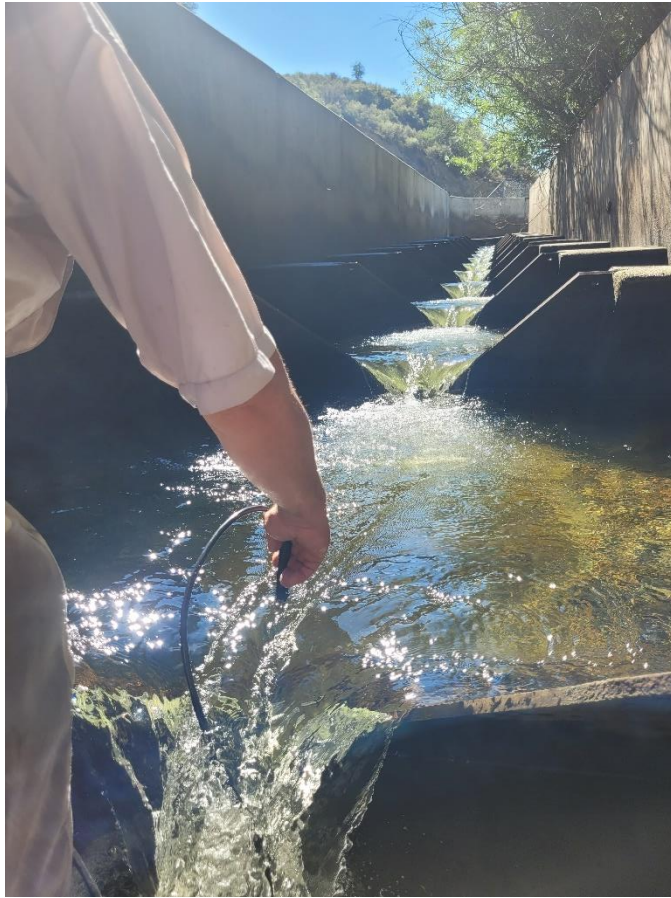
Flash Boards In	3	2	1
Staff Gauge Reading (upst ladder)	0.4'	0.6'	1.49'
CFS	1.85	4.47	7+
Baffle 1 Mean Velocity in Crest (fps)	1.12	2.88	N/A
Baffle 1 Top to Fall Crest	1'	0.64'	N/A
Baffle 1 Fall Crest to Bay Surface (Jump Height)	1.1'	0.63'	N/A
Bay 1 Surface to Bay 1 Bottom (Jump Pool Depth)	0.85'	0.85'	N/A
Baffle 1 Mean Velocity in Crest (fps)	1.07'	0.62'	N/A
Baffle 1 Top to Fall Crest	0.45'	0.43'	N/A
Baffle 1 Fall Crest to Bay Surface (Jump Height)	1.45'	1.8'	N/A
Baffle 17 Mean Velocity in Crest (fps)	1.76	3.26	3.12

Photo 10. Measuring velocity in the V notch of baffle 1 at 1.85 cfs.

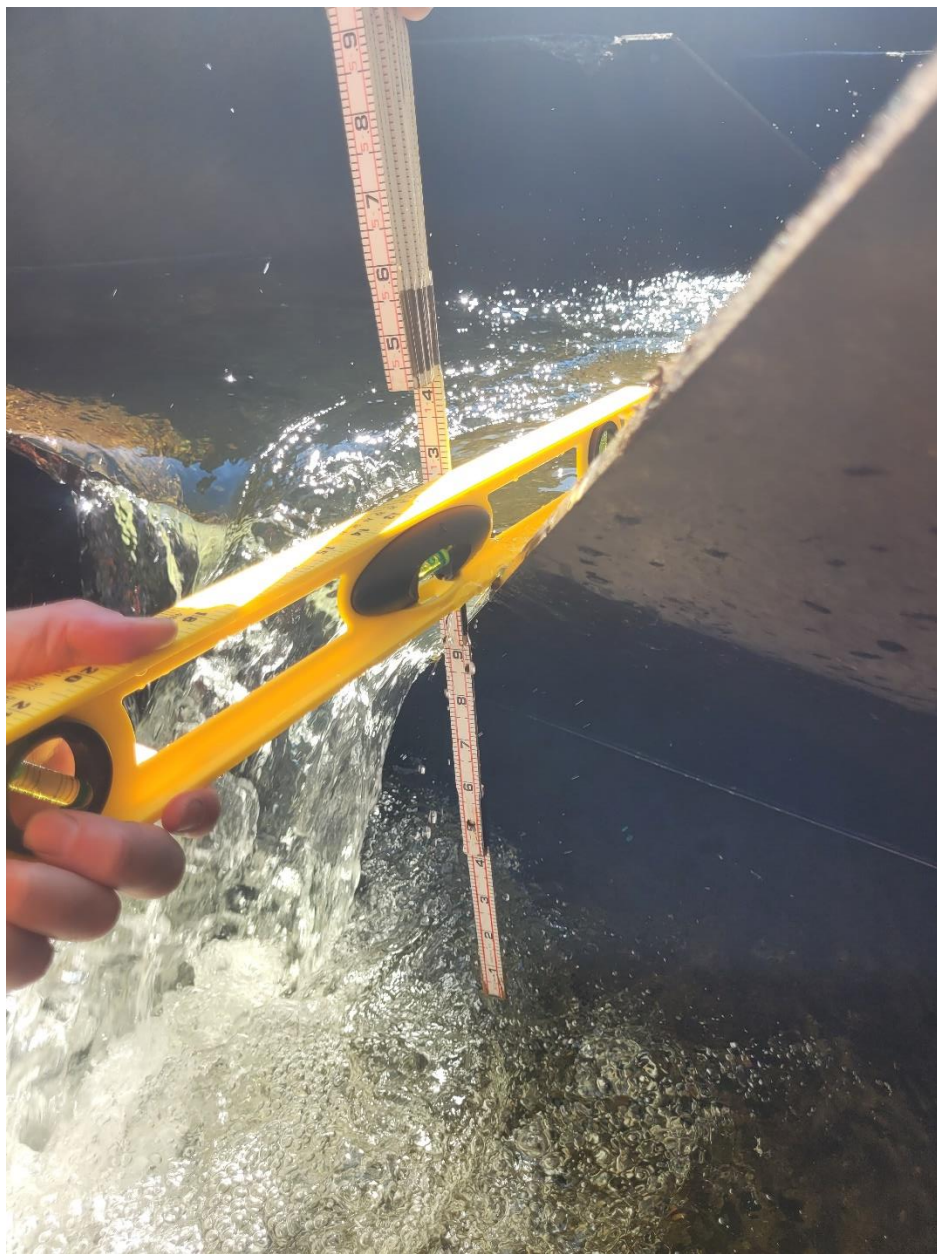
Photo 11. Measuring fall crest to bay surface and bay surface to bay bottom at 1.85 cfs.

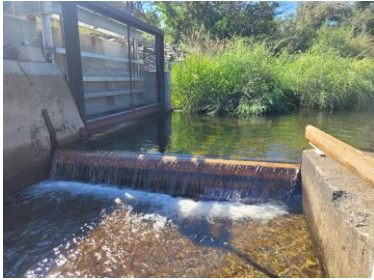
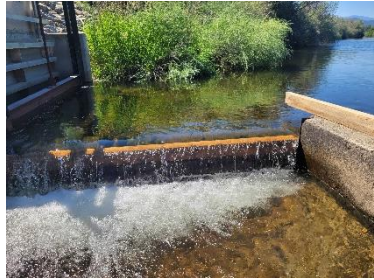
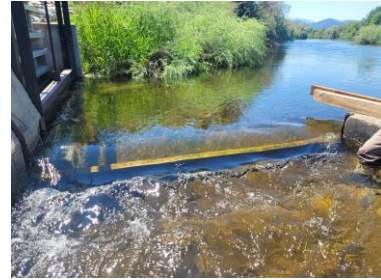
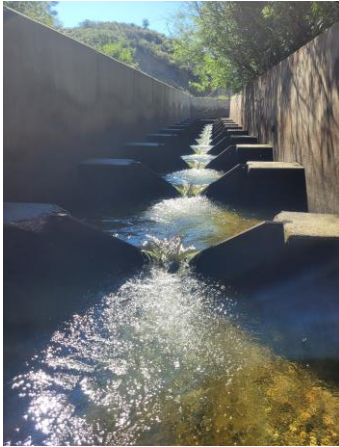
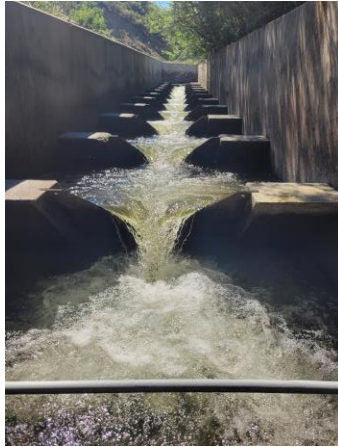
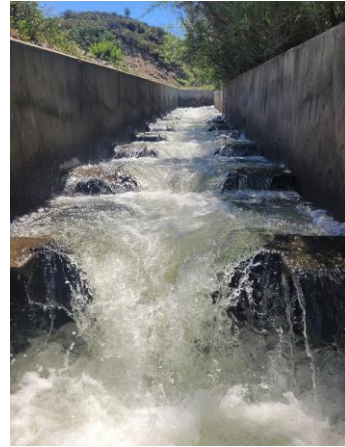
Photo 12. Flash boards (top) and view from downstream end of ladder (bottom) at 1.85 cfs (left), 4.47 cfs (middle) and 7+ cfs (right).
