STREAM INVENTORY REPORT

SCOTT RIVER

2023/2024

SISKIYOU RESOURCE CONSERVATION DISTRICT

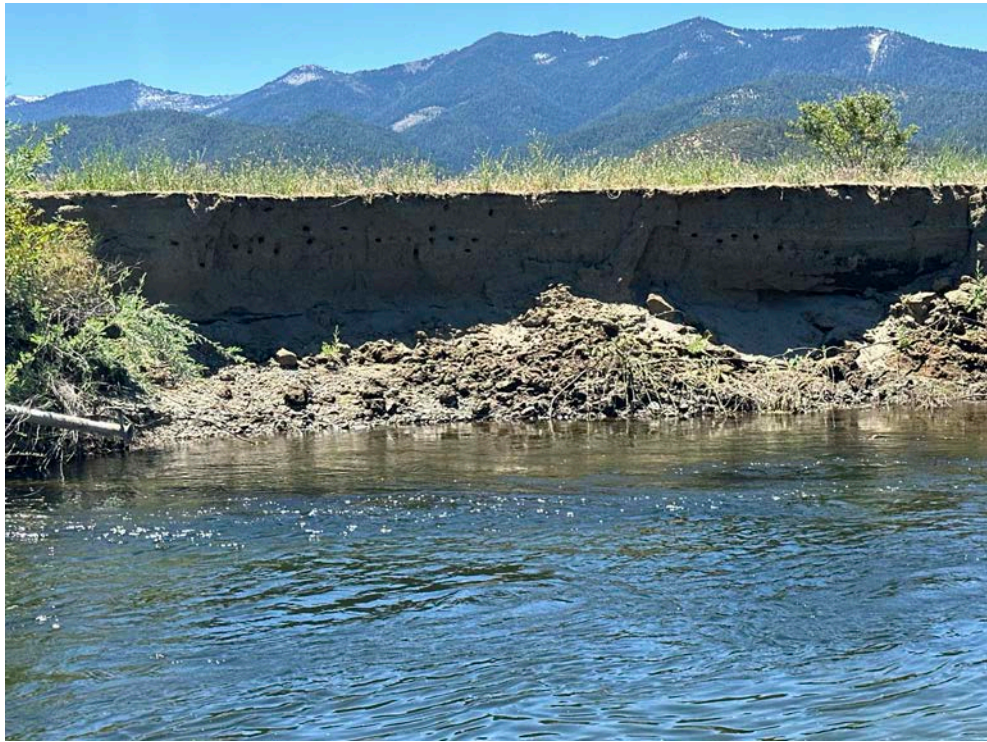
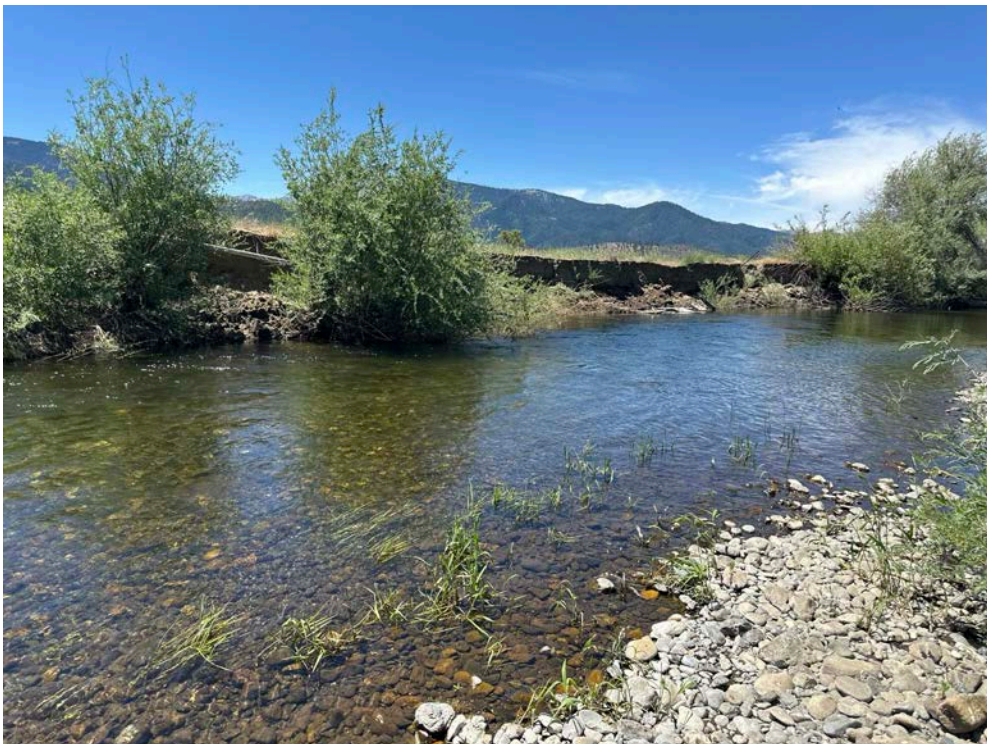
Bank erosion site in Reach 15:

Multiple sites within the survey area were identified where bank erosion may be contributing fine sediment to the channel, with the most severe being in Reach 15 from approximately 41.255597N and 122.503925W to 41.255730N and 122.504135W, approximately 650 meters upstream from Young's Dam (see images below). The addition of such fine sediment to the system may be detrimental to the quality of spawning gravels downstream.

- 5) Inventory and map sources of stream bank erosion and prioritize them according to present and potential sediment yield. Identified sites should then be treated to reduce the amount of fine sediment entering the stream.
