Scott River Riparian Restoration Analysis

Prepared by the Siskiyou RCD

For the United States Fish and Wildlife Service

Sept 2009

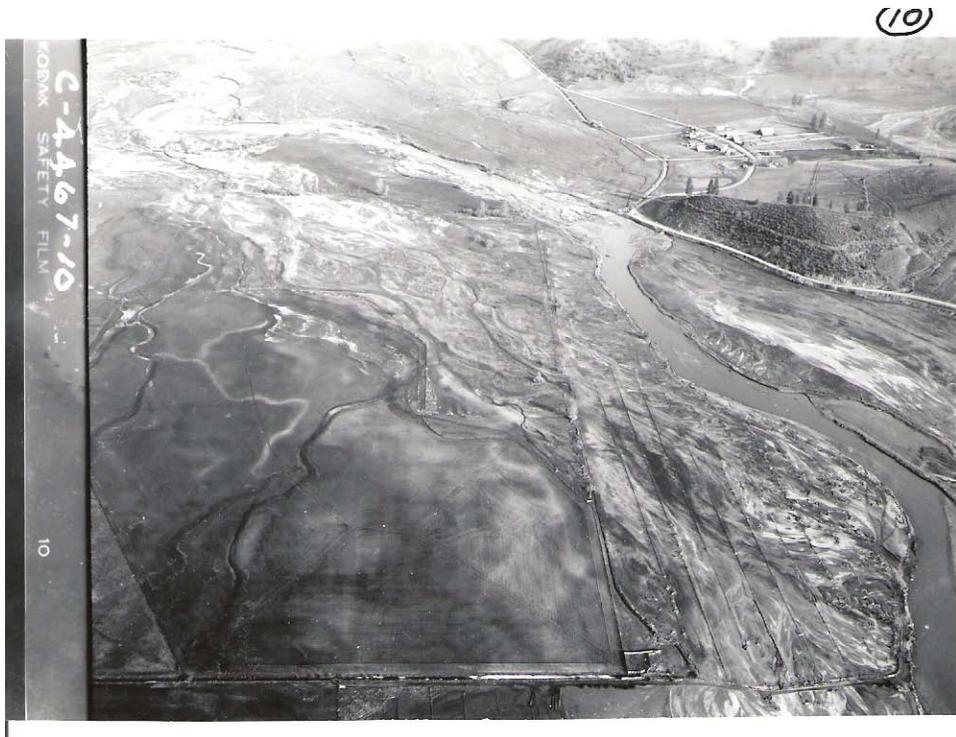
Figure 2. Scott River at Youngs Point (upper right) after the 1964 flood. (photo by F.J. Jackson)

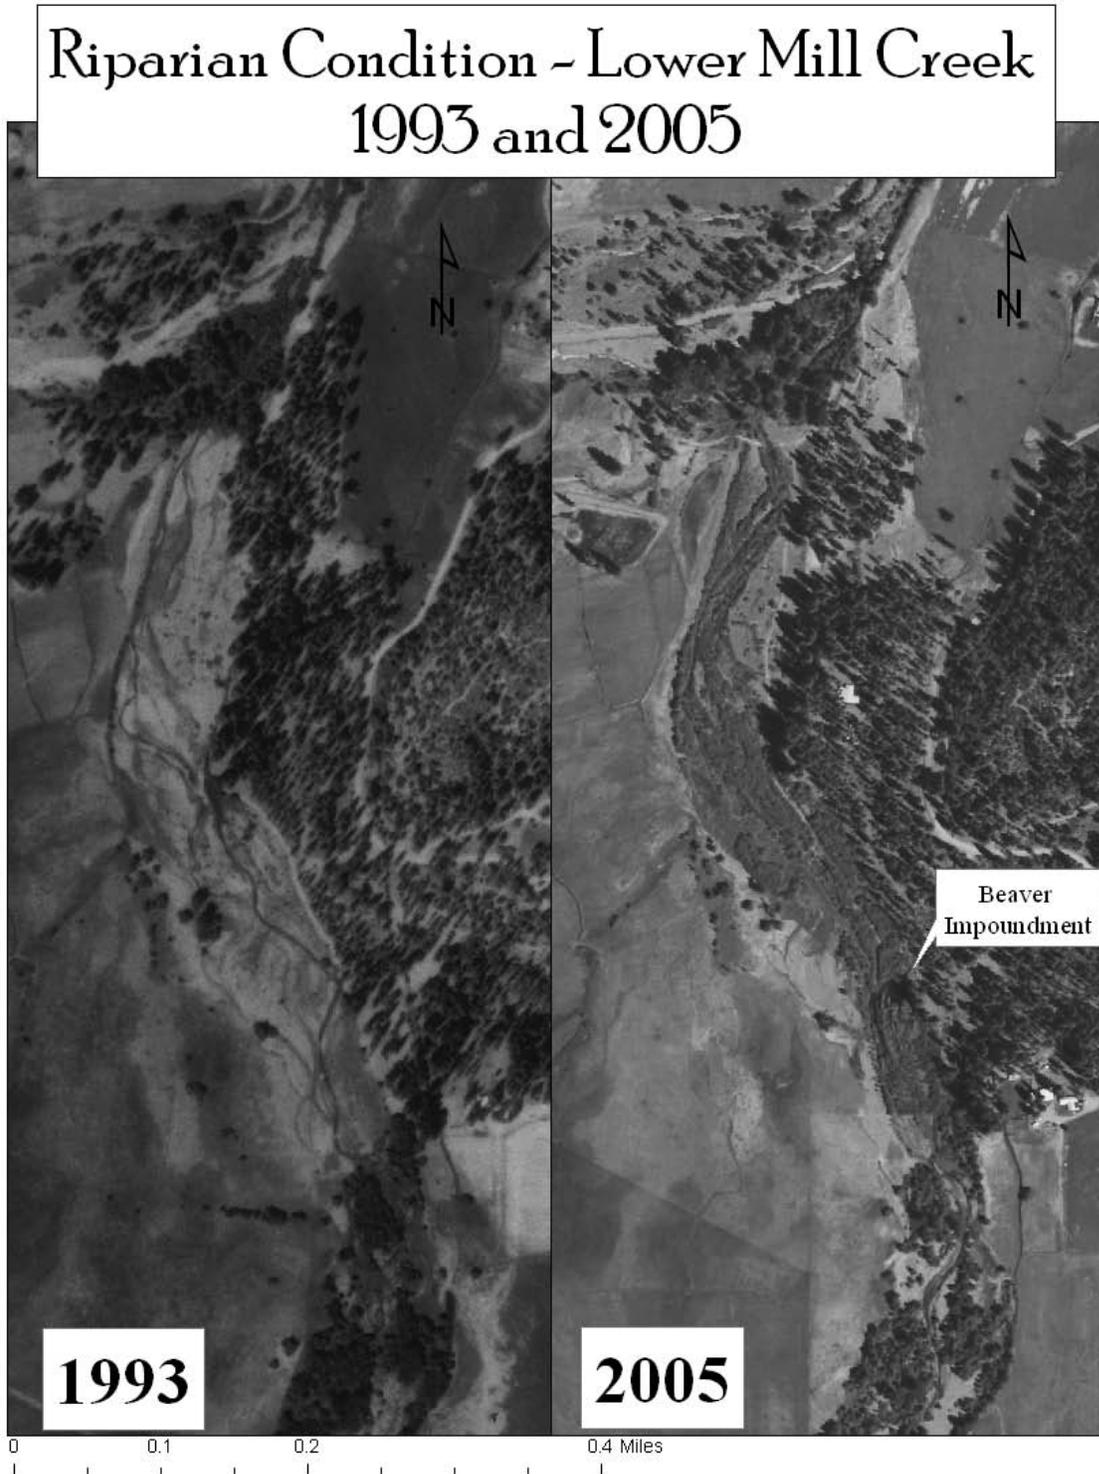
Figure 5 – Aerial images of the same reach of Mill Creek in 1993 (left) and 2005 (right).

The image above clearly illustrates the current (2005) extent of riparian vegetation in the project reach in contrast to the almost denuded state of the channel’s banks and floodplain in 1993. A beaver dam and significant impoundment currently exists in the upstream portion of this reach.

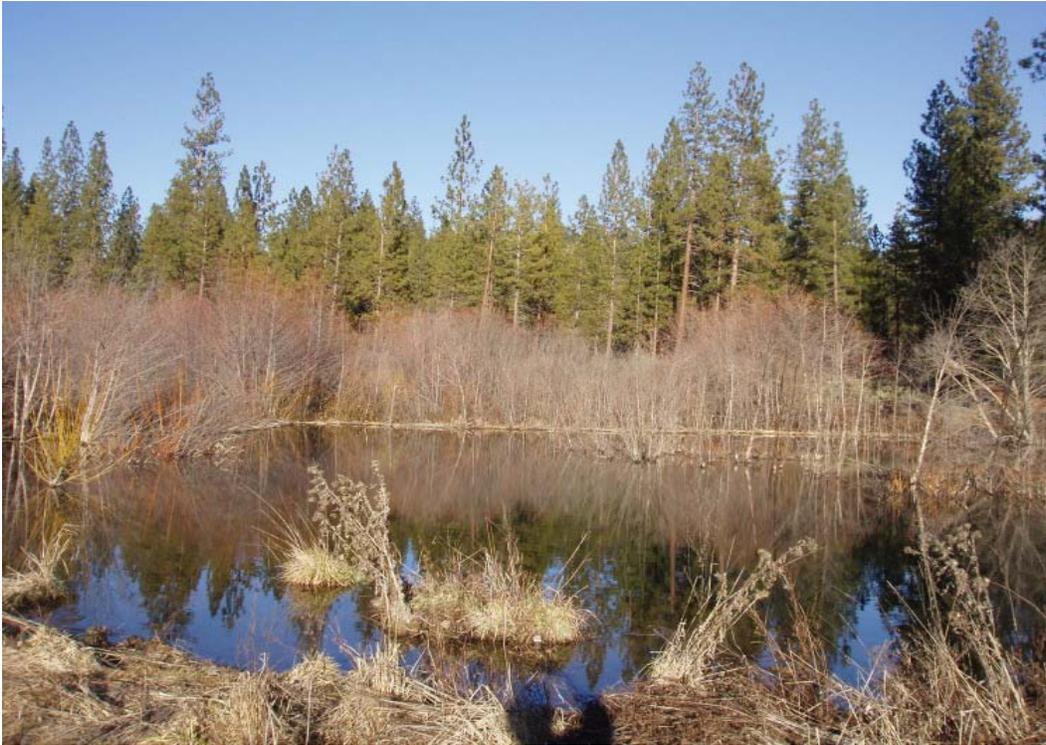
Figure 9 Impoundment behind beaver dam in Mill Creek, December 2008.

Figure 9 shows a view of the beaver dam from the west bank. The dam provides a stable water table year round that is ideal for riparian plants and rearing anadromous salmonids.

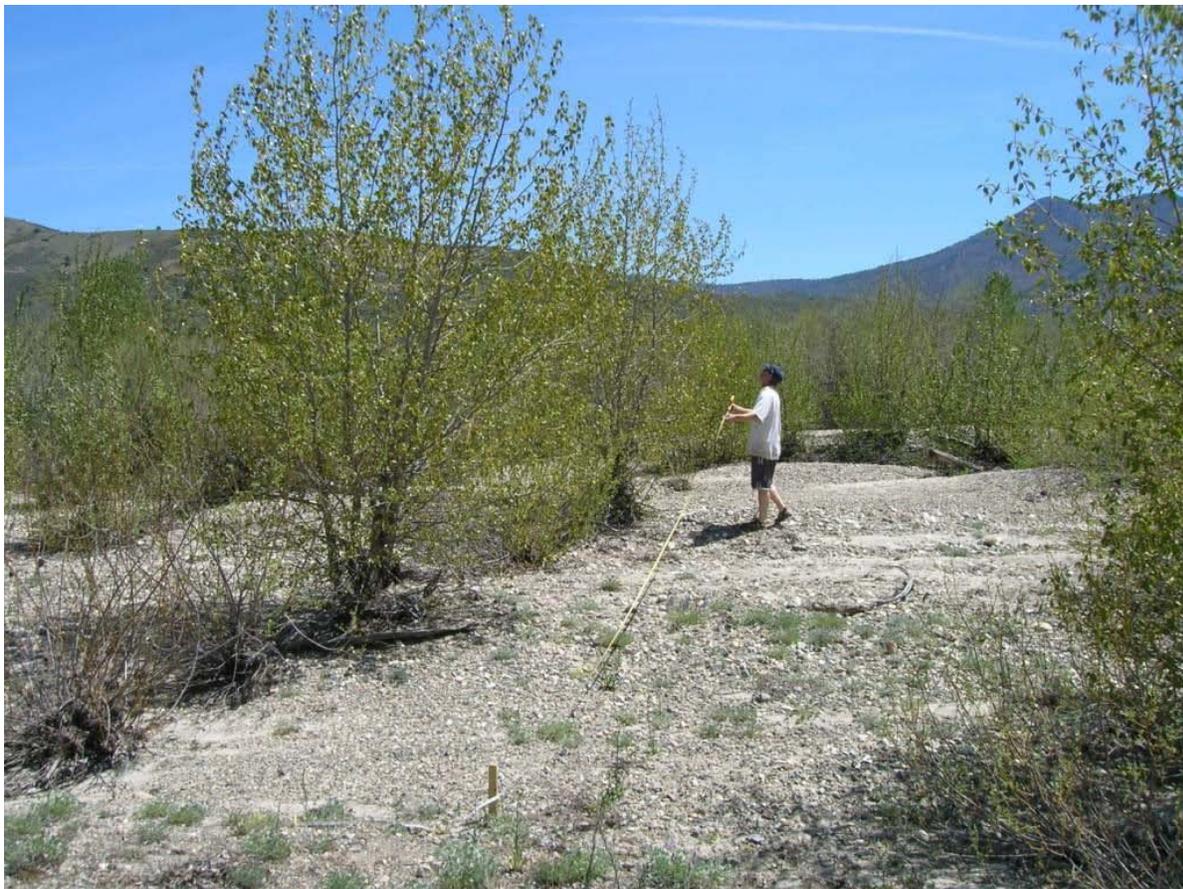
Successful sites: Plantings at the mouth of French Creek between French and Wolford Slough were the most successful (Figure 10). This is potentially attributable to a higher water table with less annual fluctuation due to the subsurface water contributions from the two streams.

Figure 10 – Successful cottonwood planting north of the confluence of French Creek

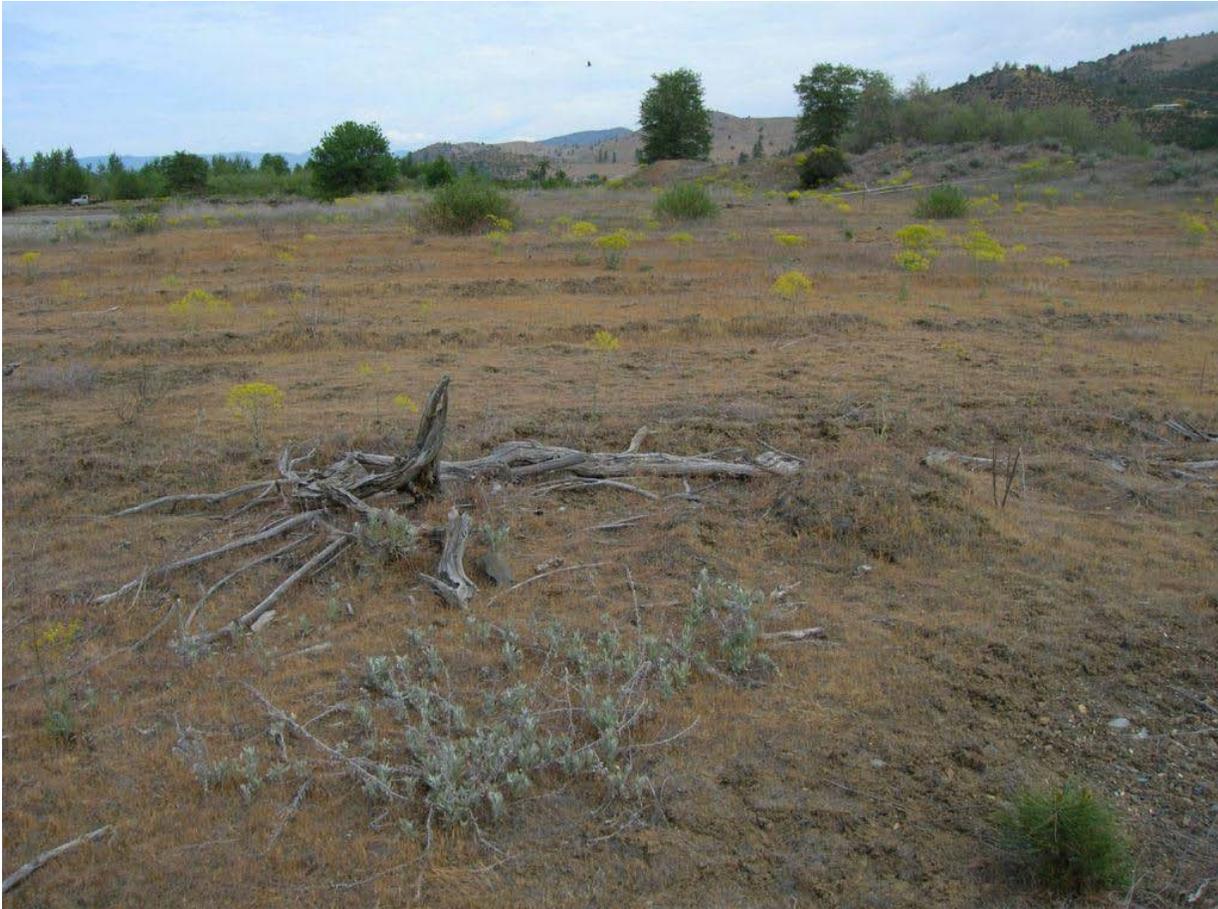
Failed sites: Plantings directly across the Scott River from Wolford Slough (e.g., Osprey Site) were a complete failure (Figure 11). This location's soil is primarily composed of gravel and cobble, with poor water retention and no protection from solar radiation. This site was planted with rooted stock and irrigated with drip line for a period subsequent to planting. The site is currently vegetated with sparse willows and severely stunted pine trees with grasses covering a portion of the ground. The exact reasons this site failed are unknown but it is hypothesized that a combination of extreme local heat on the barren bar, limited availability of water during the low flow period and poor soil conditions limited the success of the plantings. It is unknown if extensive irrigation and protection maintenance would generate success in this location. There is currently no riparian vegetation to create a shaded and cooler micro-climate during the summer months to aid the success and survival of introduced plantings. Protection measures (e.g., cages with shade cards and mulch) might create the desired micro-climate around each plant.

Figure 11 – Failed riparian planting on east side of Scott River above French Cr. Confluence

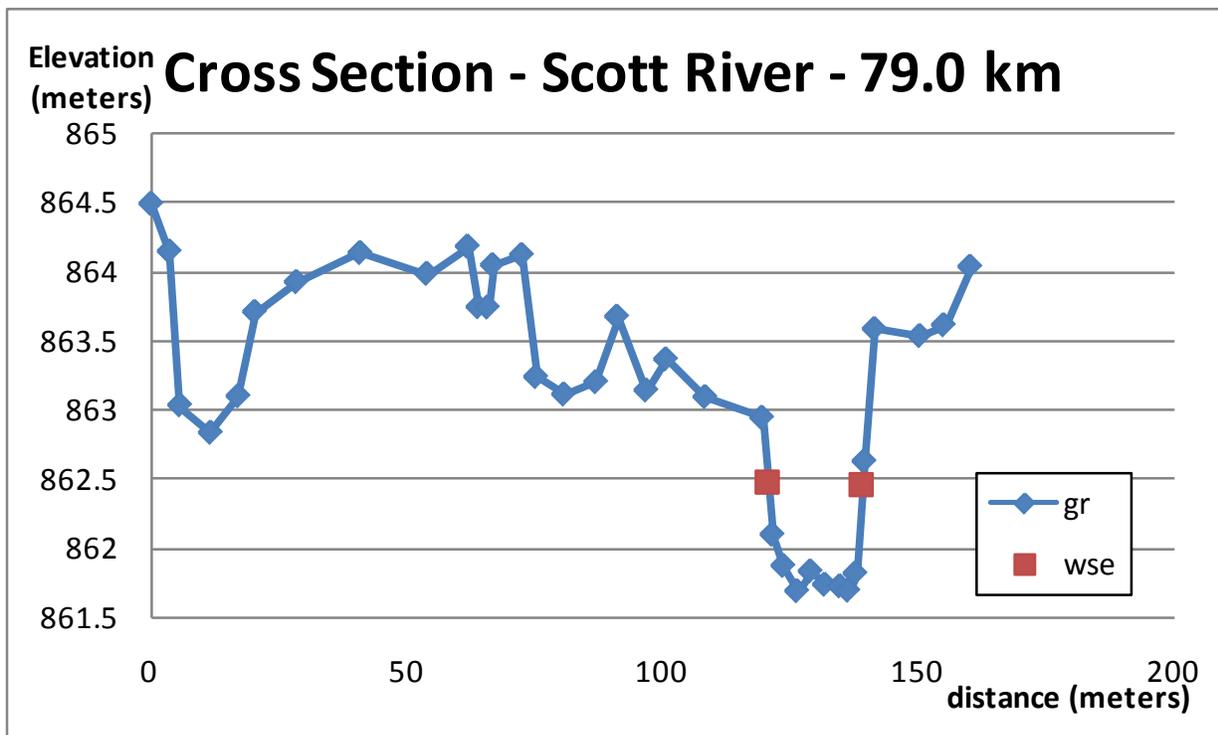
Figure 15 - Cross section of Scott River at RKM – 79.0 with water surface elevation (wse)

The cross section performed at RKM – 79.0 (Figure 15) shows a low elevation “trough” at the western edge (Left Bank). Analysis of the 2005 aerial photograph shows this trough is occupied by a strip of riparian vegetation in an area otherwise sparsely vegetated. Analysis of the aerial photograph captured in 1993 shows this area with lower elevation was occupied by the Scott River’s channel previous to the 1997 flood (Figure 17). Though the channel has migrated, the former location has significantly lower elevation than the surrounding gravel bar creating an area with a depth to water table that is less than the depths on the adjacent gravel bar. The occurrence of riparian vegetation in this corridor with access to a “higher” water table indicates the importance of the water table’s elevation in respect to the land in the success of riparian vegetation establishment.

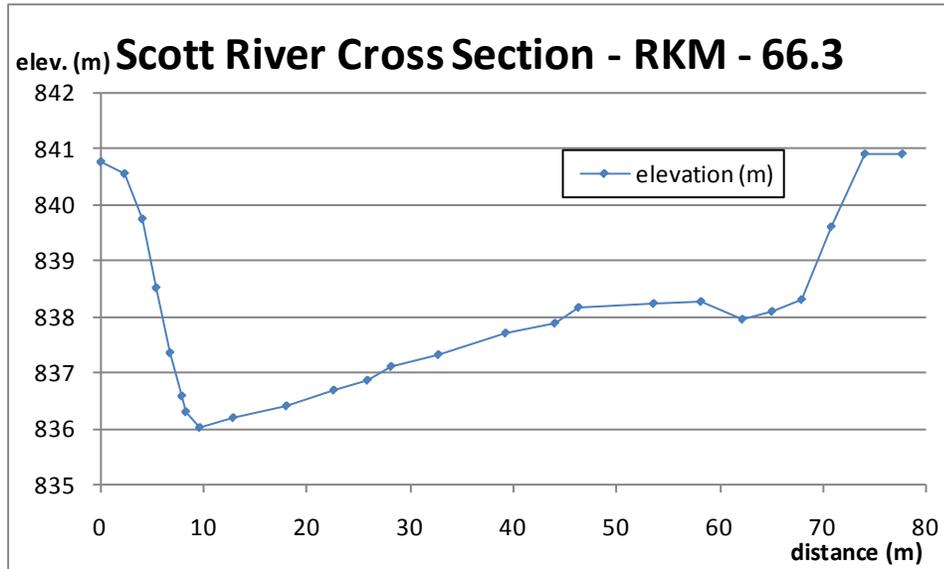
Figures 20 and 21 depict representative cross sections for the reach below Youngs Dam. Both of these cross sections have one bank that is very steep with the bank’s top 12 to 15 ft higher than the stream’s thalweg. The width of the available riparian land between fences is significantly less than the cross sections discussed for the reach upstream. Each cross section has an area of gravel bar with moderate slope on the bank opposite the steep bank. The current riparian density and distribution at RKM – 66 is mixed with areas of dense mature vegetation and areas vegetated with only grass and weeds (Figure 22). Some of the successful “riparian” plants are non-native species of trees introduced by the Soil Conservation Service – the trees on the right of this photograph are examples of these introduced trees. These trees are a mix of conifers, deciduous

Figure 20 – Cross section at RKM – 66.3

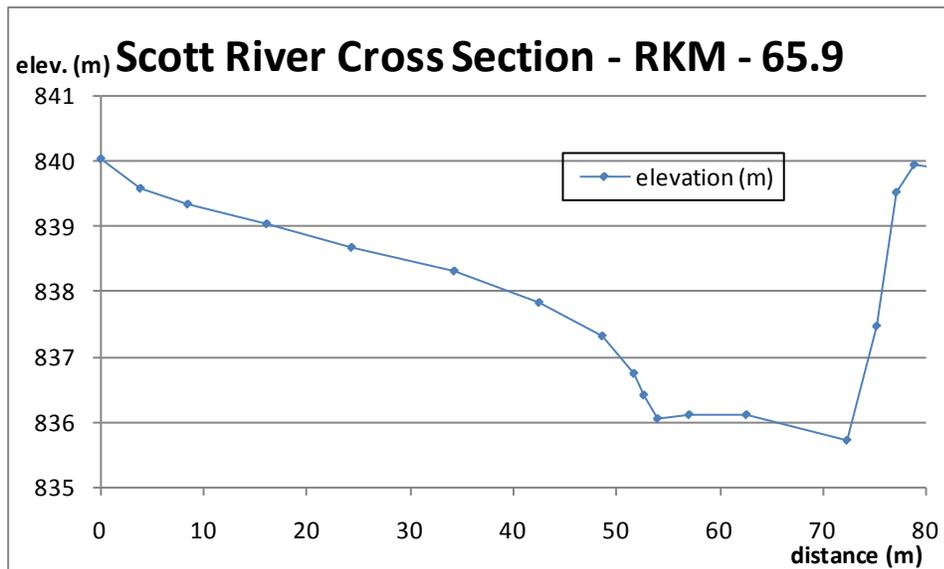
Figure 21 - Cross section at RKM – 65.9

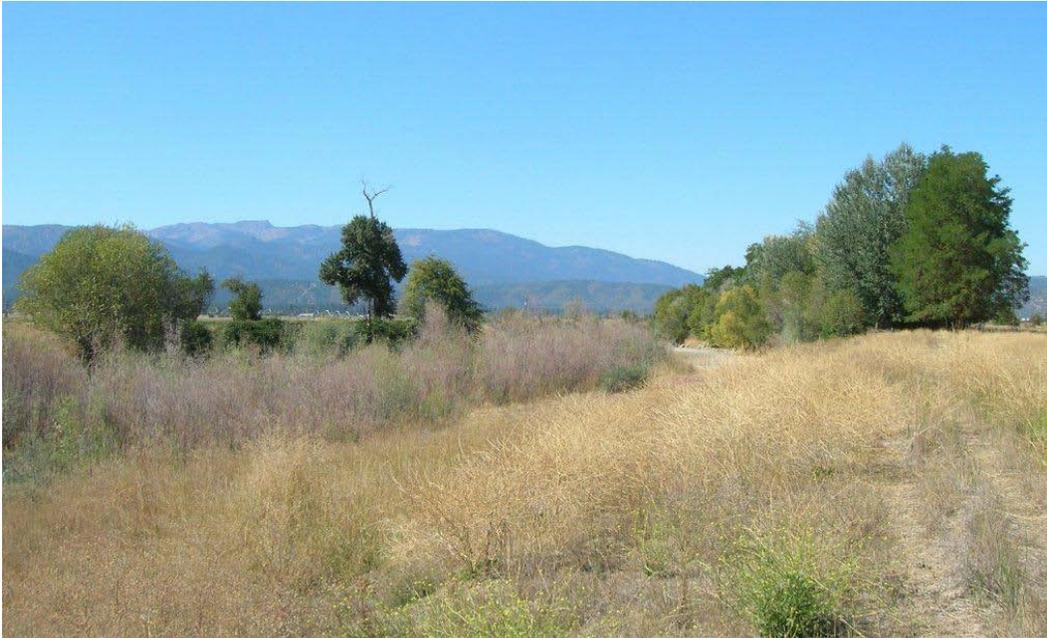
The landowner of the surveyed reach has noted that a large number of the mature cottonwoods that were present through this reach have died in the near past. It is hypothesized that stream down cutting through this reach has lowered the water table effectively leaving the mature trees root structure above the base flow water table resulting in death. This example demonstrates the importance of insuring the survival of existing riparian vegetation while trying to introduce new riparian growth.

Figure 22 – Riparian canopy in area of RKM - 66
