# **Assessment of Restoration Actions on Big Springs Creek, Shasta River, California 2009-2010**

**Jeffrey F. Mount, Peter B. Moyle, and Michael L. Deas**  
**Principal Investigators**

**The National Fish and Wildlife Foundation**

**UC DAVIS**  
**Center for Watershed Sciences**

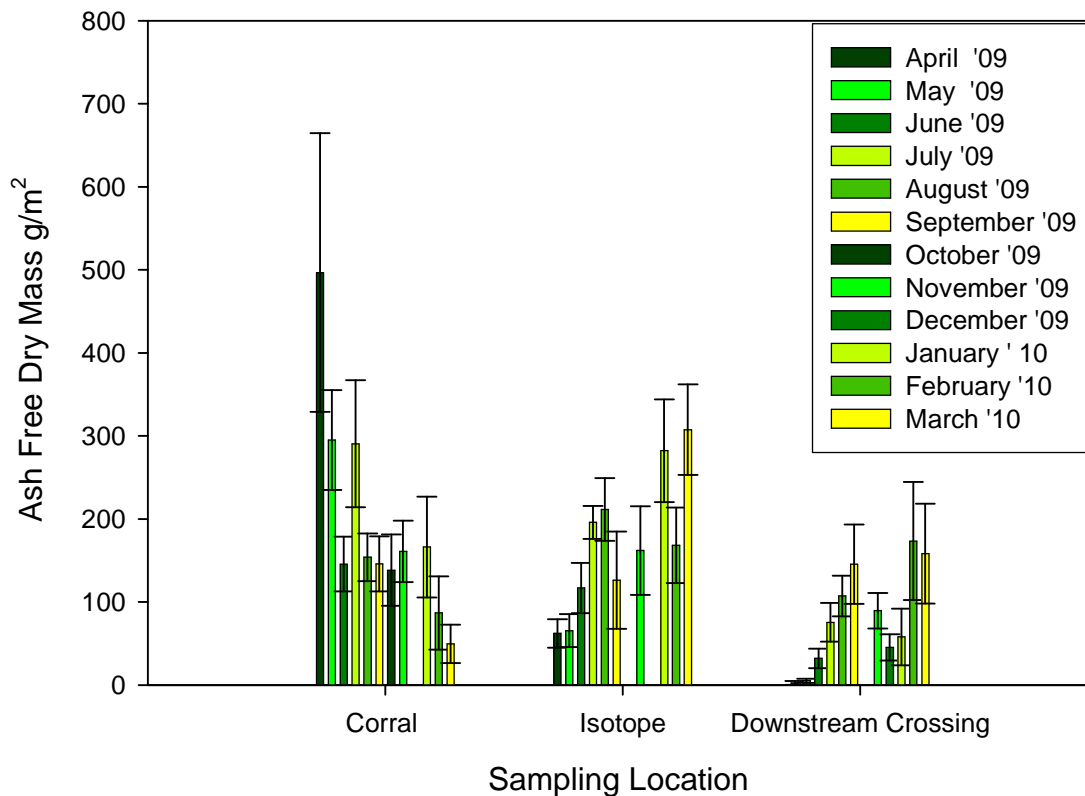
Figure 4. Ash Free Dry Mass (AFDM) of aquatic macrophytes collected in Big Springs Creek from April 2009 through March 2010. Bars represent the mean value of the six subsamples and error bars are standard error.

Immediately following cattle exclusion in April 2009, biomass sampling and qualitative observations revealed that initial aquatic macrophyte community size and composition varied greatly, depending on the location within Big Springs Creek (Figure 3). The primary cause of this difference was management of cattle during the winter prior to cattle exclusion (January through March 2009). Cattle were primarily grazed on pastureland adjacent to the “Downstream Crossing” sampling site, with intermittent access to pastures adjacent to the “Isotope” sampling site, and little to no access to pastures adjacent to the “Corral” sampling site. The amount of cattle grazing on adjacent pastureland, and consequently the stream, during the previous winter was inversely proportional to the biomass of aquatic macrophytes measured at each sampling site at the beginning of the post-exclusion study period in April 2009 (Figure 4).

Comparison of the mean standing crop of aquatic macrophyte samples collected at the “Isotope” sampling site in March 2008 (pre-restoration), April 2009 (immediately following cattle exclusion) and March 2010 (one year following cattle exclusion) allows direct analysis of the macrophyte community response to passive restoration actions. While the expected seasonal growth and senescence of the standing crop was observed

Similar post-cattle exclusion differences in macrophyte biomass were also observed at the “Downstream Crossing” study site. Comparison of the mean standing crop of aquatic macrophyte samples collected in April 2009 ( $2.65 \text{ g/m}^2$  AFDM) and March 2010 ( $158.38 \text{ g/m}^2$  AFDM) reveal an increase of approximately 60 times the spring-time standing crop one year following cattle exclusion.

Interestingly, mean standing crop of aquatic macrophytes at the “Corral” sampling site has seen a gradual decrease in biomass following cattle exclusion. Reasons for this reduction are unclear, and may be related to successional dynamics or self-shading as plant biomass reaches a yet undescribed threshold. Future data collection will be necessary to ultimately determine the cause decrease in the corral biomass.

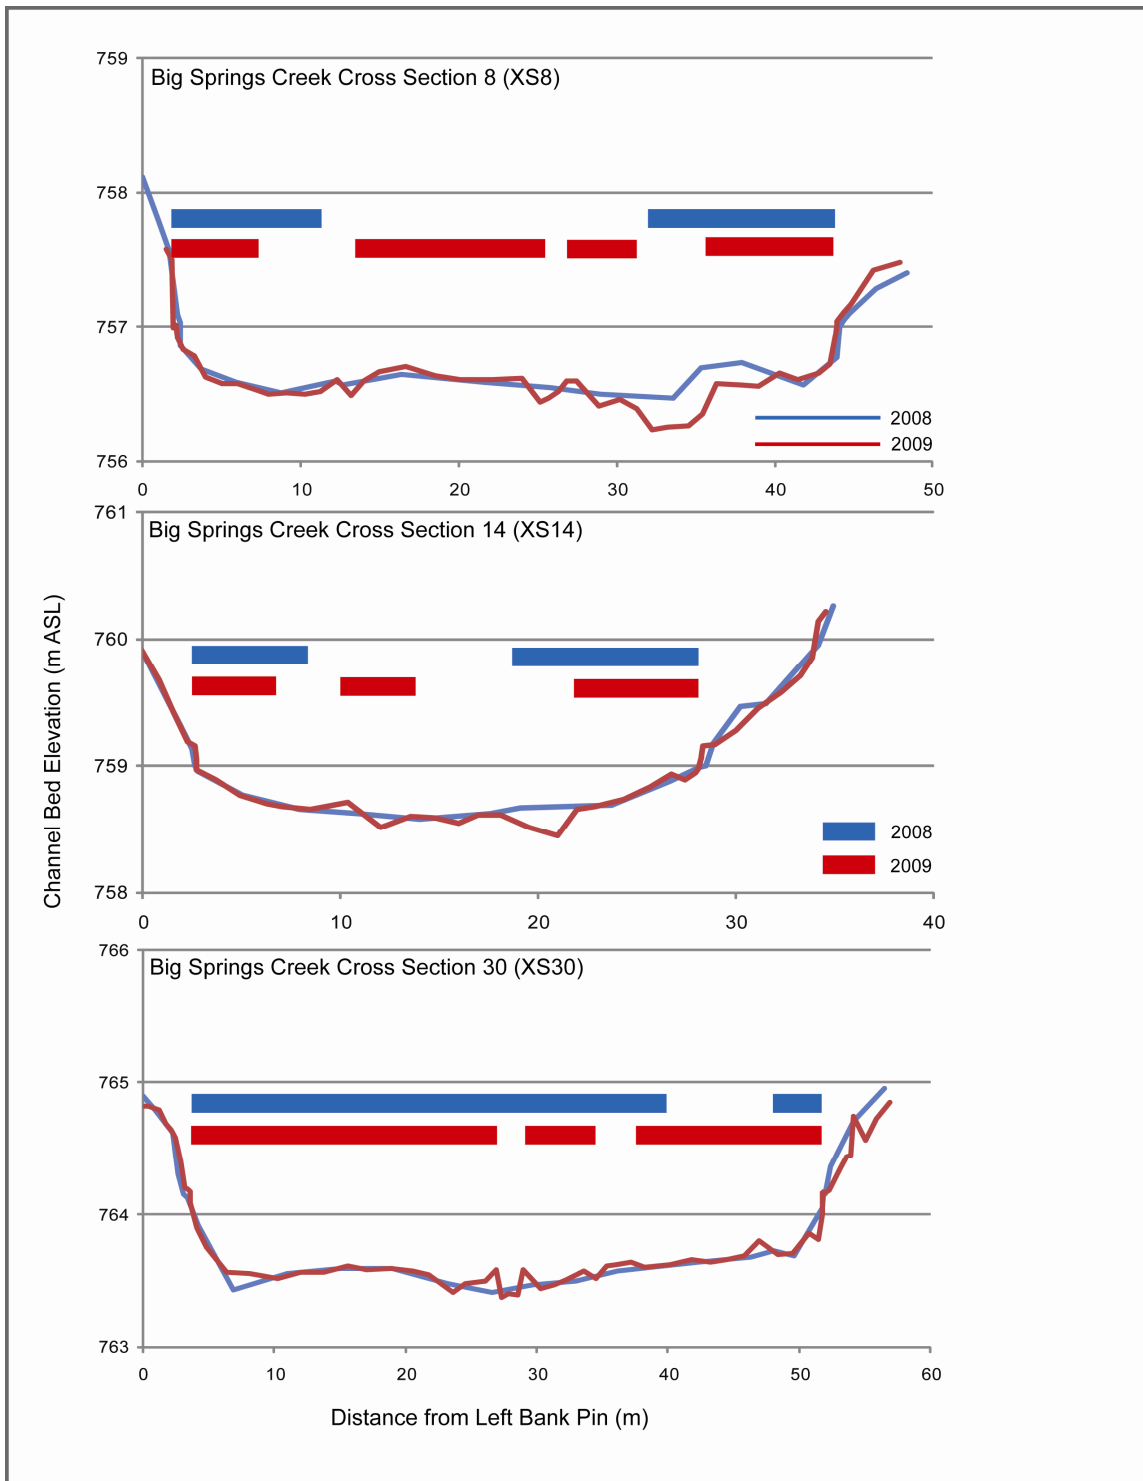
Figure 7: Representative cross section topographic surveys occupied in both 2008 and 2009. Lateral distribution of aquatic macrophyte patches are illustrated for 2008 (blue bars) and 2009 (red bars). Channel widths and depths did not appreciably change during the project period. However, local changes in erosion and deposition largely coincided with deviations in the lateral distribution of aquatic macrophytes.

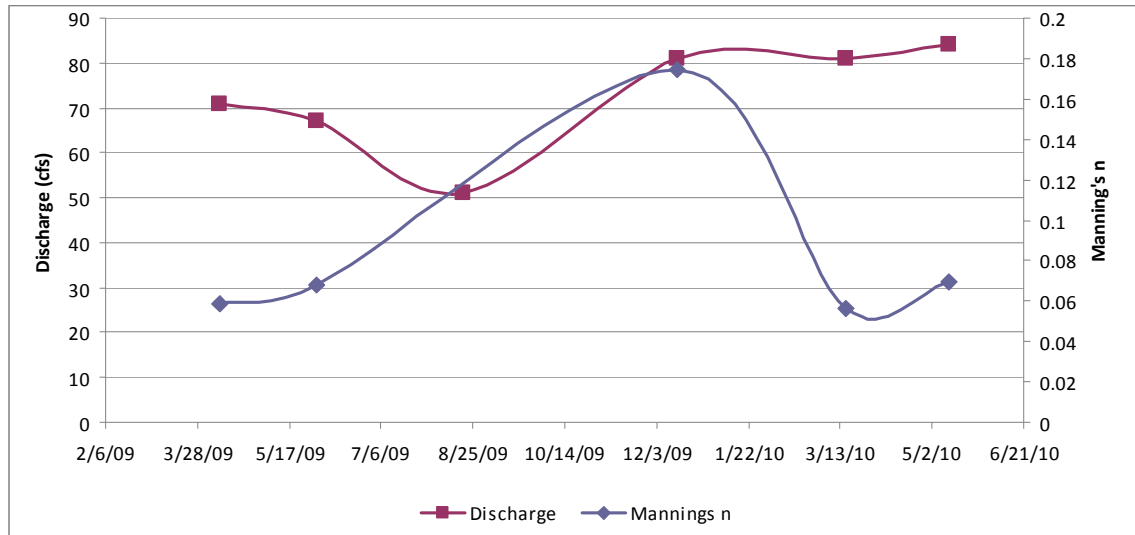
Figure 12a. Seasonal changes in discharge and channel roughness (Manning's  $n$ ) at the Big Springs Creek Downstream Crossing study site velocity transect.

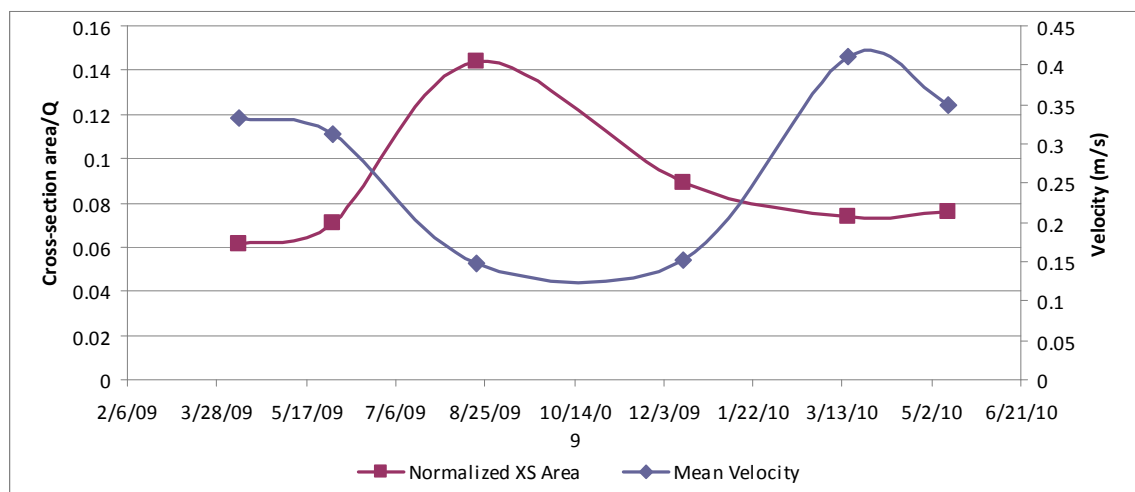
Figure 12b. Seasonal changes in wetted cross section area and mean velocity at the Big Springs Creek Downstream Crossing study site velocity transect. Note that cross-sectional area is normalized by discharge.

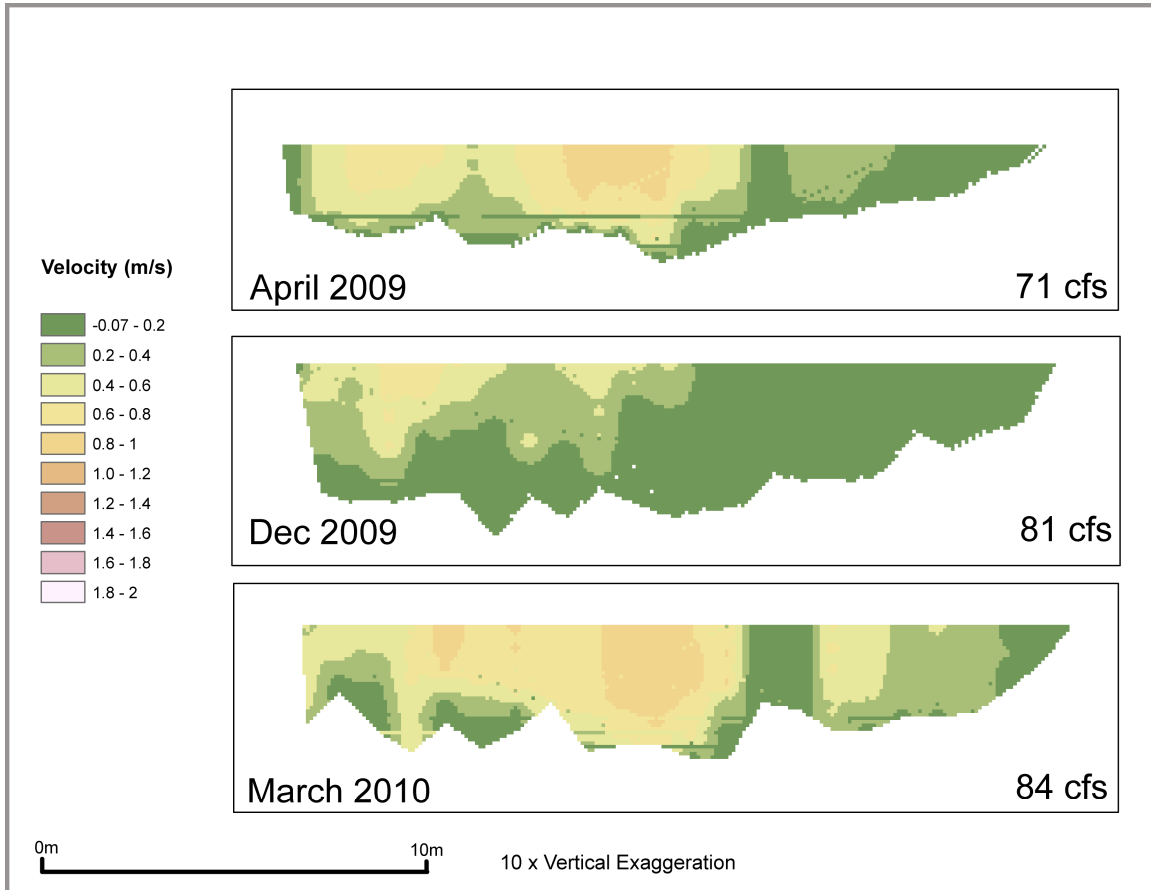
Figure 13: Flow velocity contour plots created from point velocity measurements collected at the Big Springs Creek Downstream Crossing study site transect location. Dark green colors can largely be used as a proxy for cross-section areas blocked by aquatic macrophytes.

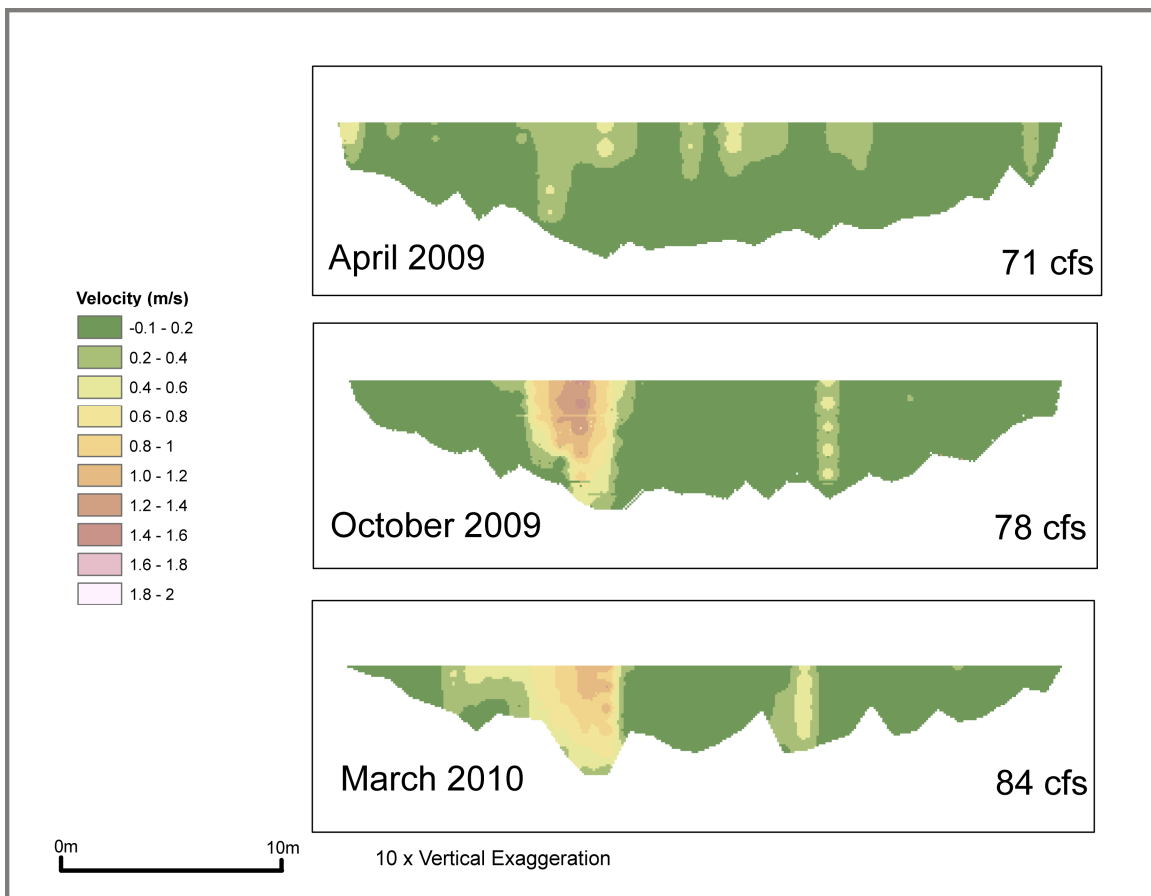
Figure 15: Flow velocity contour plots created from point velocity measurements collected at the Big Springs Creek Corral study site transect location. Dark green colors can largely be used as a proxy for cross-section areas blocked by aquatic macrophytes.

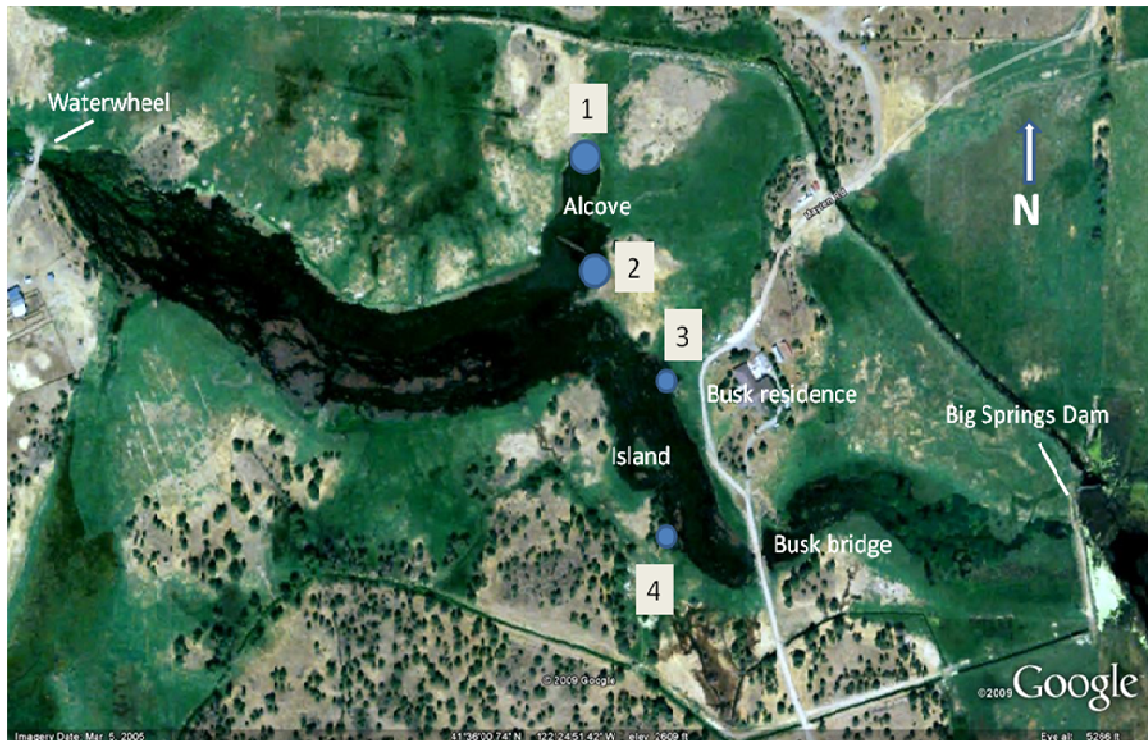
Figure 18. Spring sources monitored for water temperature.

The locations of discrete springs were identified using field observations and thermal imaging (Figure 17). These springs are part of a regional complex called the Big Springs Complex. Though areas of diffuse spring inputs are included in this complex, discrete springs were identified for the purposes of water temperature monitoring (Figure 18). These springs included:

A preliminary analysis of temperature data determined that the springs generally emerge between 10°C and 12°C (Willis and Deas 2009). Additional monitoring supported this initial finding (Table 1). The north alcove spring (RKM 3.1) is the warmest, emerging at temperatures between 11.5°C and 12.5°C. The spring located below the Busk bridge on river right (RKM 3.2), emerges cooler than the other springs, with temperatures ranging from 10.4°C to 10.9°C.

\*Location based on Figure 18; \*\*RR = river right, RL = river left

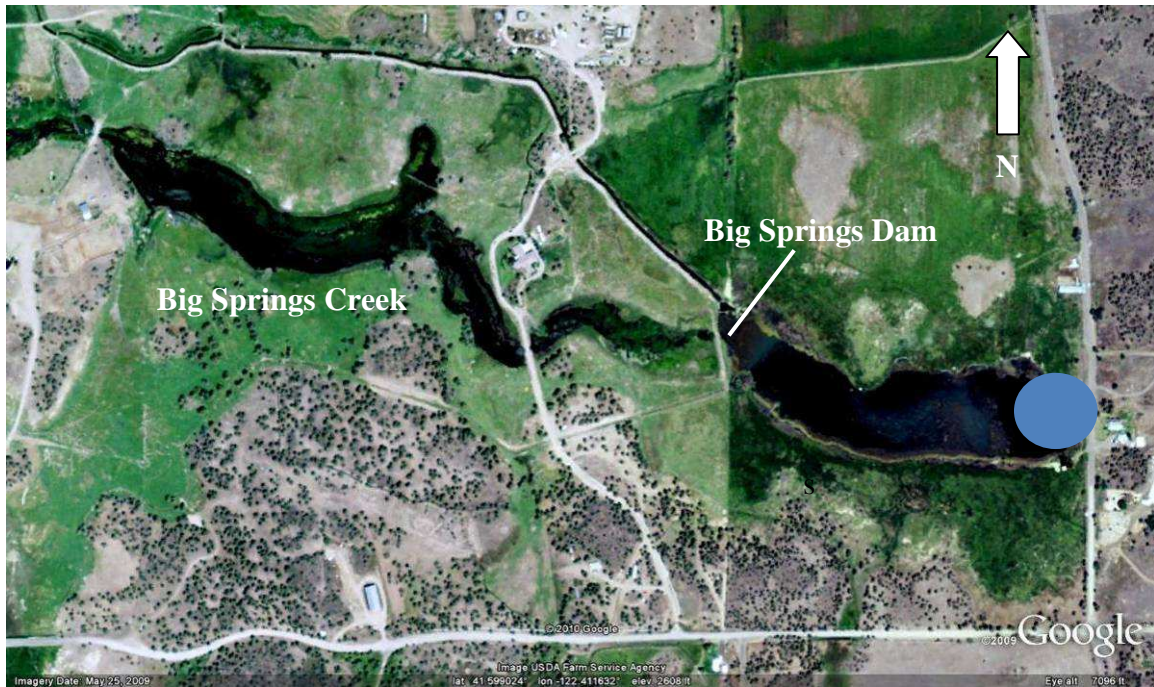
Figure 24. Big Springs Lake is located east of Big Springs Dam and flows into Big Springs Creek. The blue dot indicates the principal location of springs that provided water impounded within Big Springs Lake.

As discussed in Section 6 of this report, there were two main sources of inflow to Big Springs Creek, which result in two areas of strong thermal inputs. The two types of inflow were from discrete and diffuse springs (discussed in section 8.2.1) and periodic releases from the Big Springs Dam outlet (RKM 3.6). Big Springs Dam impounds Big Springs Lake, which is fed from springs at the east end of the lake (Figure 24). (Monitoring Big Springs Lake was outside the scope of this project). Though water stored in Big Springs Lake emerges as spring water, travel time through the lake results in variable water temperatures as water flows through the dam outlet into Big Springs Creek. Seasonal trends illustrated that water temperatures were warmer during the summer and cooler during the winter (Figure 25). Maximum and minimum water temperatures below the Big Springs Dam outlet were 19.3°C (observed on 21 July, 2009) and 6.8°C (observed on 25 January, 2010), respectively.

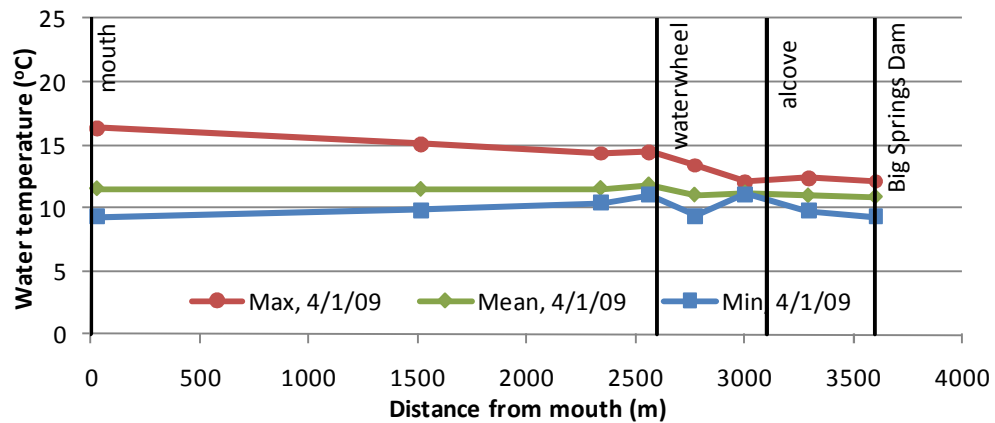
Figure 28. Maximum, mean, and minimum temperatures along the longitudinal profile of Big Springs Creek on 4/1/2009.

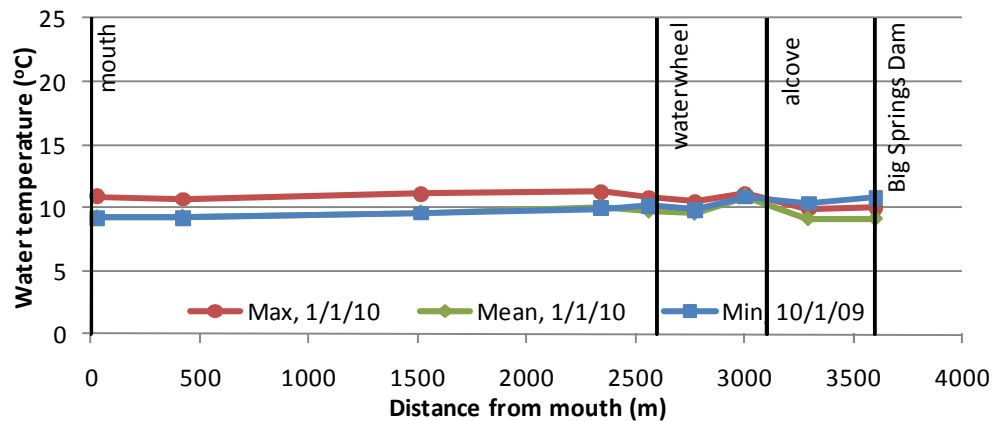
Figure 31. Maximum, mean, and minimum temperatures along the longitudinal profile of Big Springs Creek on 1/1/2010.

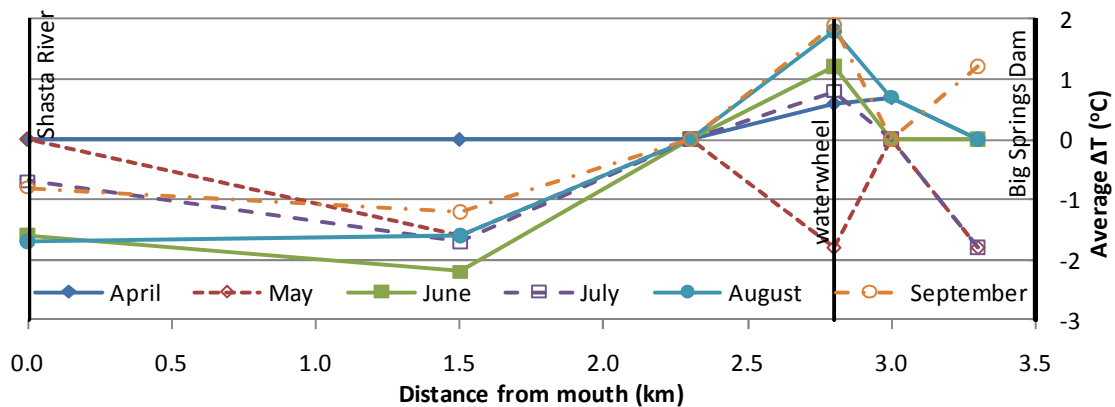
Figure 32. Average change in local daily maximum temperatures from 2008 to 2009 in Big Springs Creek.

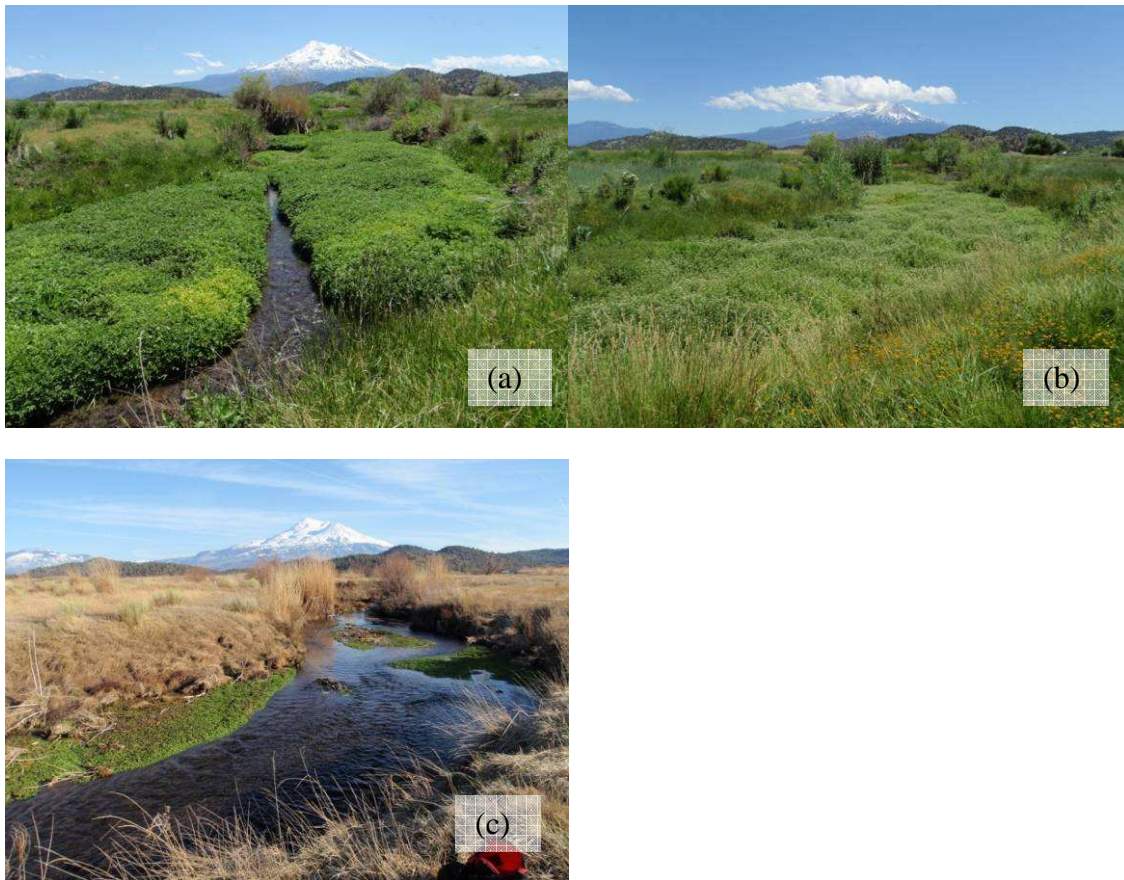
**Figure 7(a-c).** Progression of vegetation grown and senescence in the diffuse springs from (a) 19 May 2009, (b) 25 June 2009, and (c) 19 February 2010.
