Scott River Watershed Restoration Strategy & Schedule

**Prepared by
the Scott River Watershed Council
&
Siskiyou RCD**

Revised January 2014

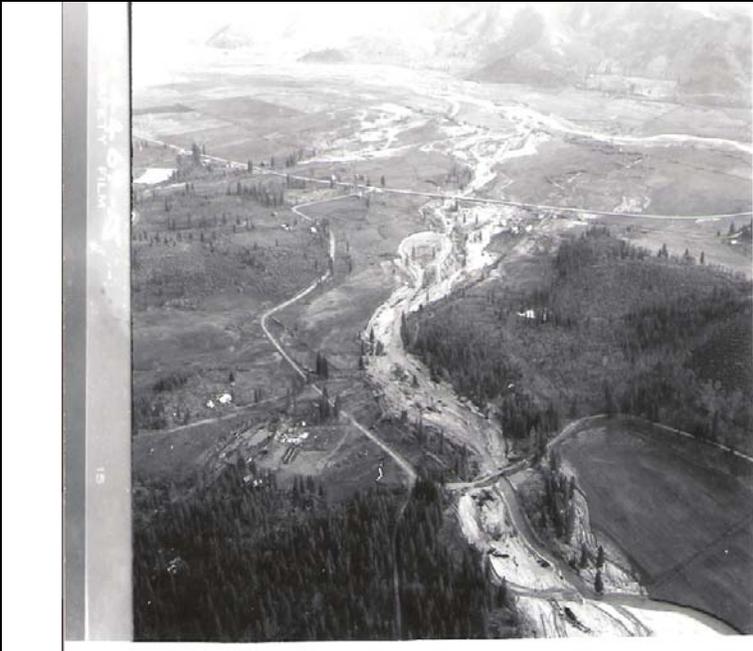
February 1965 Looking downstream at the mouth of French Creek following the 1964 flood.

The series of photographs below show changes in riparian vegetation in the Scott River Watershed over a 30-50 year timeframe. These photos show an improvement in riparian vegetation. However, vegetative growth takes a long time in the extreme conditions that exist along the gravel bars and banks of the Scott River.

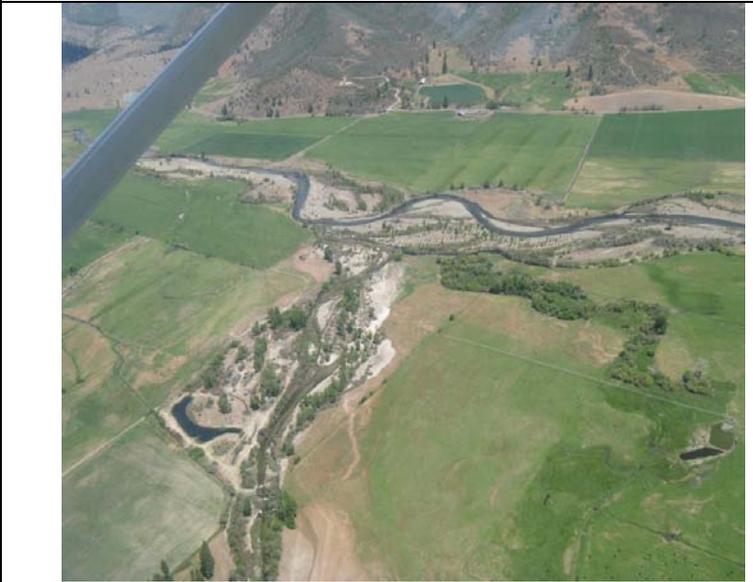
May 2008 Same location as above, following extensive riparian planting and fencing beginning in the late 1990's.

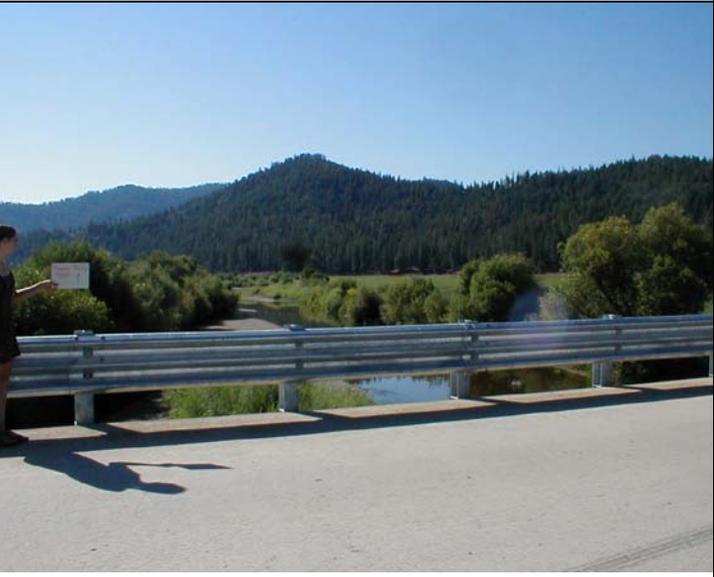
<p data-bbox="1015 949 1193 982">July 28, 2004</p> <p data-bbox="1015 1039 1388 1176">Scott River same location as above, USGS Flows recorded at 39 cfs</p>

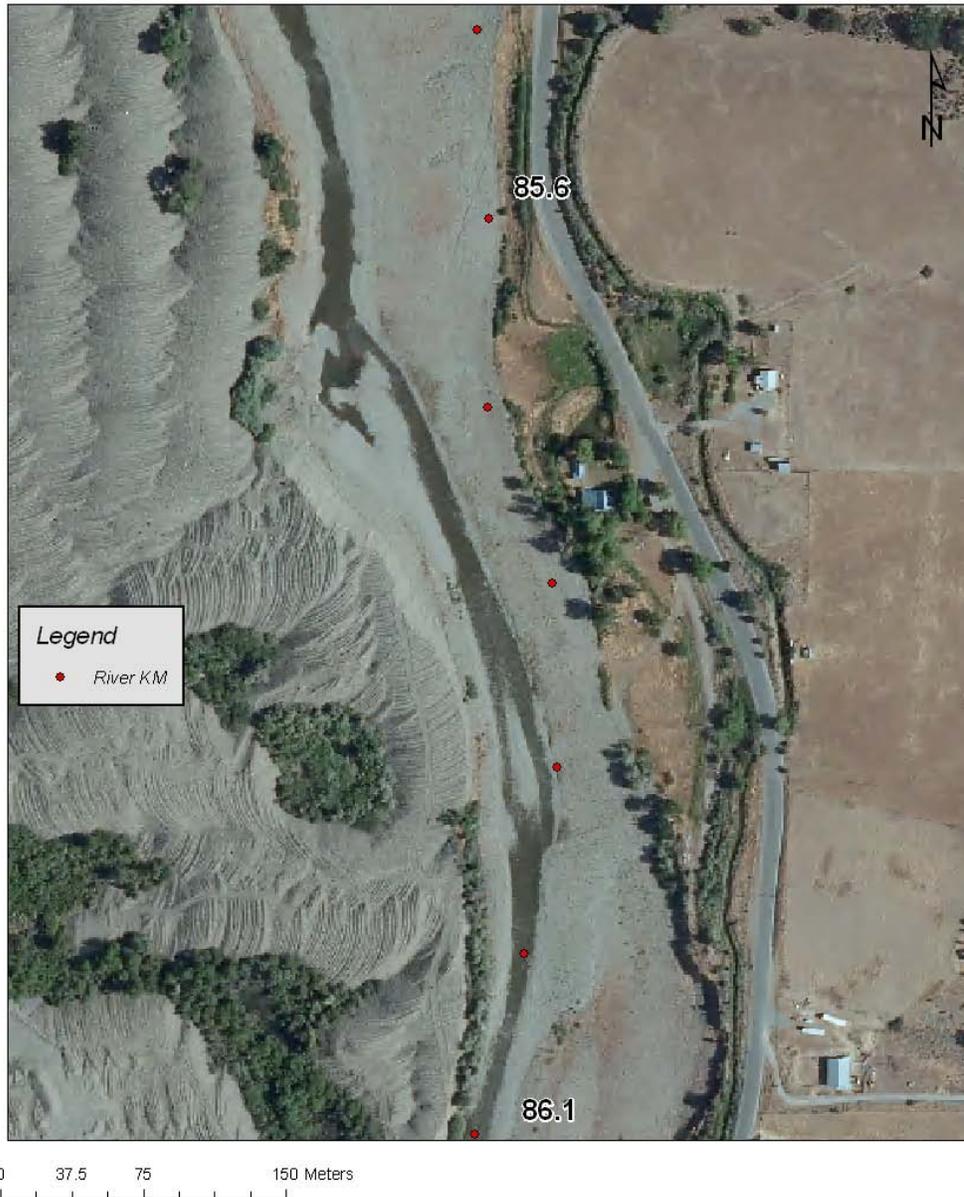
RKM 86.1 - 85.5 - NAIP 2010

Figure 4. Section of the Callahan tailings

The 2,500 foot segment shown in Figure 4. located at the downstream end of the tailing reach, was restored to a wider channel and flood plain in 2007. This reach is located where the tailings piles begin to taper off and open up to a wider channel. This lower portion of this reach has some potential to establish a riparian corridor. **See Appendix C for cross-section information.** However, the substrate in this reach is extremely large cobble with little to no fines present. The reach is very hot and dry, and the river goes

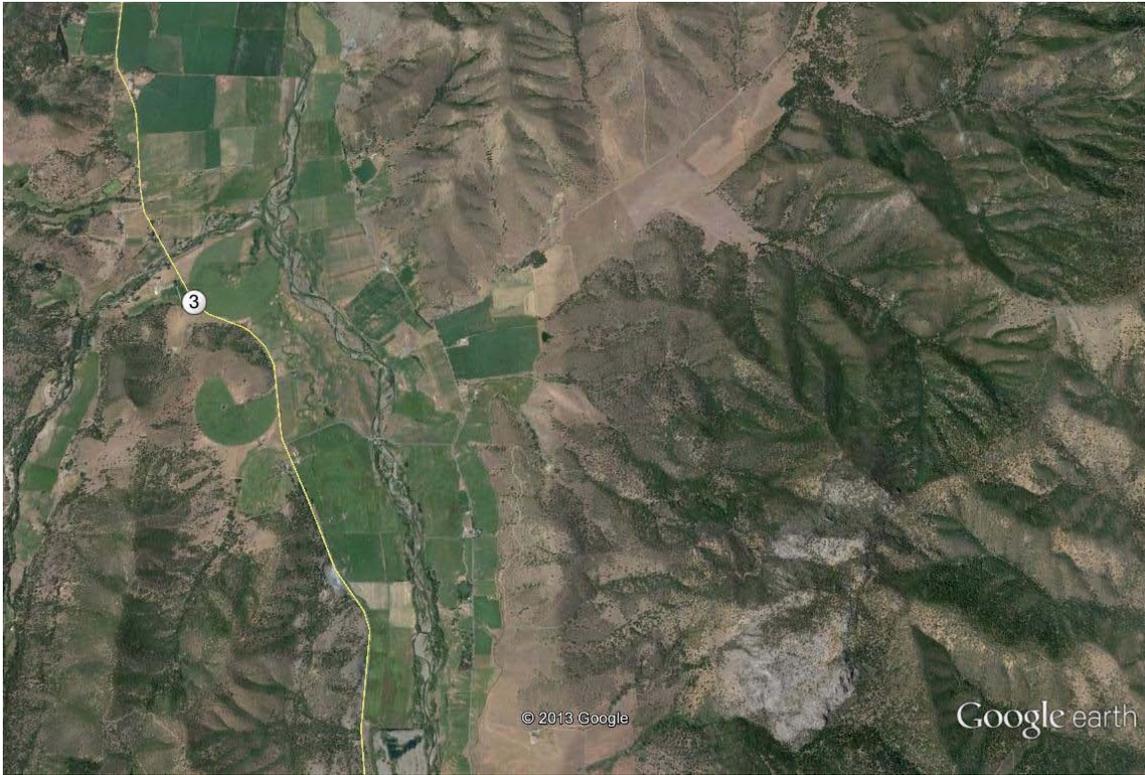
Figure 5 . Reach II. French Creek is seen entering the Scott River Center left of image.

This reach is defined by a wide floodplain and riparian zone with a relatively shallow water table, compared to the rest of the Scott River. The combined width of the available riparian zone on both sides of the stream varies from 200 to 1,000 feet, with an average of 600 feet (RCD data 2010). The available riparian zone is identified as the area between riparian exclusion fencing and the stream bank. This reach has the widest fenced riparian land and flood plain on the main stem Scott River. All locations in this reach with livestock have had exclusion fencing installed for 15 years or more. Figure 3 shows aerial imagery (GoogleEarth) taken in 2012. **Figure 5** shows the aerial imagery of this reach, with French Creek entering the Scott River in the upper left corner.

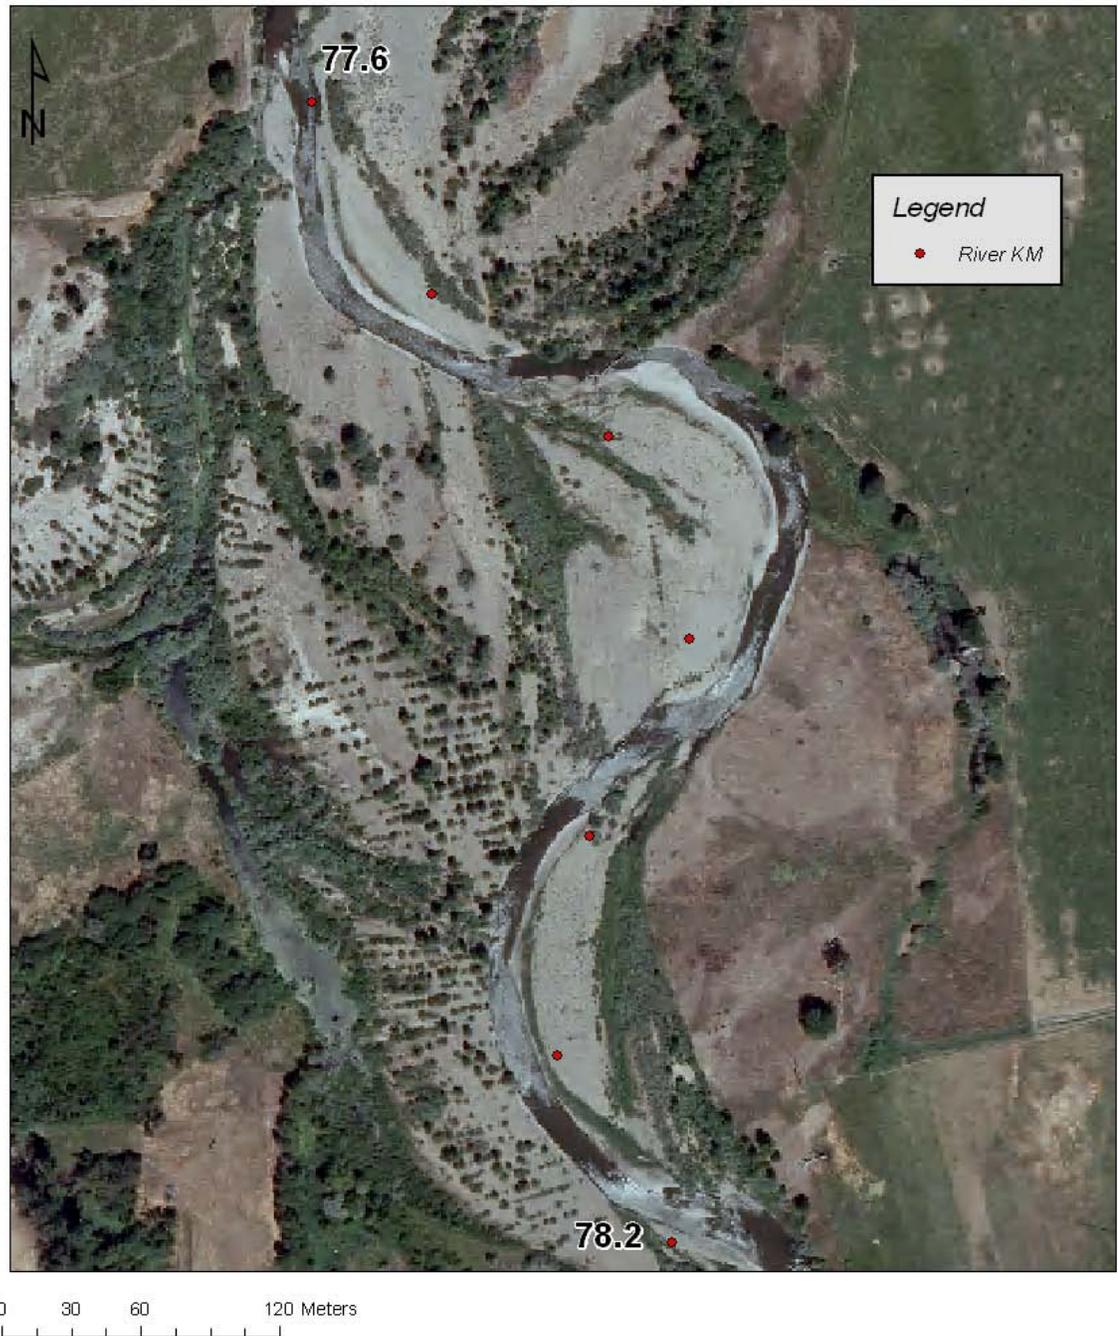
RKM 78.2 - 77.6 - NAIP 2010

Figure 6: Scott River vicinity of French Creek (Middle left of image) and Wolford Slough(bottom left quarter of image) Lidar 2010

Beaver are present in **Reach II** and **Reach III**. Current beaver dam building activity in lower French Creek and the Scott River in the vicinity of Wolford Slough may be raising groundwater elevations and contributing to the success of the plantings in this reach. Figure 6 below shows the successful plantings established in 1996 and 1997.

Planting rows visible in Figure 6 were planted in 1997 as part of the Fay Lane Project. These plantings are some of the most successful in the Scott River, both in terms of vigor and survival.

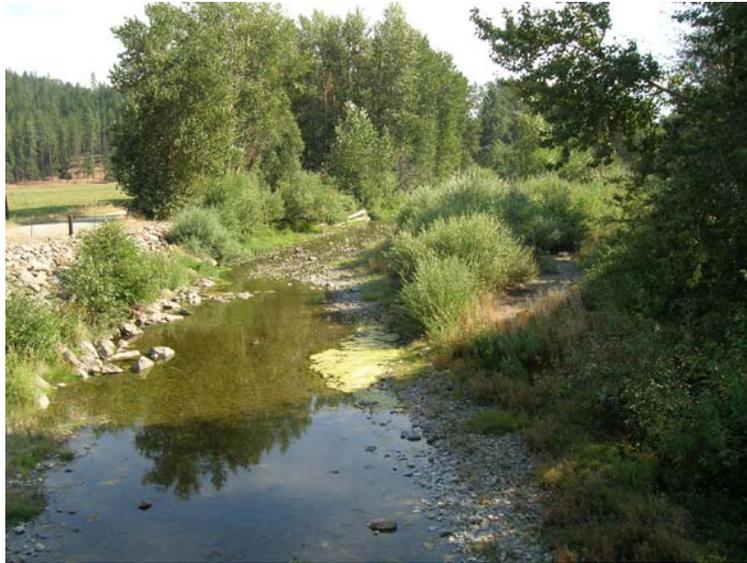
Riparian vegetation in lower Shackleford Creek.

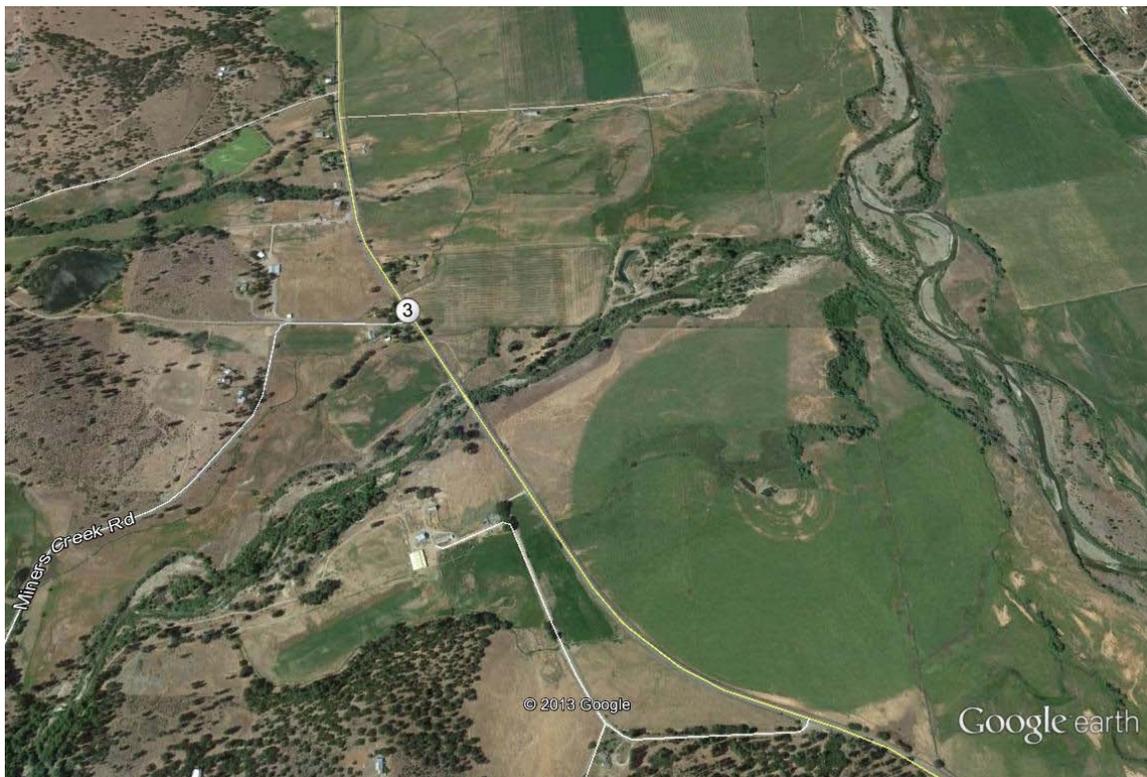
Figure 16. Scott River at the confluence with French Creek.

Beaver play an important role in the riparian ecosystem of French Creek and the mainstem Scott in the vicinity of French Creek. The dam building in this area likely contributes significantly to an elevated groundwater table. Plantings implemented in the Scott River in the vicinity of French Creek have been some of the most successful in the watershed.

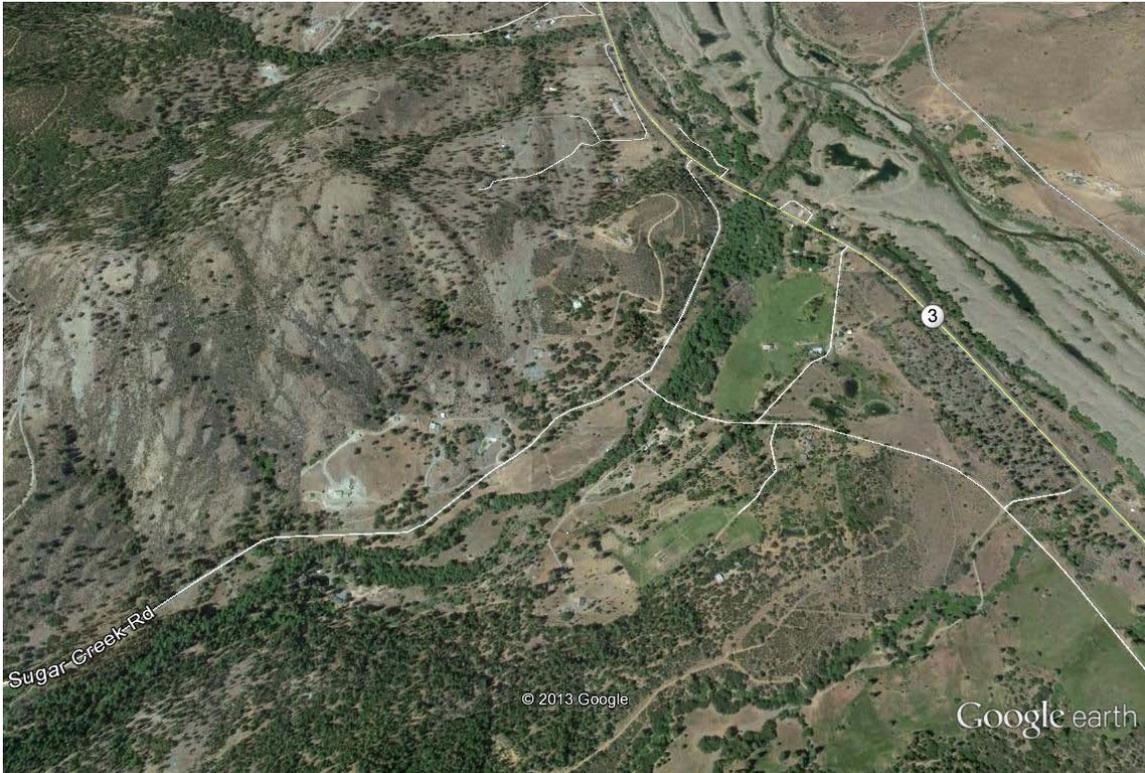
Figure 17. Sugar Creek.

Sugar Creek has no alluvial deposition section, and flows year-round. Sugar Creek has an active beaver population in the lower ½ mile, contributing to water storage and salmon habitat. The riparian canopy in Sugar Creek is mature, and provides sufficient shade to the creek. The combination of canopy, aspect, and snow-melt keep the water in Sugar Creek at an average of 16-18°C in the summer. At this time riparian replanting is not needed in Sugar Creek. However, some landowners have identified a need to protect key trees from beaver damage. This protection will be done on an as needed basis, with some tree caging beginning in 2013.

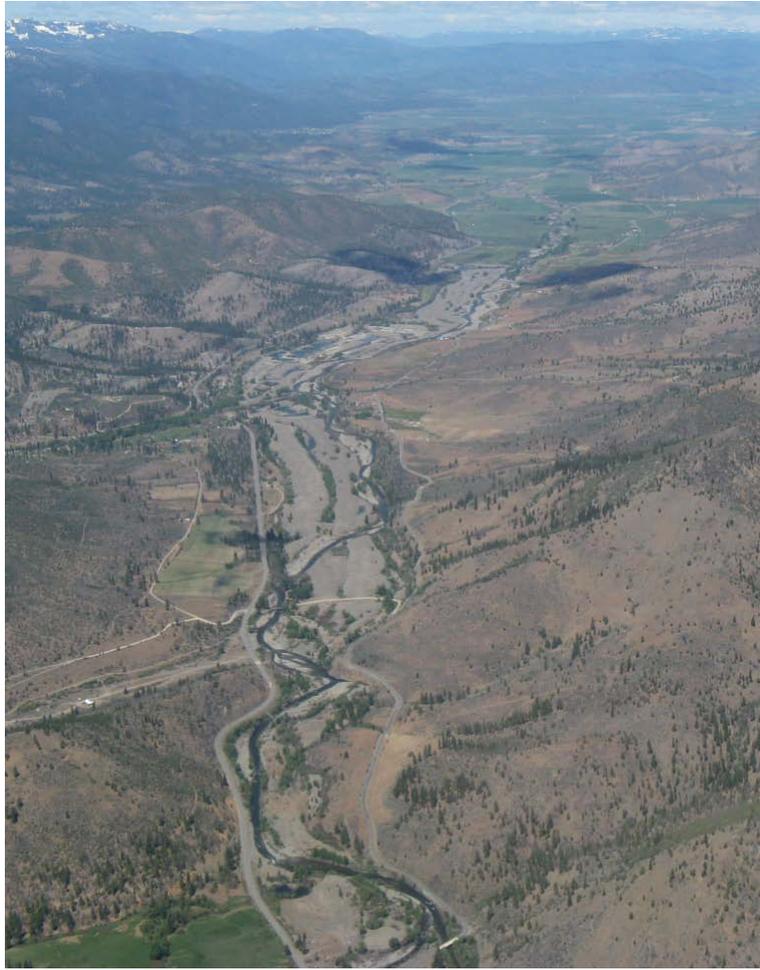
Figure 1. Aerial view of Scott River Tailing reach – confluence of Scott River Forks in extreme foreground

Several large tributaries of the Scott River (including McAdams Creek and the South Fork of the Scott River) have significant amounts of tailings along the stream's banks and floodplain. Large scale dredger mining of the Scott River's main stem (RM 52.3 – 56.4) from 1936 – 1951 by the Yuba Consolidated Gold Fields Company heavily impacted the channel and riparian corridor. Dredger mining essentially turns the river bed's substrate "upside down" compared to natural conditions. This leaves the surface substrate as primarily large cobble with little fines to provide nutrients and store water. Generally, the tailing piles are several feet in elevation above the water's surface limiting access to the floodplain and the dissipation of energies during high water events. Frank J. Jackson - a former Conservationist of the Siskiyou Soil Conservation District - stated in an undated document: "The handling of these dredger tailings and the damage they are causing to the best lands in Scott Valley was one of the most important reasons or motivations for the formation of the Siskiyou Soil Conservation District in 1949." (F.J. Jackson, Undated).

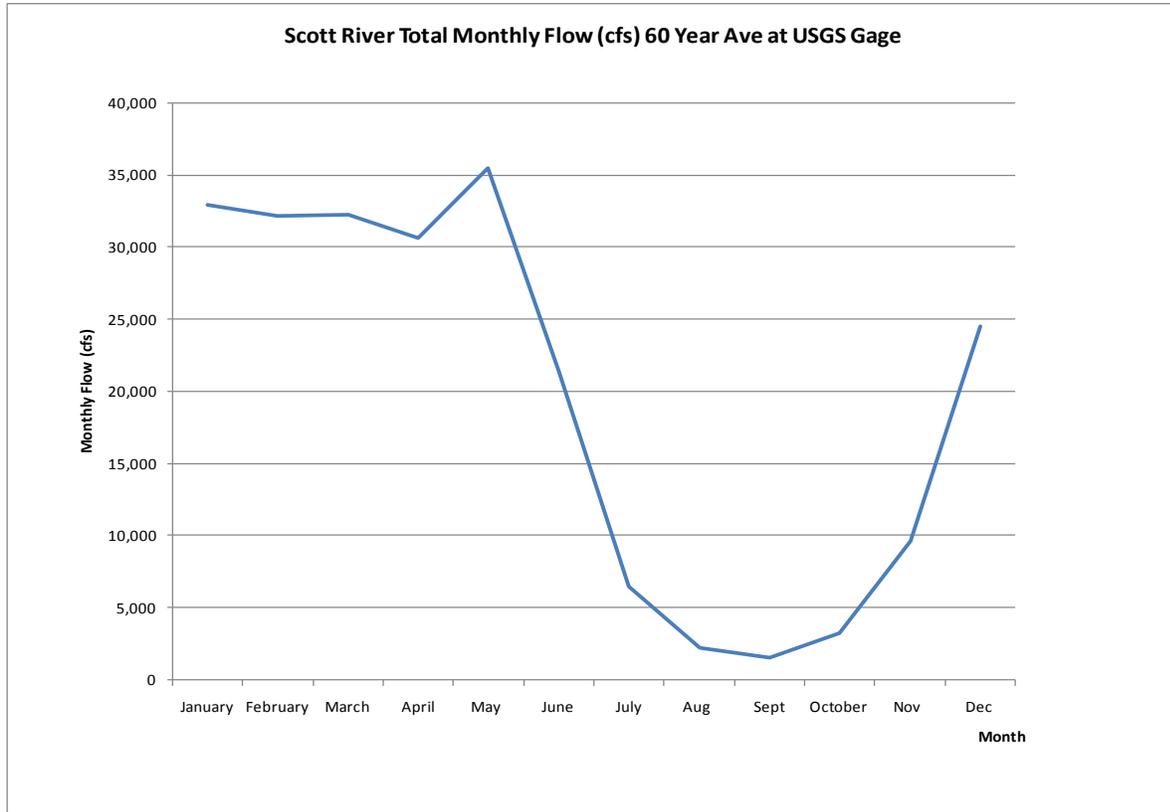
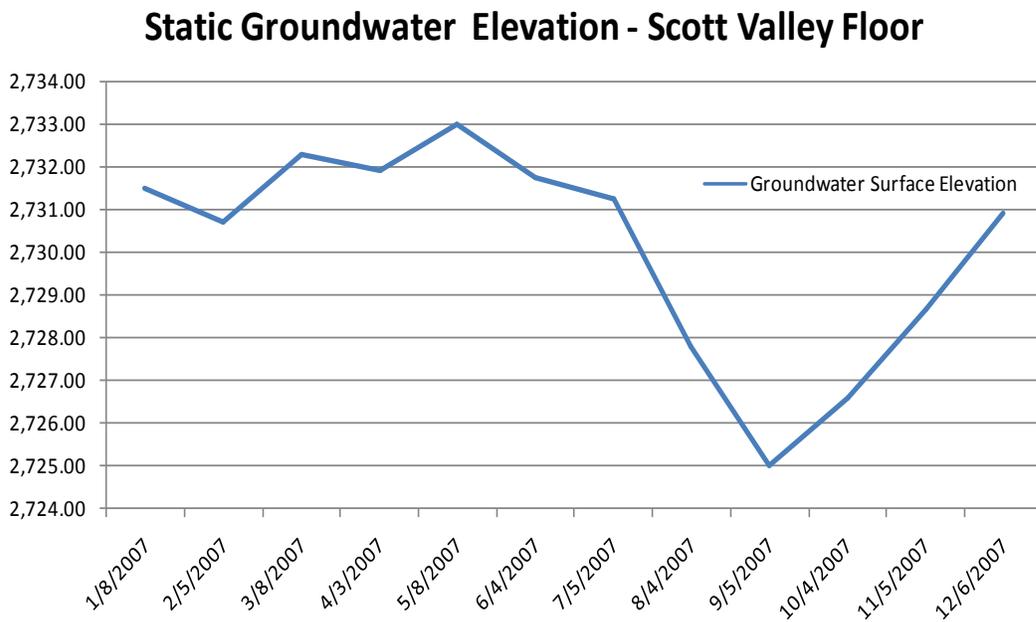
Figure 3 – The top graph depicts accumulated monthly flow (60 year average) at USGS gage Scott River below Ft. Jones and the bottom graph depicts the static groundwater elevation in a randomly selected well on the Scott Valley Floor

Altered hydrologic regime and access to the flood plain: The Scott River typically has relatively high flows during the period of snow melt runoff which lasts from spring until early July. After this point instream flows, and potentially the water table, drop relatively rapidly (Figure 3). The rapidly dropping water table can cause the root structure of newly established plantings to become dry and die during the months of summer and early fall. The soil moisture in the soil profile above the water table (vadose zone) becomes extremely low to non-existent in areas that are not irrigated during the dry months of summer and fall. It is hypothesized that access to the aquifer’s water table or irrigation is essential for the survival and establishment of riparian plantings.

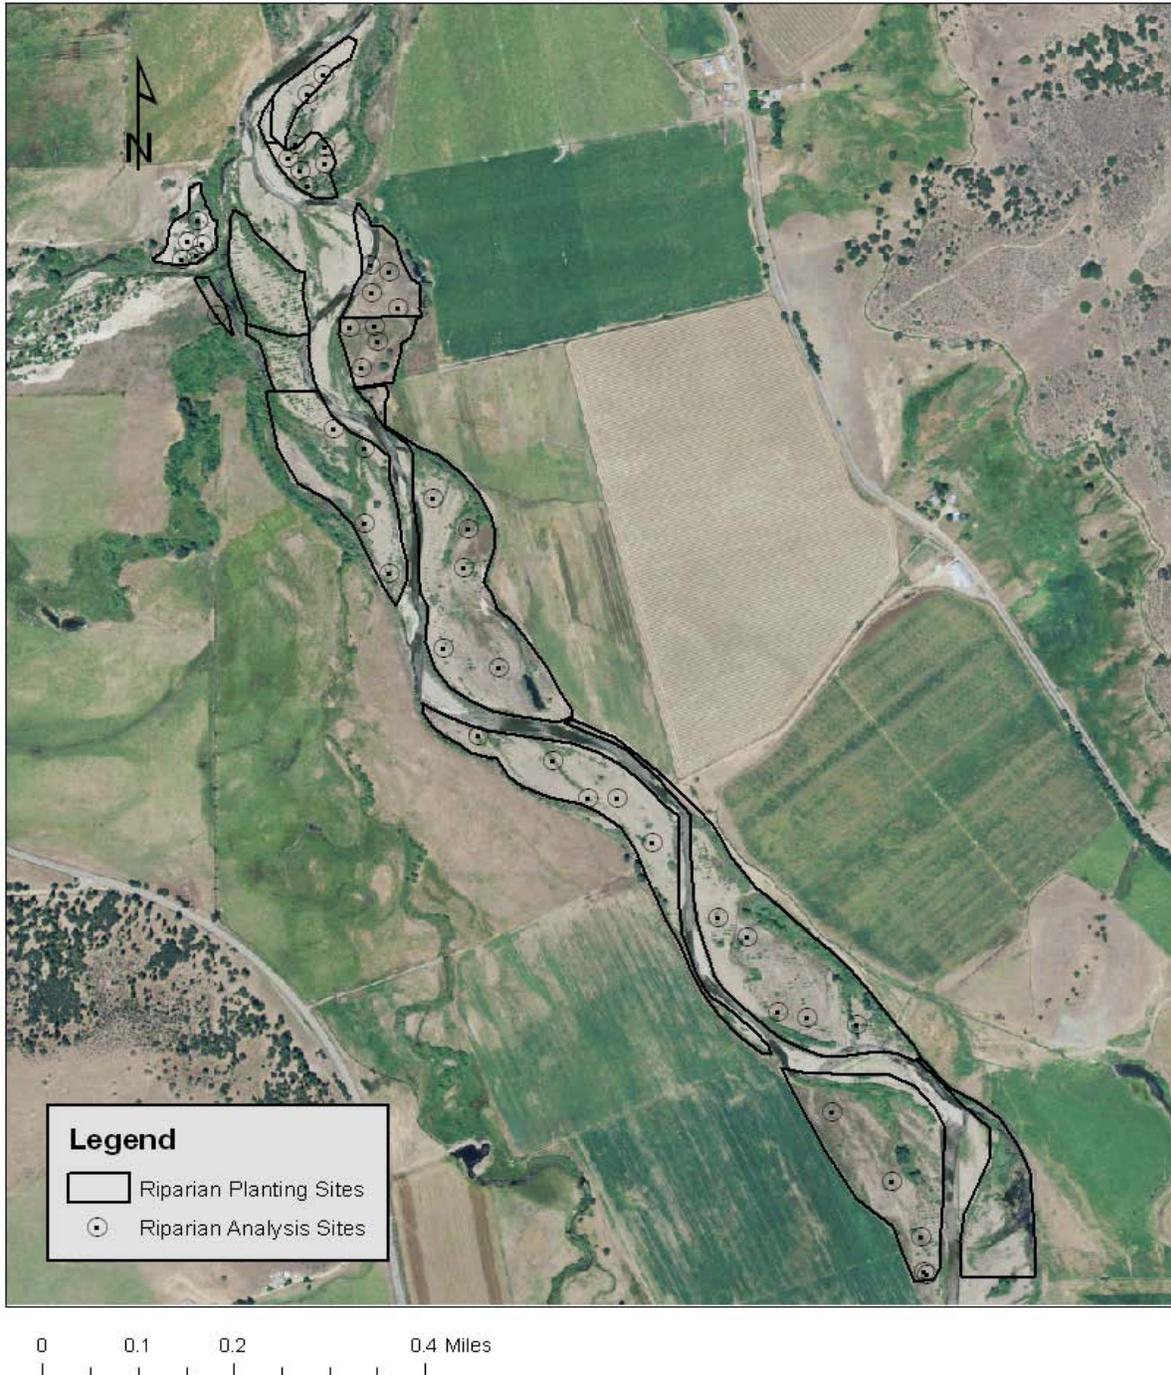
Cantara above Fay ~ Planting plots and Analysis Sites

Map #5 – Cantara plantings and analysis sites

replanted in 1998. Plantings on gravel bars were subject to cambium burn from heat reflected from the exposed substrate. There are plantings surviving at nearly all of the planting sites with the exception of a couple plots on the east side of the river that are currently barren.

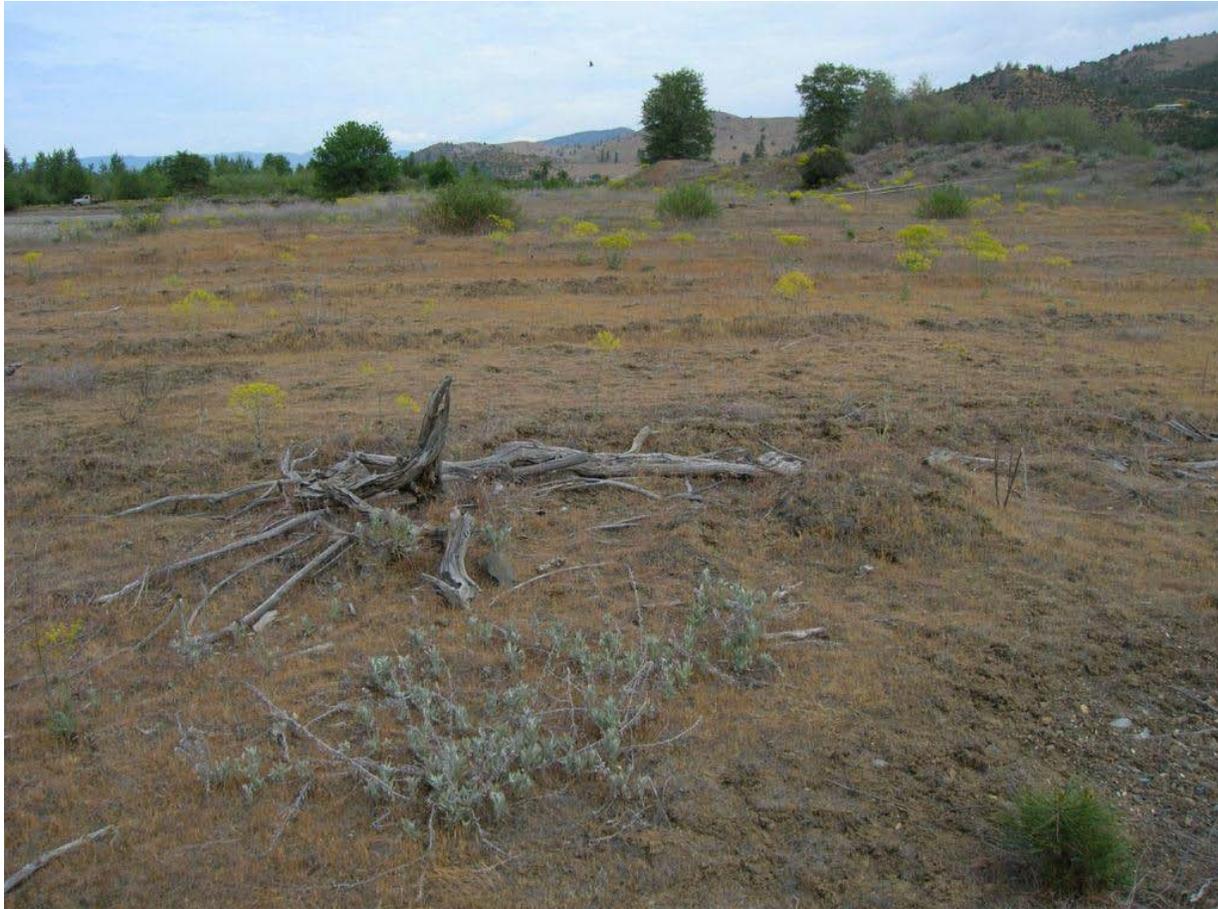
Figure 11 – Failed riparian planting on east side of Scott River above French Cr. Confluence

Failed sites: Plantings directly across the Scott River from Wolford Slough (e.g., Osprey Site) were a complete failure (Figure 11). This location's soil is primarily composed of gravel and cobble, with poor water retention and no protection from solar radiation. This site was planted with rooted stock and irrigated with drip line for a period subsequent to planting. The site is currently vegetated with sparse willows and severely stunted pine trees with grasses covering a portion of the ground. The exact reasons this site failed are unknown but it is hypothesized that a combination of extreme local heat on the barren bar, limited availability of water during the low flow period and poor soil conditions limited the success of the plantings. It is unknown if extensive irrigation and protection maintenance would generate success in this location. There is currently no riparian vegetation to create a shaded and cooler micro-climate during the summer months to aid the success and survival of introduced plantings. Protection measures (e.g., cages with shade cards and mulch) might create the desired micro-climate around each plant.

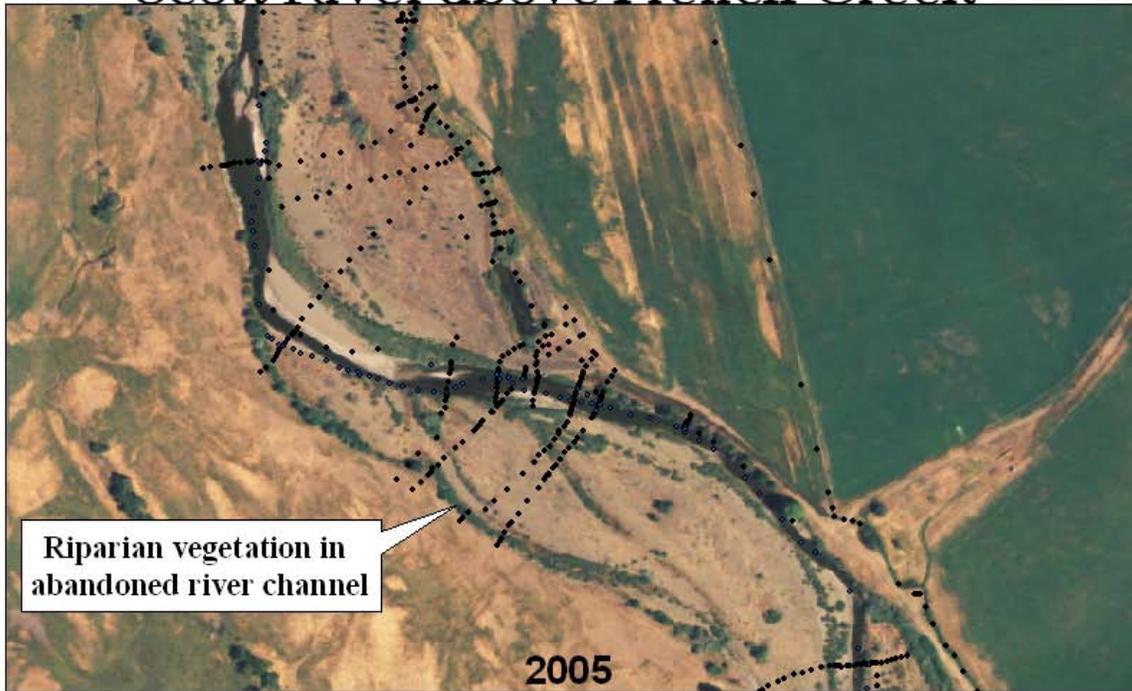
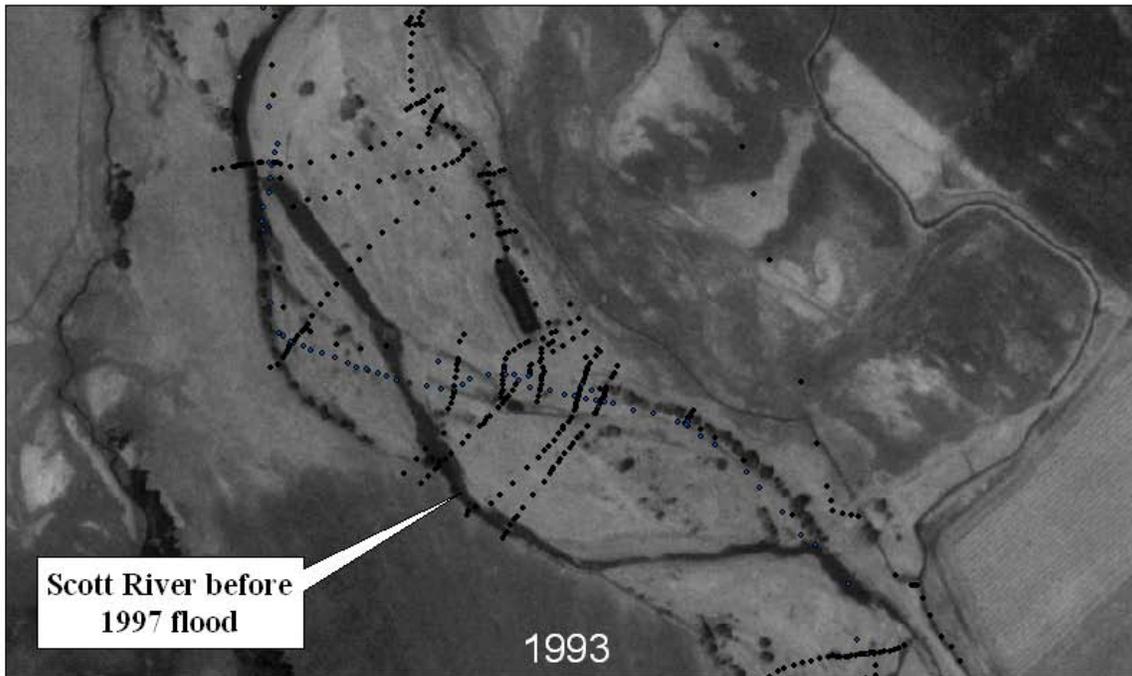
Figure 17 – Aerial images of study reach in 2005 (above) and 1993 (below)

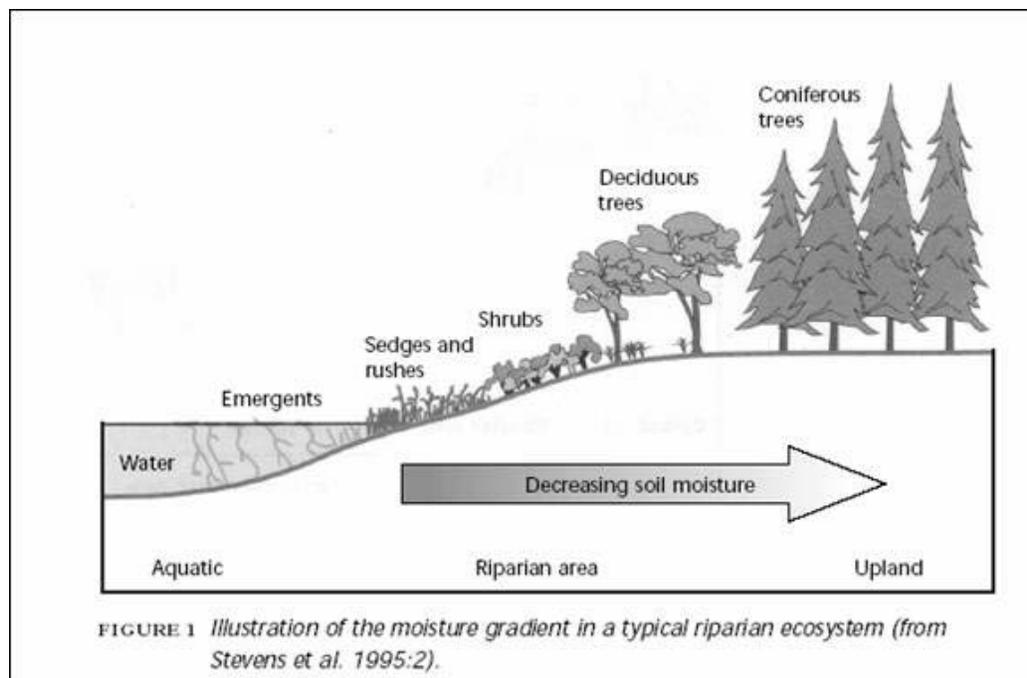
Figure 19 – Schematic illustration of “typical” riparian ecosystem

Riparian plantings in this reach have not been very successful. It is hypothesized that this is partially attributable to the levees and constrained channel conditions and deeper water table. It is hypothesized that the leveed nature of the banks of this reach (downstream from Etna Creek especially) makes it not truly “riparian” This area lacks the bank structure to fully support a riparian corridor. The elevations and soil moisture of the leveed banks are characteristics more representative of the “upland zone” (Figure 19). It is expected that cottonwoods and pine trees might flourish in this but willows might have a more difficult time becoming established. The development of effective planting techniques for areas adjacent to the stream with high land elevations relative to surface and groundwater and low soil moisture is an essential prerequisite to direct future planting efforts in this reach with limited historic planting success.

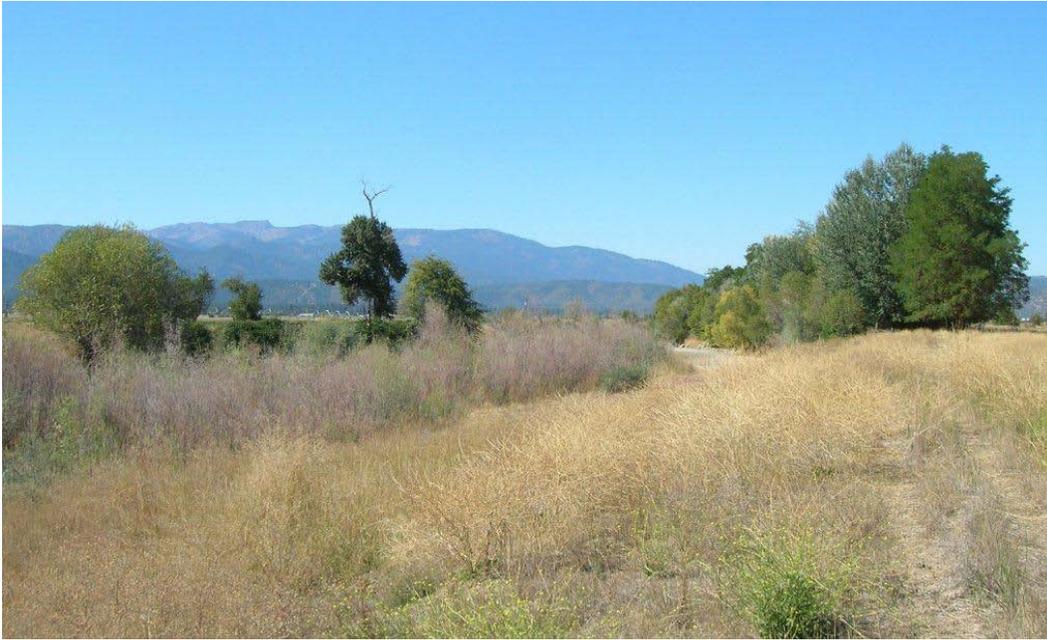
Figure 22 – Riparian canopy in area of RKM - 66

The landowner of the surveyed reach has noted that a large number of the mature cottonwoods that were present through this reach have died in the near past. It is hypothesized that stream down cutting through this reach has lowered the water table effectively leaving the mature trees root structure above the base flow water table resulting in death. This example demonstrates the importance of insuring the survival of existing riparian vegetation while trying to introduce new riparian growth.

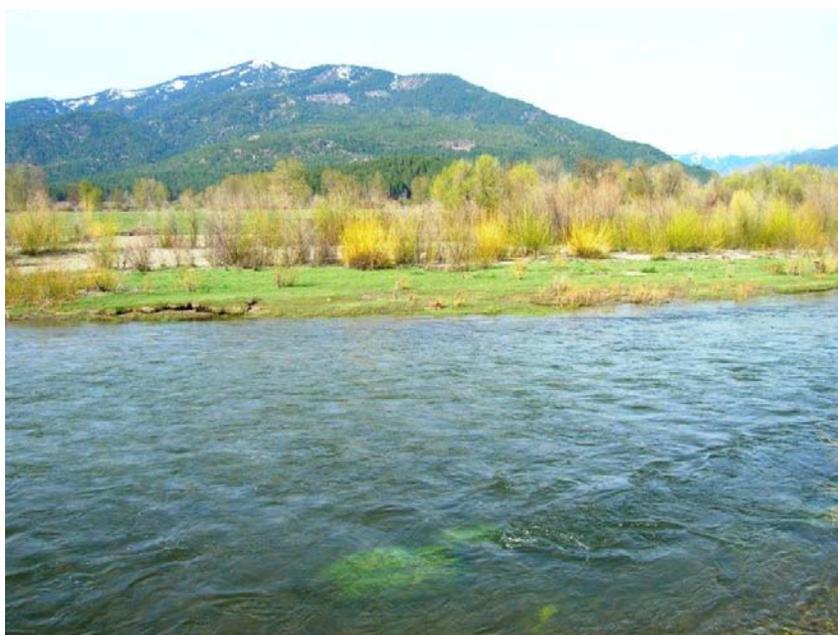
Figure 24 – representative stream bank above Shackelford Creek

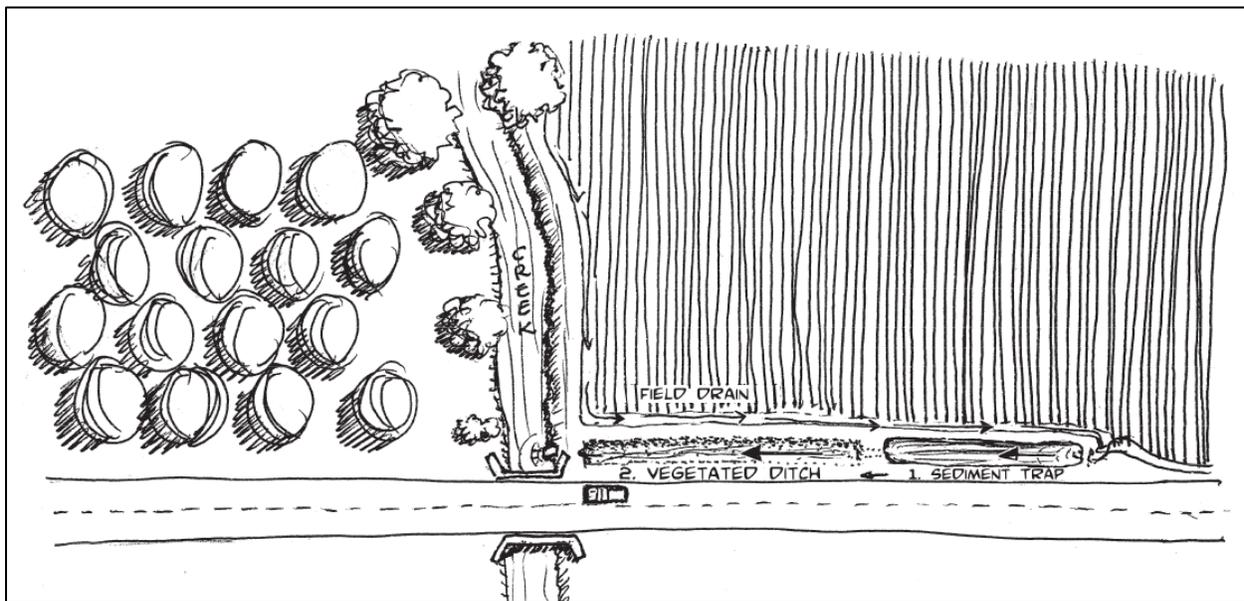
Figure 1. A sediment trap and vegetated drainage ditch slow and filter water as it runs off an agricultural field to a nearby creek

Vegetated drainage ditches are typical agricultural drainage ditches planted with a selection of plants, which act as binding sites for pesticides and fertilizers that have run off fields during irrigation or storm events, reducing movement of agricultural chemicals from the field to the waterway. At sites with high concentrations of sediment in runoff water, it may be necessary to couple vegetated ditches with an upstream sediment trap to reduce sediment deposition that can smother the vegetation to prolong the useful life of the ditch (Figure 1).

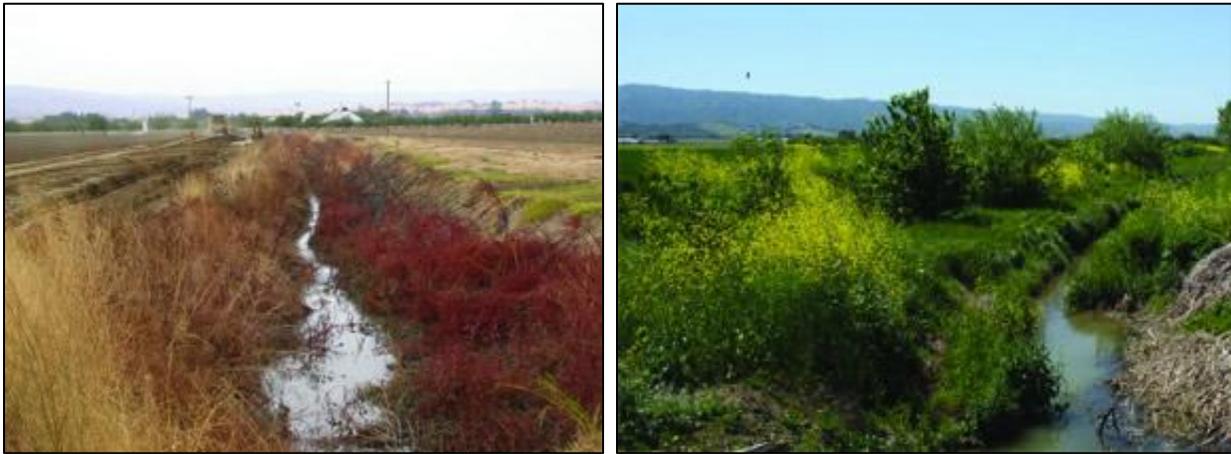
Figure 3. Willow Slough on Oakdale Ranch before the project (left, an incised drainage ditch with steep banks covered in non-native vegetation) and after (right, more gently sloped banks provide a lower bench for high floods covered in native grasses and an upper bench with a maturing riparian forest).

John Stephens originally approached Audubon California with the idea of restoring wildlife habitat on his land. Early on, all parties agreed that improving flood control and water conveyance along the one-mile stretch of Willow Slough where it crosses the ranch was also a priority. Each winter the incised slough flooded fields and a nearby highway and required reshaping with heavy machinery. The maintenance was costly for Stephens, the local water district and the neighboring town of Madison. Thus, the project was designed to achieve multiple benefits: improving wildlife habitat and also minimizing harmful flooding. In the project's second year, Willow Slough's banks were sloped back, rising gently above the channel, mimicking a natural floodplain and re-vegetated with native plants (EDF 2005). Stephens enthusiastically describes the teams of teenagers that came out to plant the native vegetation through the Student and Landowner Education and Watershed Stewardship program (SLEWS). SLEWS engages California high school students in habitat restoration projects that enhance classroom learning, develop leadership skills and result in real positive impact for the environment.

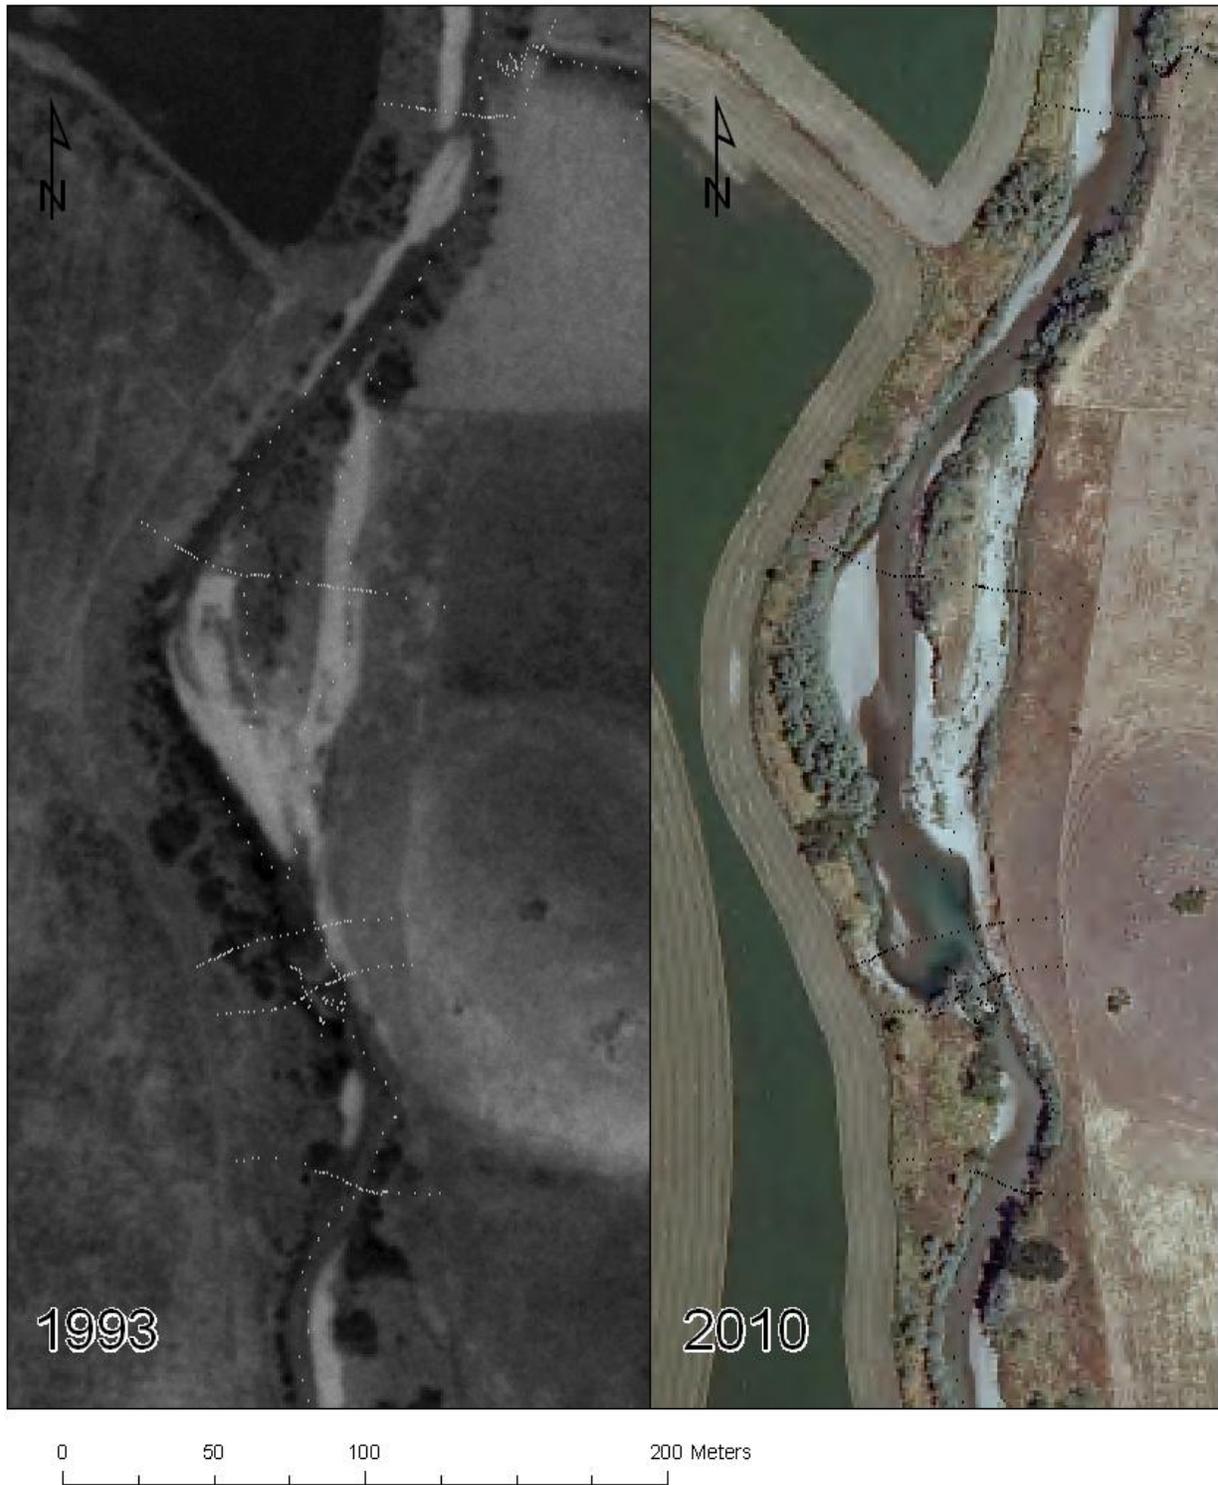
Map 5 – aerial images from 1993 and 2010 – site of failed bridge and “island”
