Scott River Watershed Restoration Strategy & Schedule

**Prepared by
the Scott River Watershed Council
&
Siskiyou RCD**

Revised January 2014

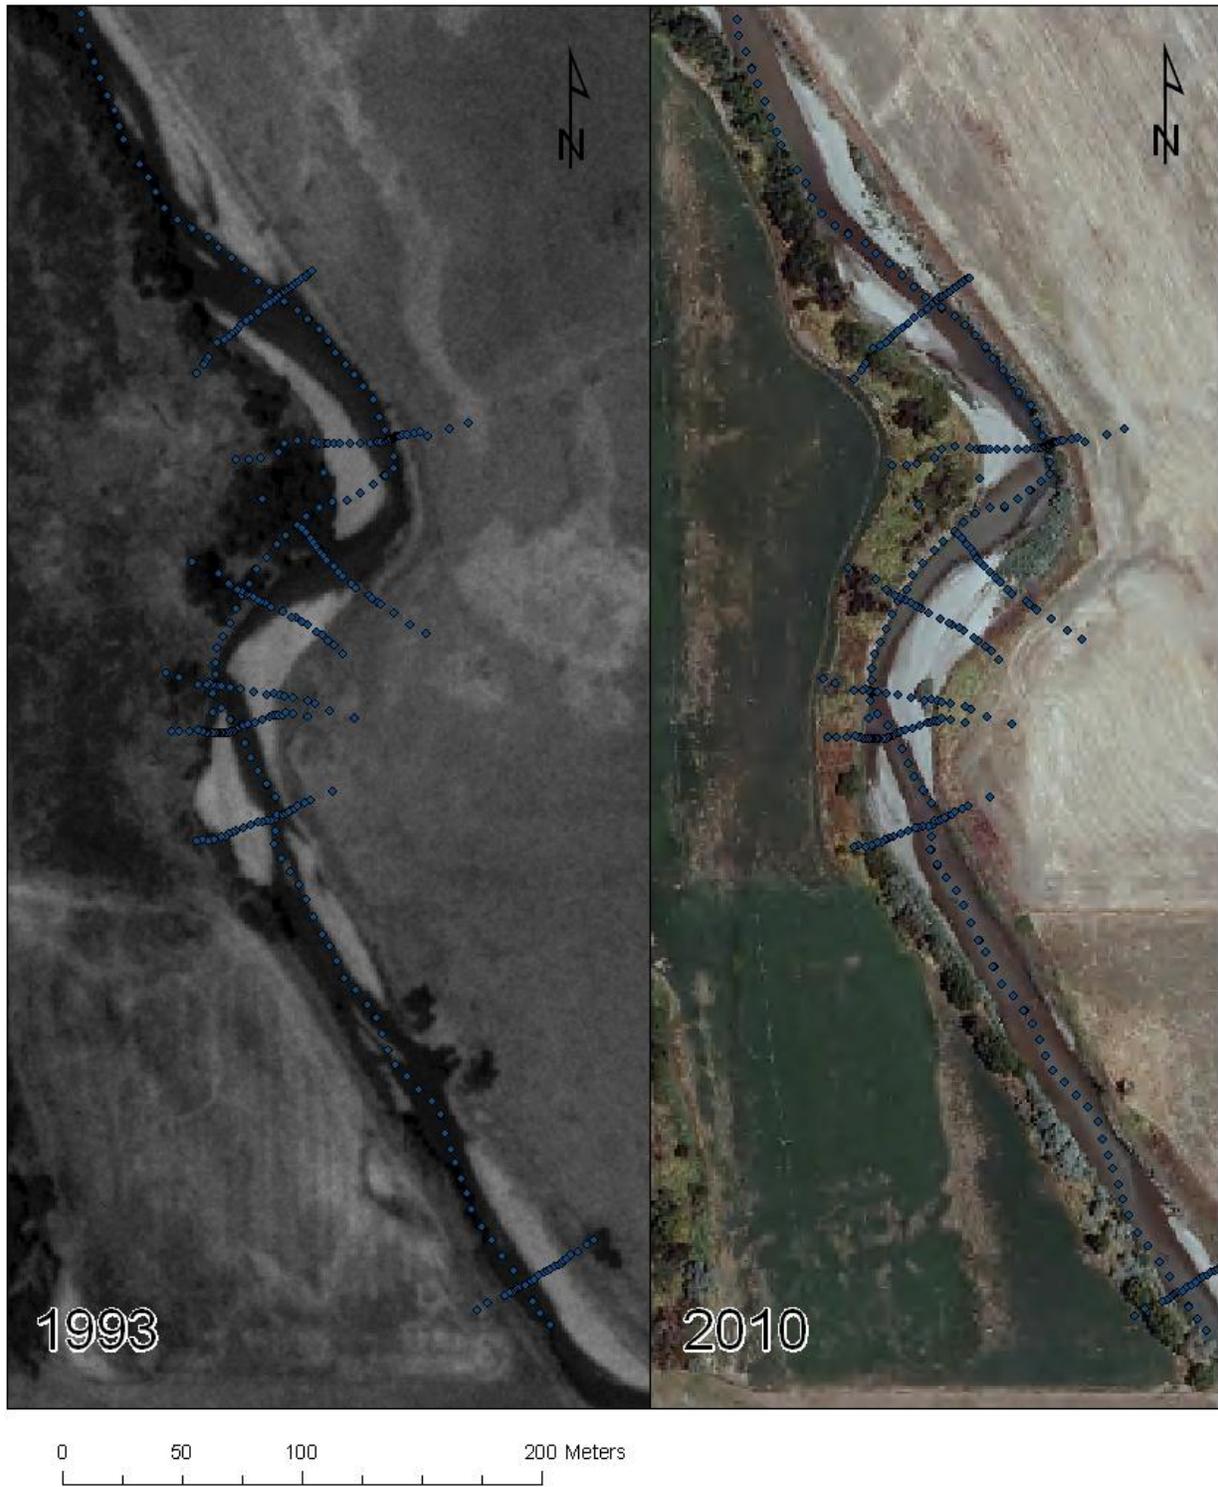
Map 4 – aerial images of reach with vertical cut bank – 1993 and 2010

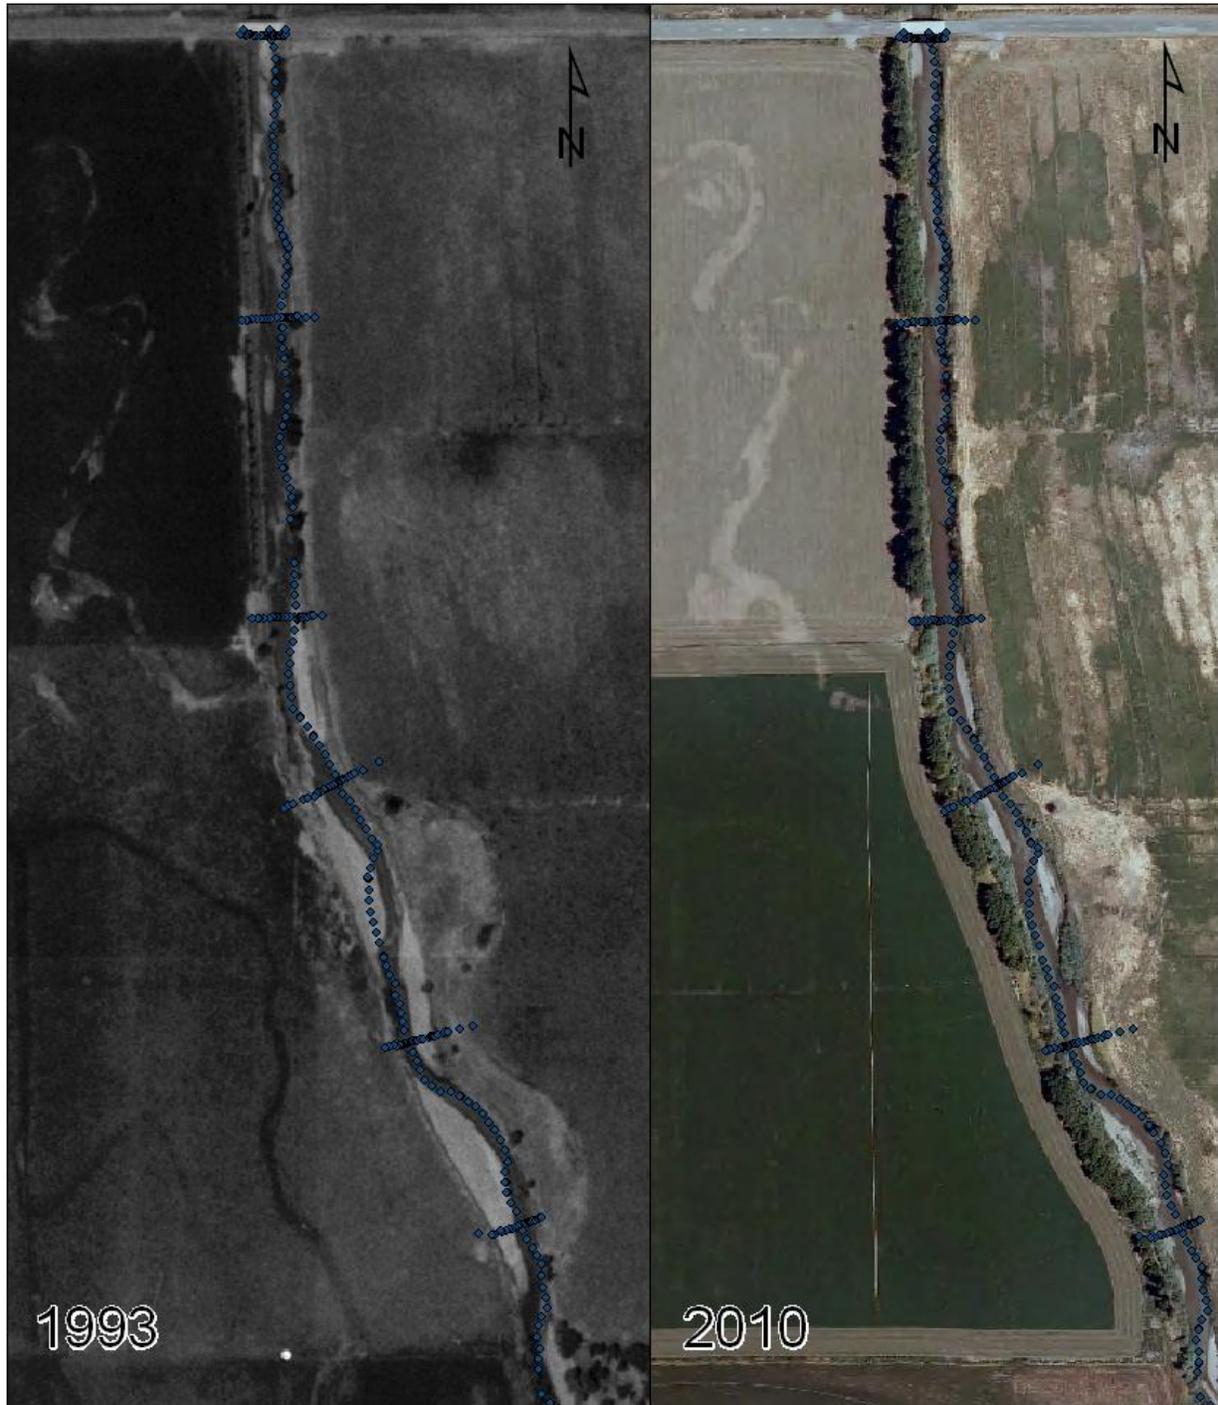
Map 5 – aerial images of reach with successful riparian plantings on West bank – 1993 and 2010

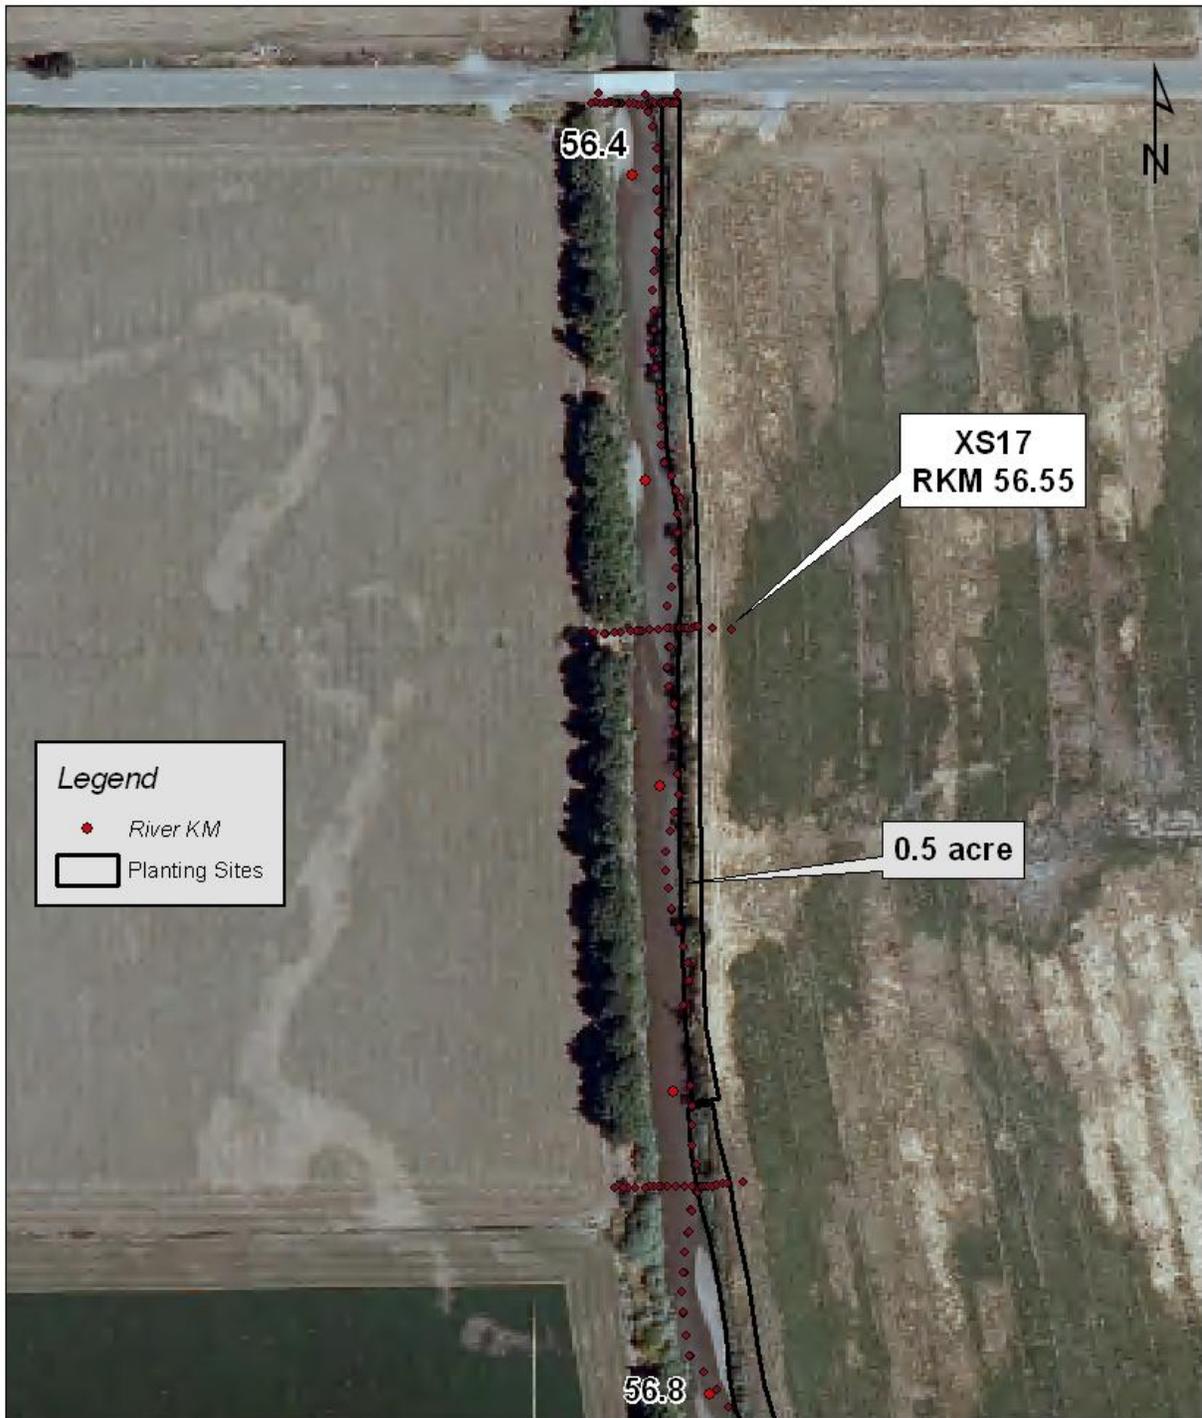
Map 6 – potential planting sites – RKM 56.4 – RKM 56.7

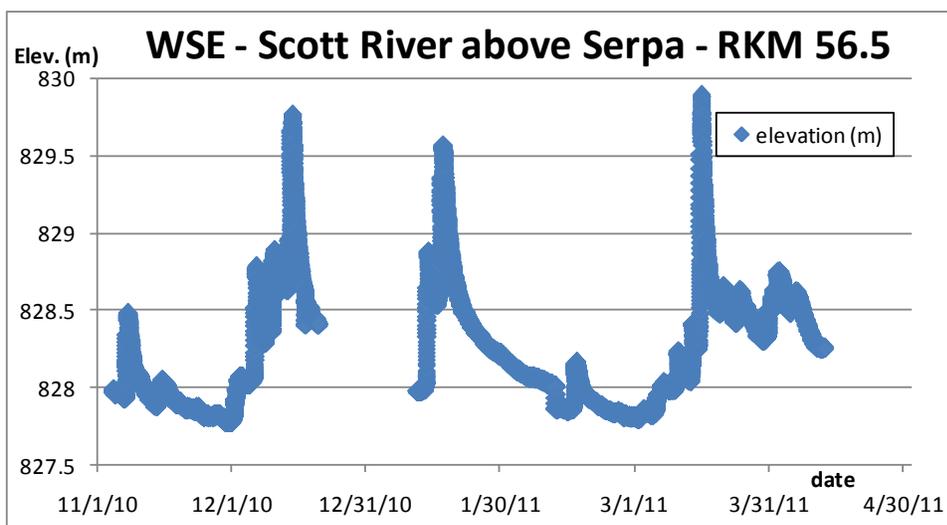
Graph 22 – water surface elevation during winter and early spring runoff – WY2011

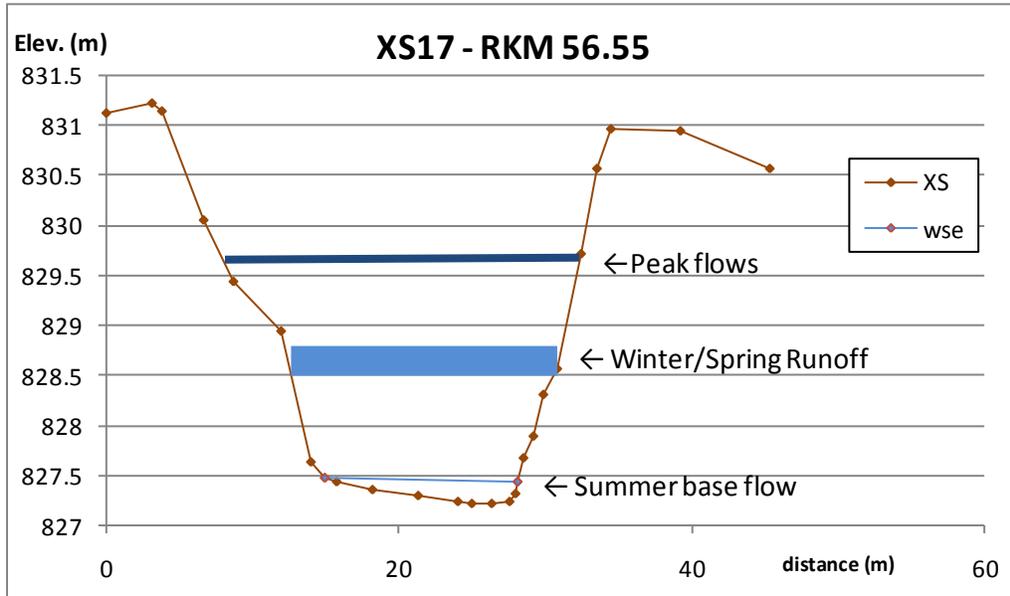
Graph 23 – Calculated water surface elevation during summer and winter flow regimes

A transect (XS17) was surveyed directly upstream of gauged pool. The elevation for summer base flow , average winter runoff and peak flow events was transposed onto the upstream transect (Graph 23). This demonstrates that the water surface elevation of winter and spring runoff is approximately 1 meter higher than the elevation of summer base flow. The water surface elevation for the observed peak flows are greater than 2 meters higher than the elevation of summer base flow. This analysis will assist in the determination of the lowest elevation of desired plantings.

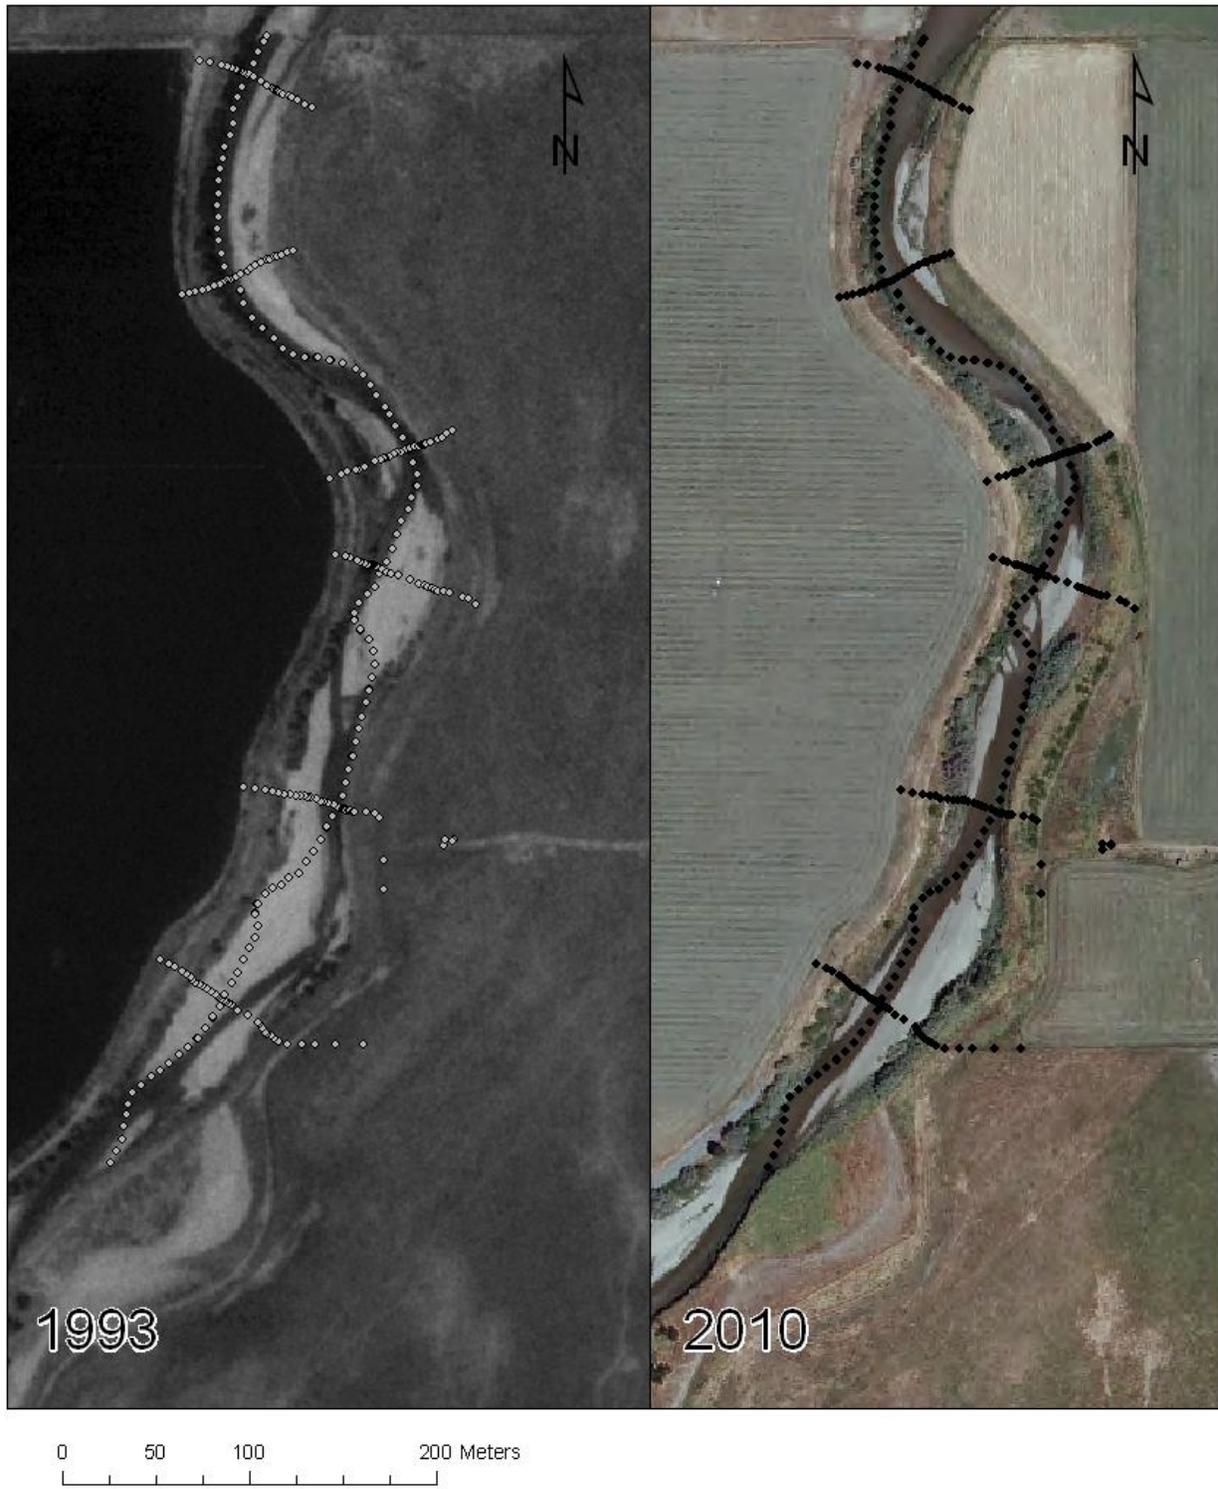
Map 2 – Scott River Morphology RKM 60.3 – 59.6 – 1993 & 2010

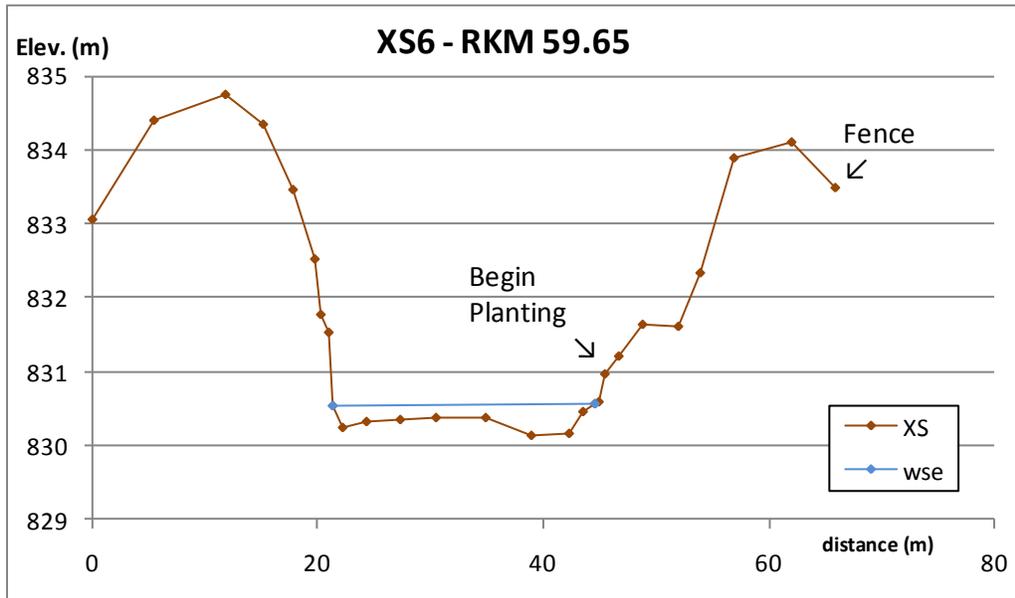
Graph 9 – XS6 – depicting potential planting site on right bank

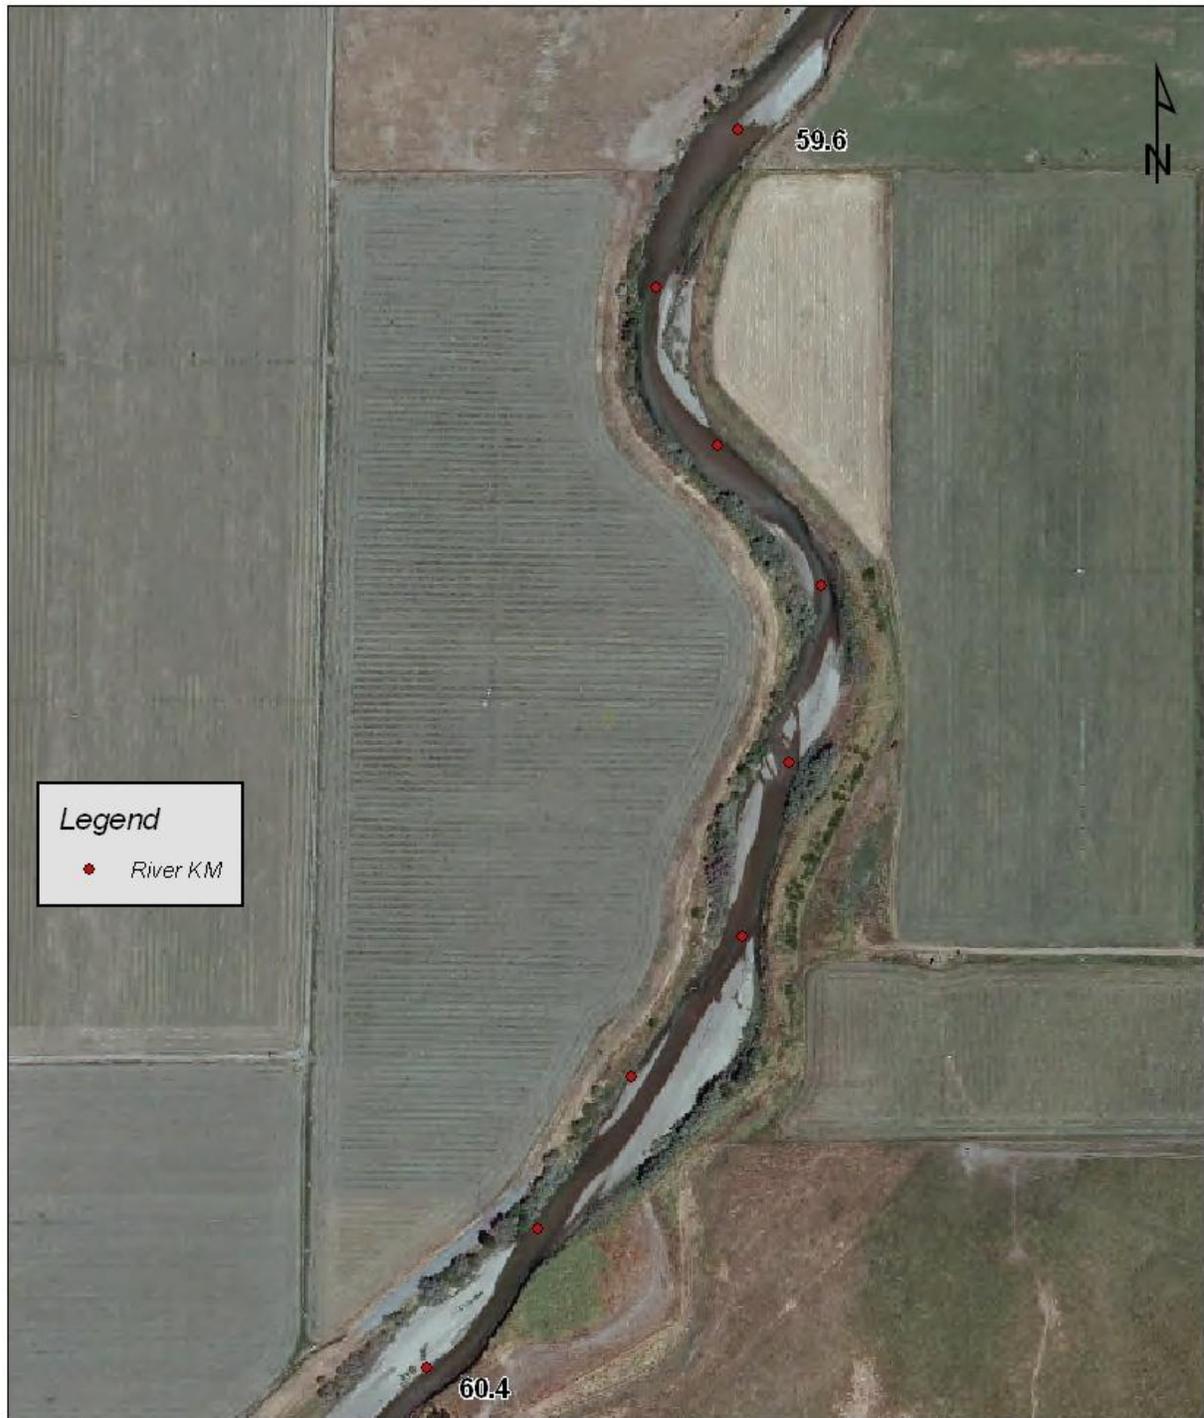
Map 4 – 2010 NAIP imagery of reach

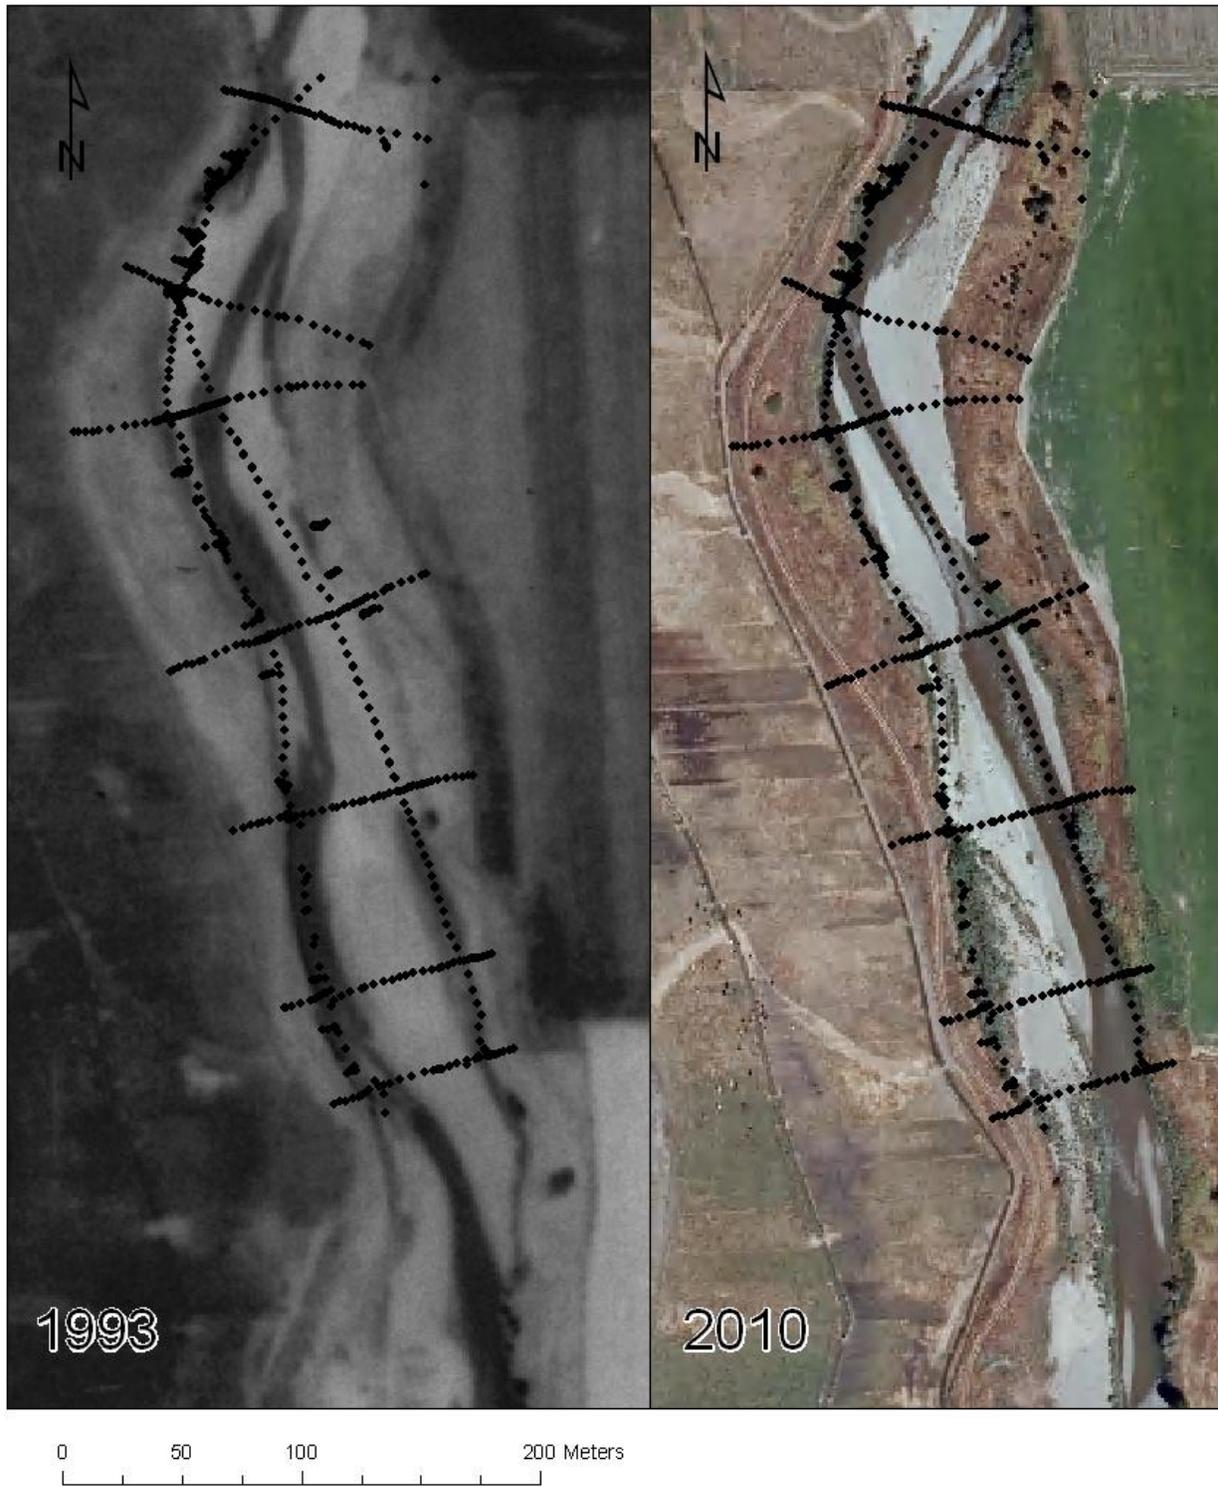
Map 2 – Surveyed reach – aerial images from 1993 and 2010

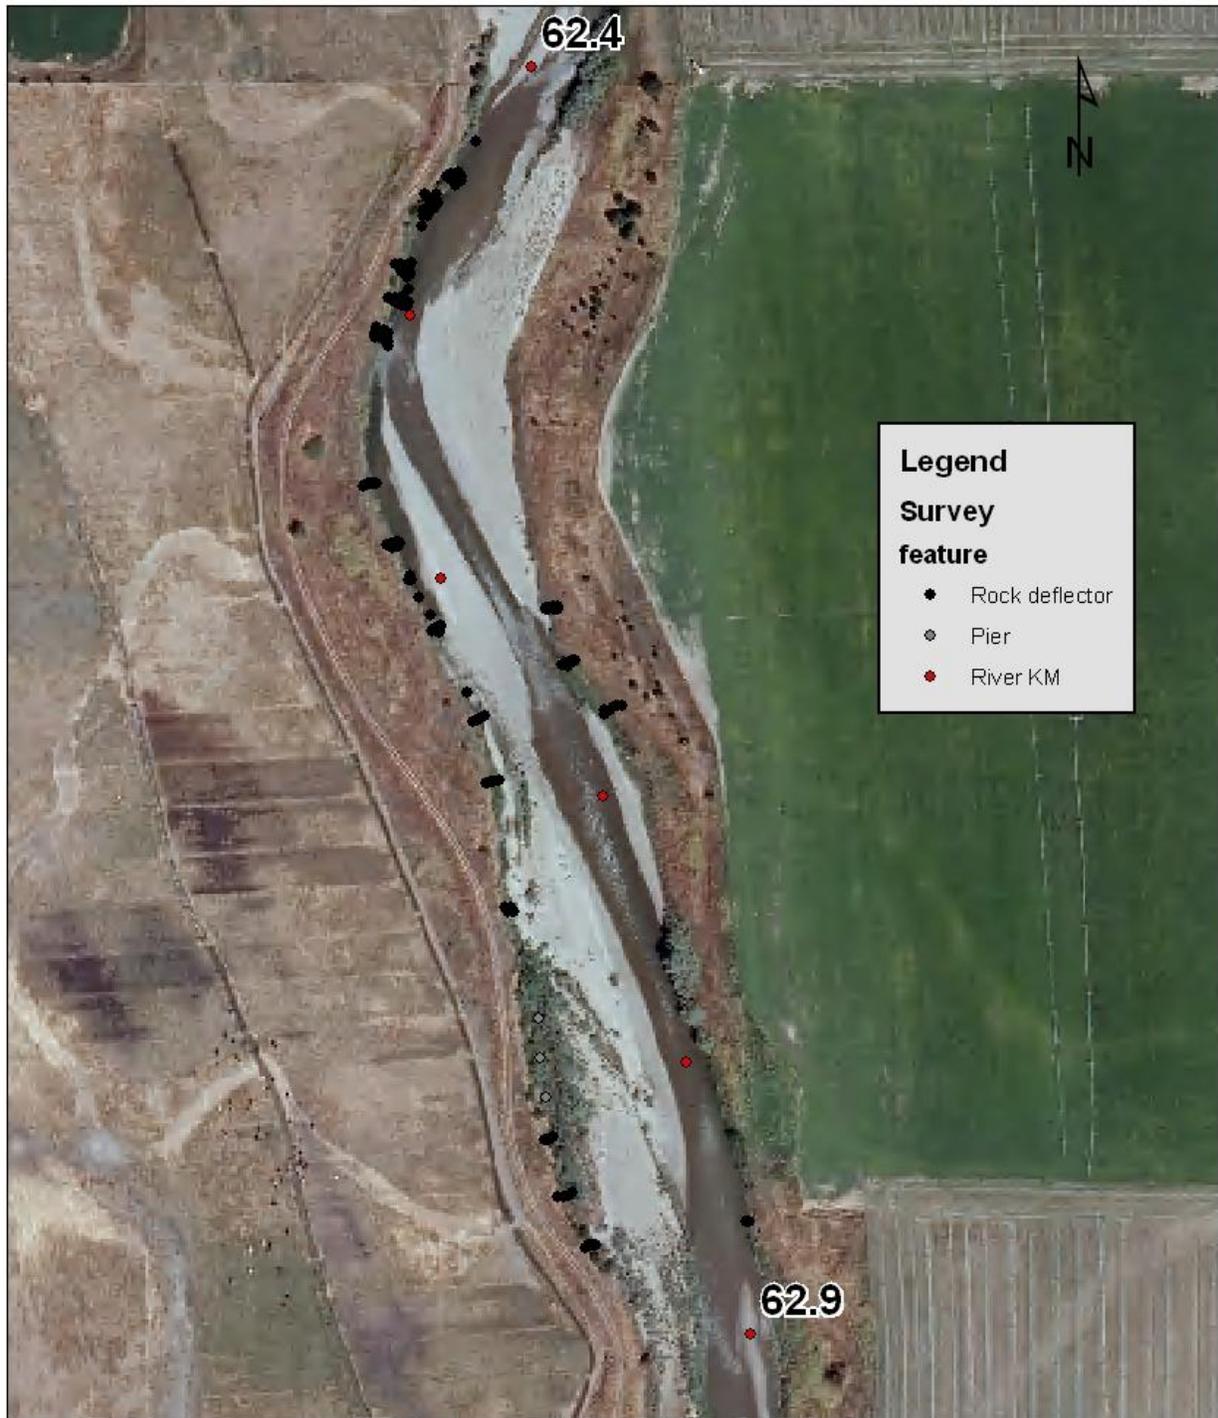
Map 3 – Rock deflectors and historic wooden piers in survey reach

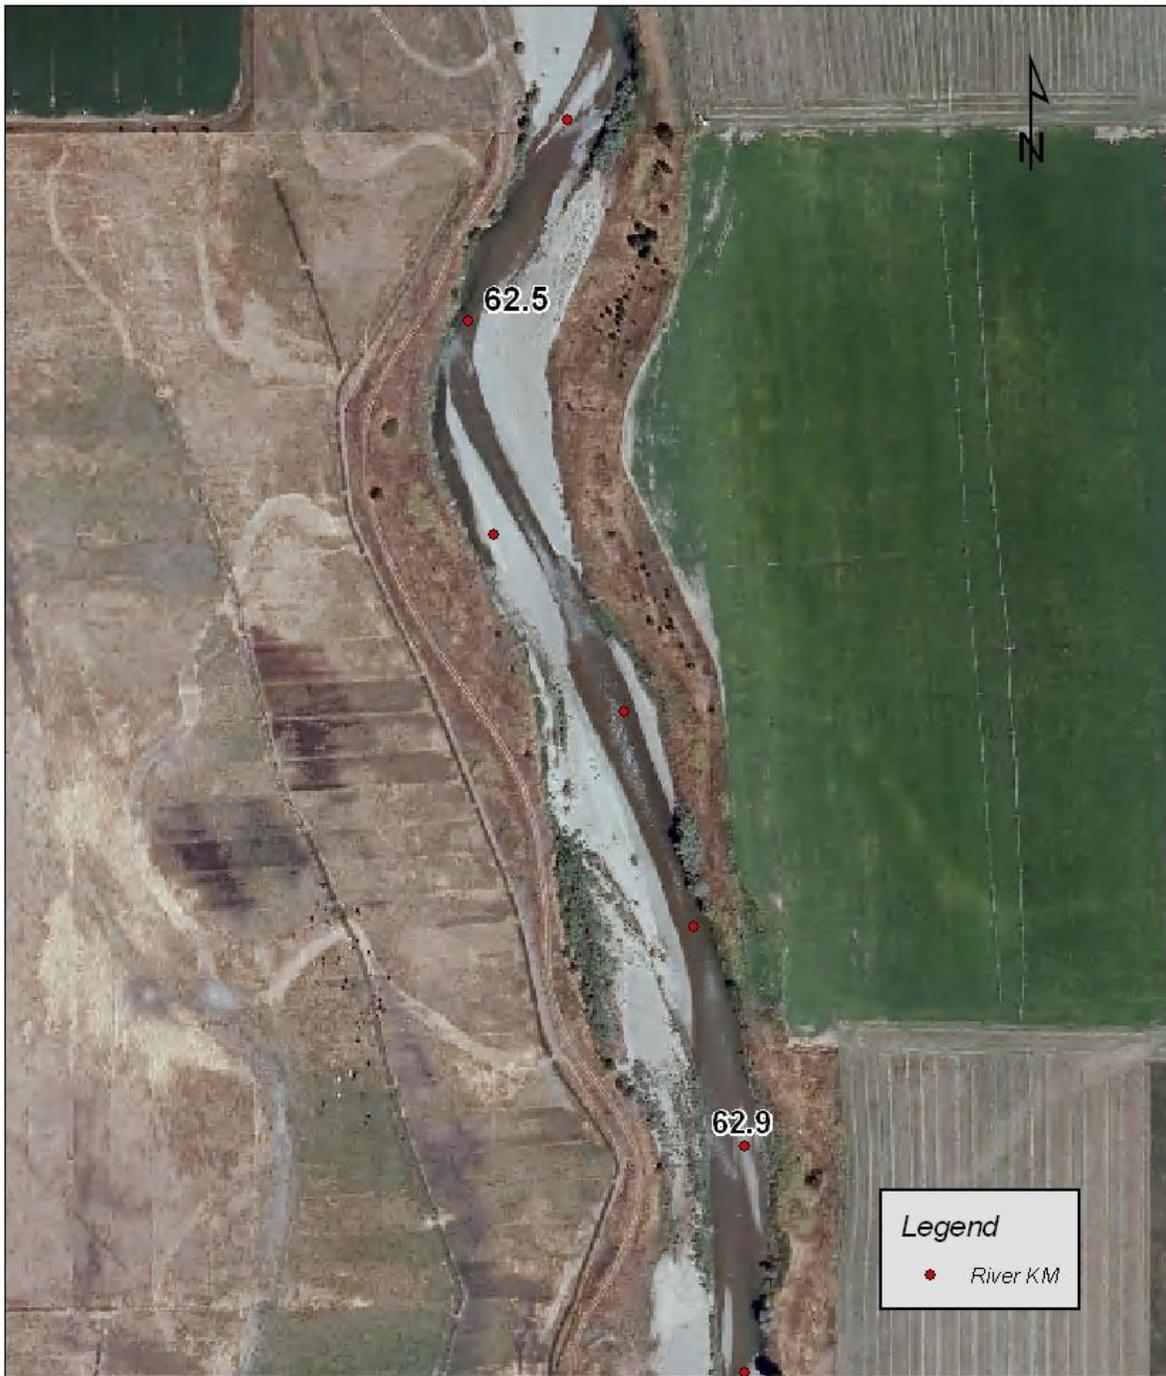
Map 4 – NAIP aerial imagery - 2010

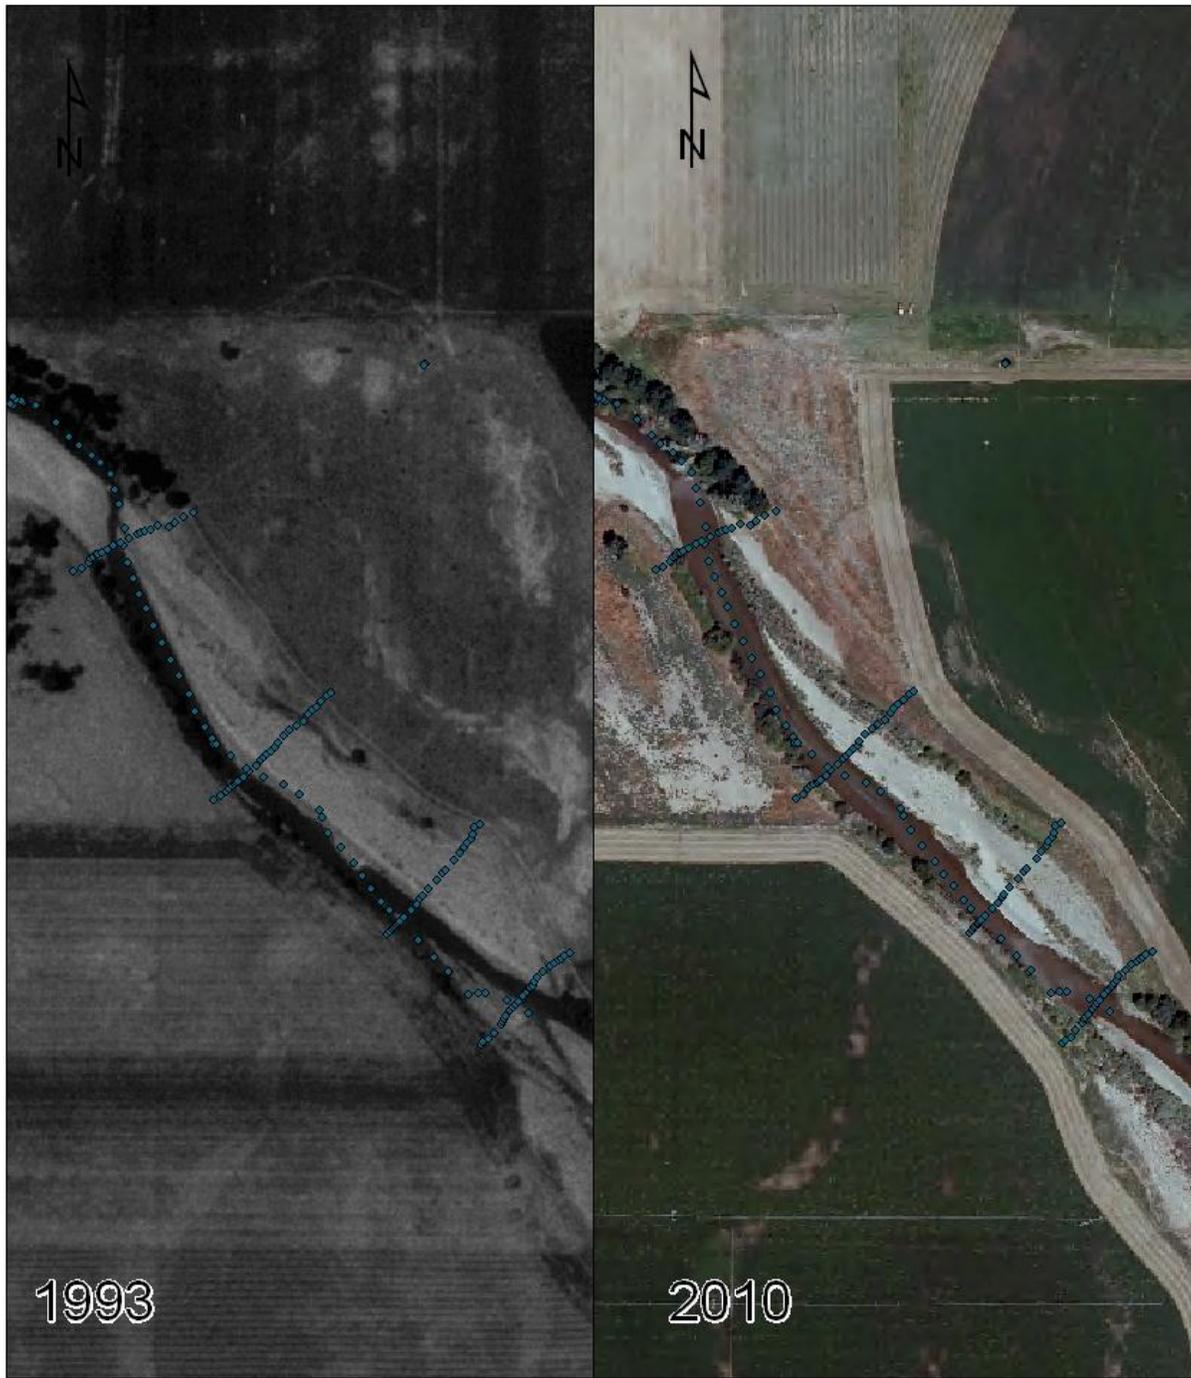
Map 3 – upstream portion of surveyed reach – aerial images from 1993 and 2010

Analysis of aerial images from 1993 and 2010 (Maps 3 and 4) show that the channel alignment in this reach has been very stable over the 17 year span.

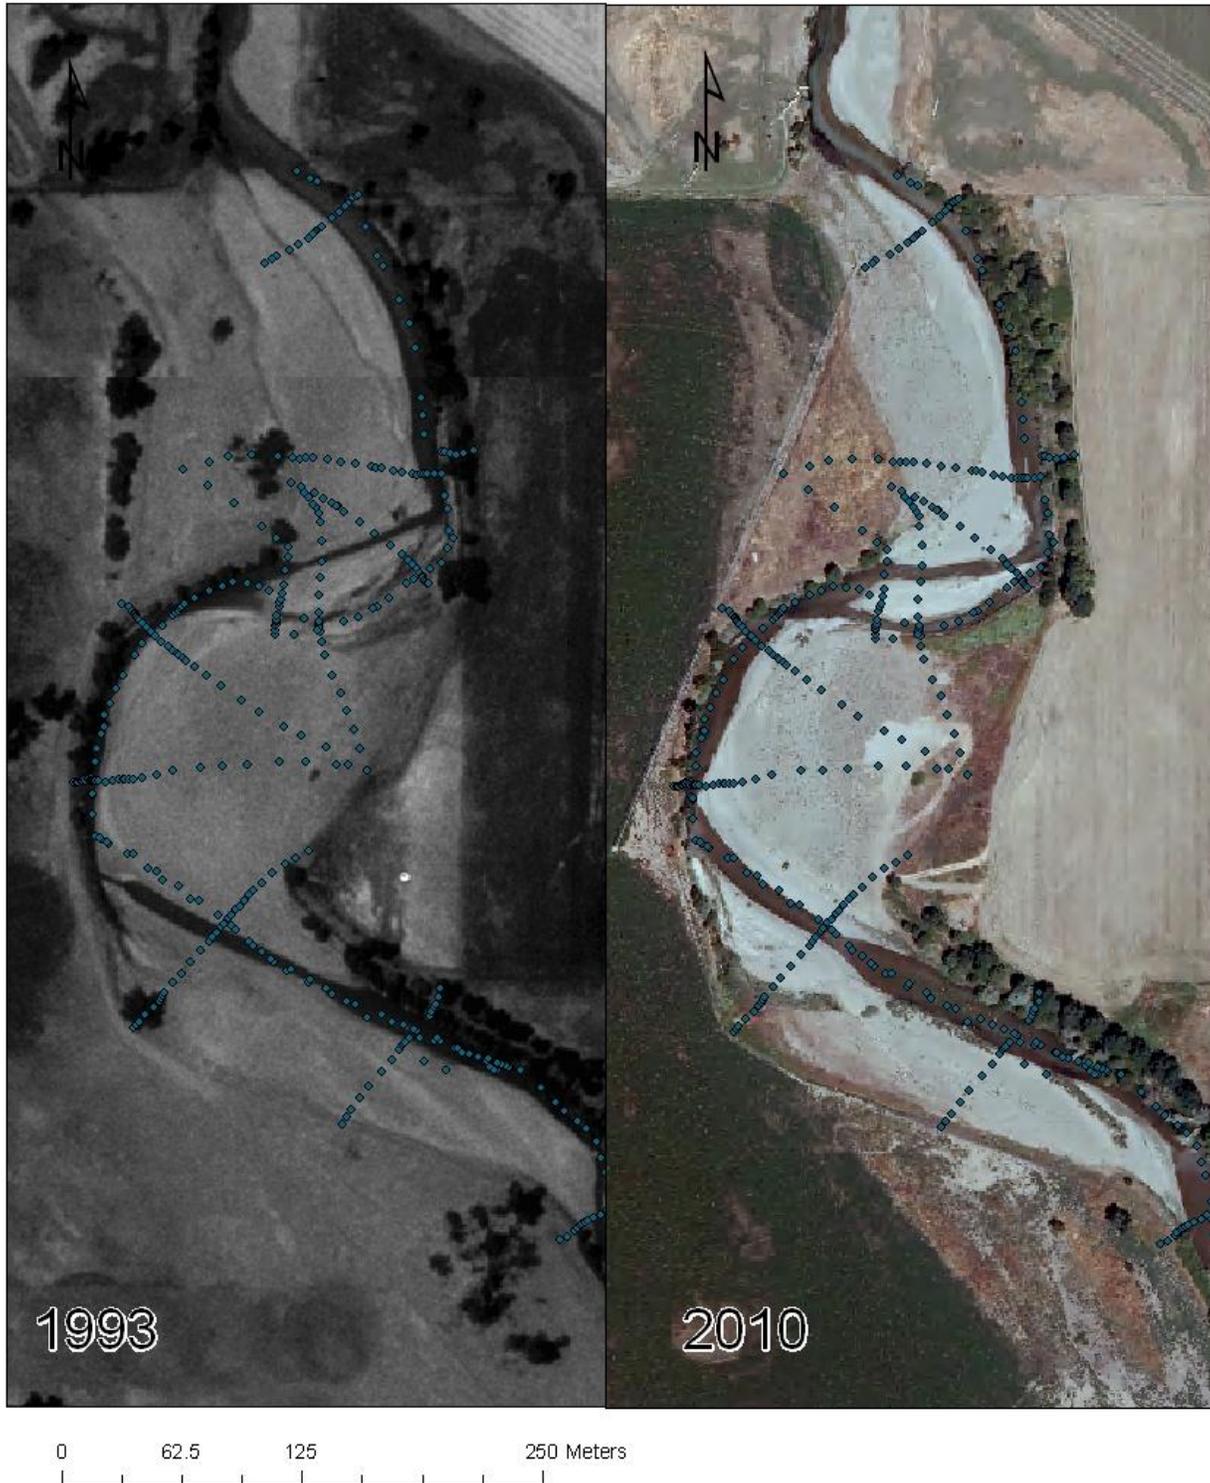
Map 4 – downstream portion of surveyed reach – aerial images from 1993 and 2010

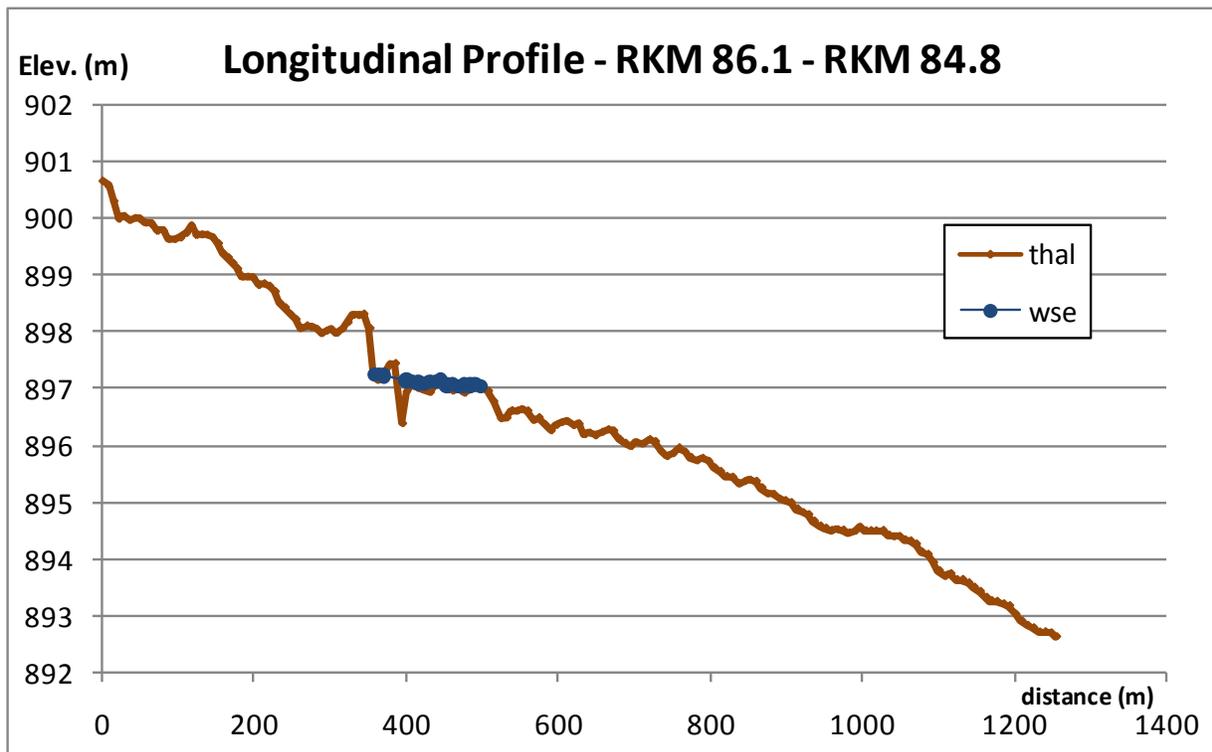
Graph 1 – Longitudinal profile of the Scott River thalweg – RKM 86.1 – 84.8

The surveyed reach from RKM 86.1 – RKM 84.8 is located in the tailing reach of the Scott River downstream of Callahan. This reach was mostly dry during the survey period (10/14/2010). This reach is disconnected during the base flow period of most if not all water years. A section of wetted channel was documented from RKM 85.7 – RKM 85.6 indicating the water surface elevation in that location. Though the thalweg continued to lose elevation no surface water was observed downstream of this wetted area (Graph 1). The surveyed reach was approximately 0.5% slope.

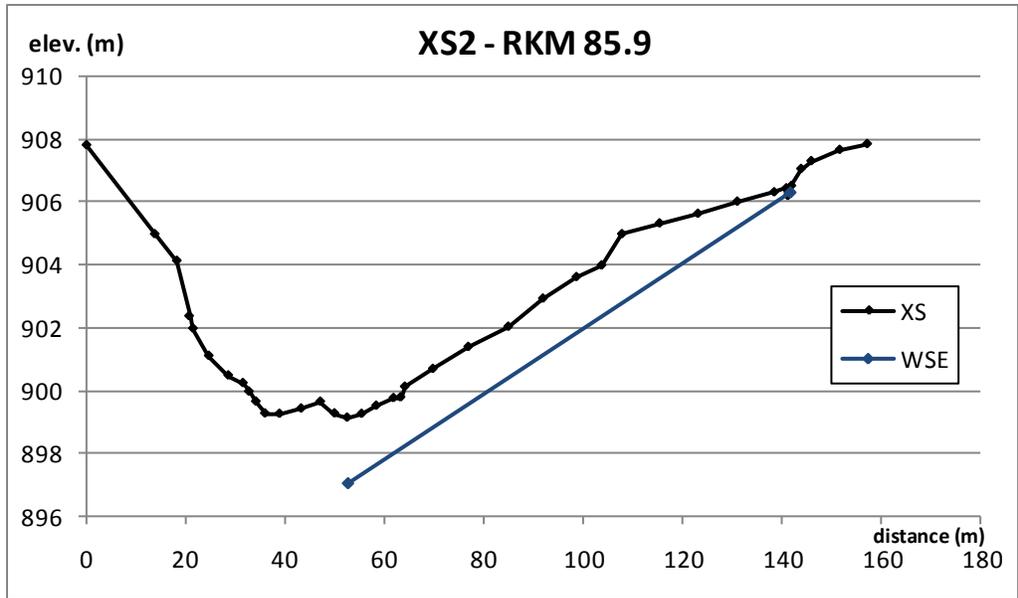
Graph 15 – surveyed and potential water table elevation at XS2
