SCOTT RIVER STREAM RESTORATION AND SEDIMENT REDUCTION PROGRAM 2017-2021 FINAL REPORT

Siskiyou Resource Conservation District
Scott River Watershed
February 2021

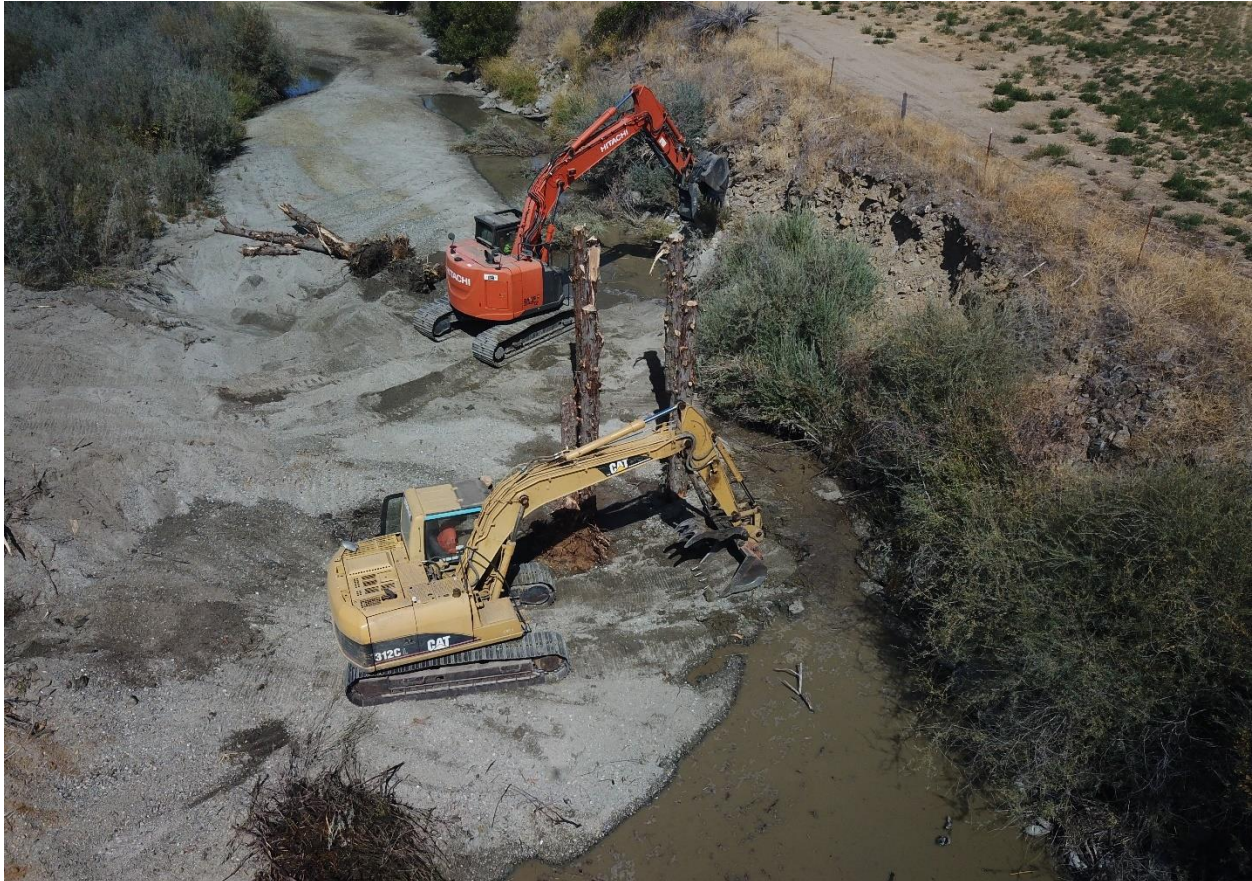
Construction of bio-engineered log jam on eastern bank of the Scott River, fall 2018

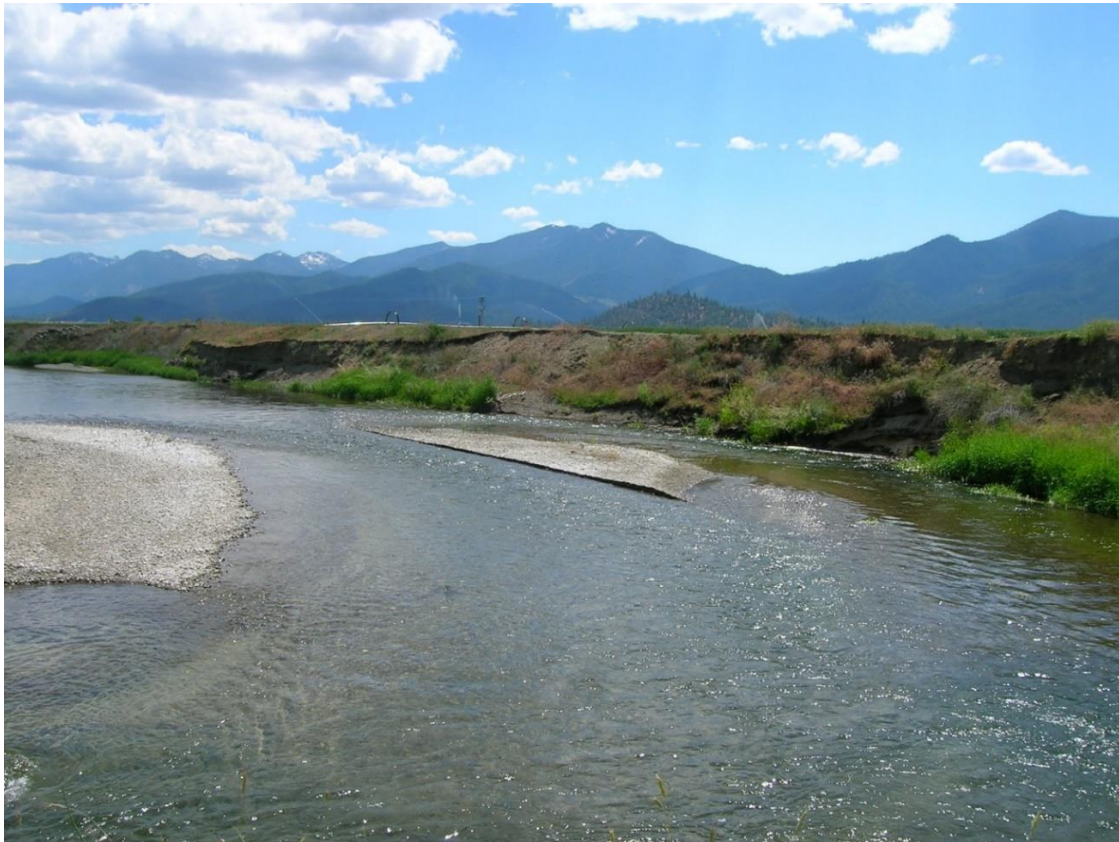
Figure 4. Scott River rkm 67 (western bank), 2012

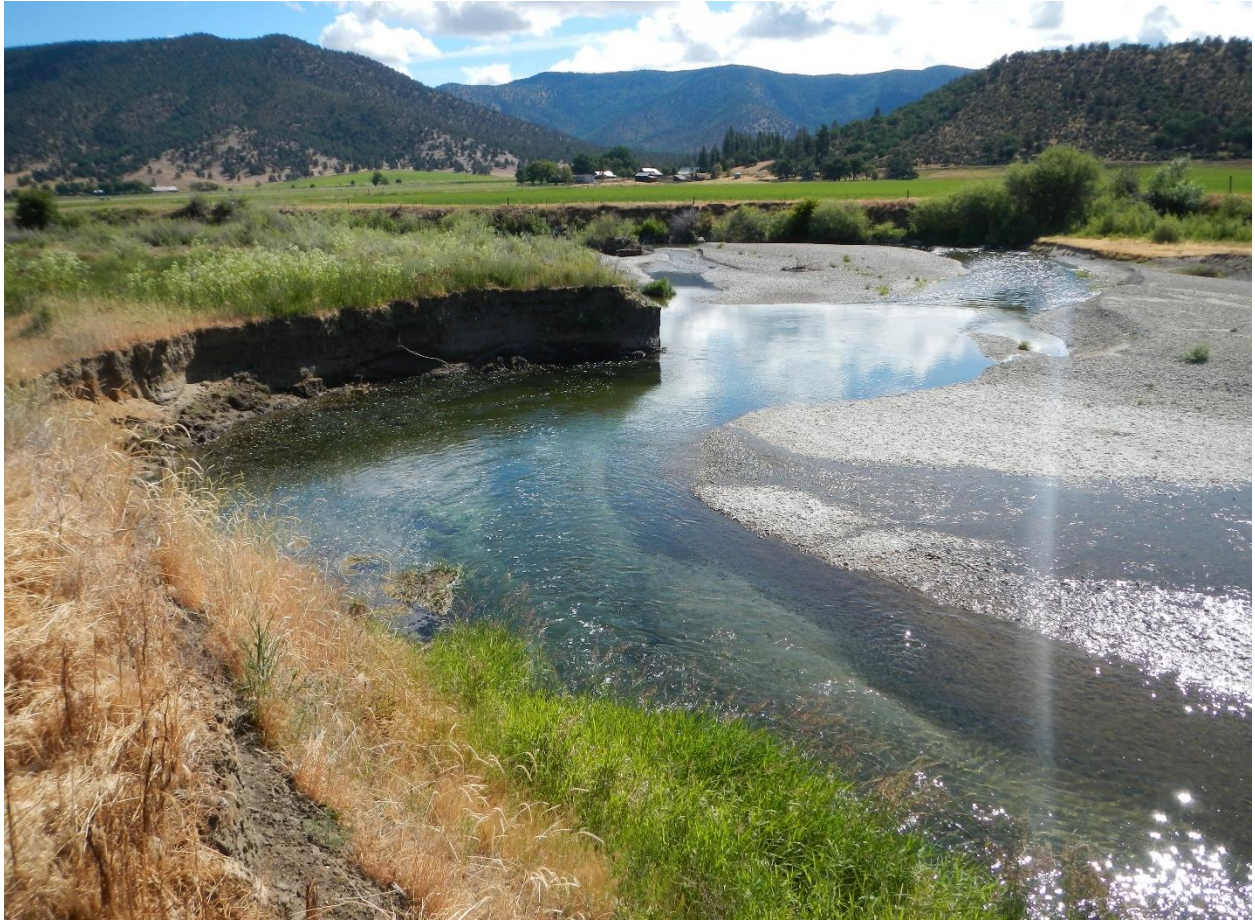
Figure 5. Scott River rkm 67 (northwestern terrace), 2013

While the banks maintained their position, a portion of the intermediary northwestern terrace has continued to migrate downstream following treatment. Much of the sediment loss during this period resulted from attenuation of the sharp bend of the primary channel. Comparison of the site surveys between 2018 (as-built) and 2020 shows that the depositional lateral bar migrated downstream and the northwestern terrace retreated as the primary channel adjusted to the log structures, and the river-left to river-right bend became less abrupt. The reconfiguration of the northwestern terrace resulted in the mobilization of approximately 0.37 acres of sediment. Though the terrace is currently behaving as an erosional area, it is anticipated that eventually the lower northwest terrace will come to store sediment. Treatment enhanced floodplain connectivity while also increasing riparian vegetation density, the latter of which will increase localized roughness and reduce shear stress. This combination of factors will lead to more regular inundation of relatively low velocity water that will lead to the accretion of sediment in that area.

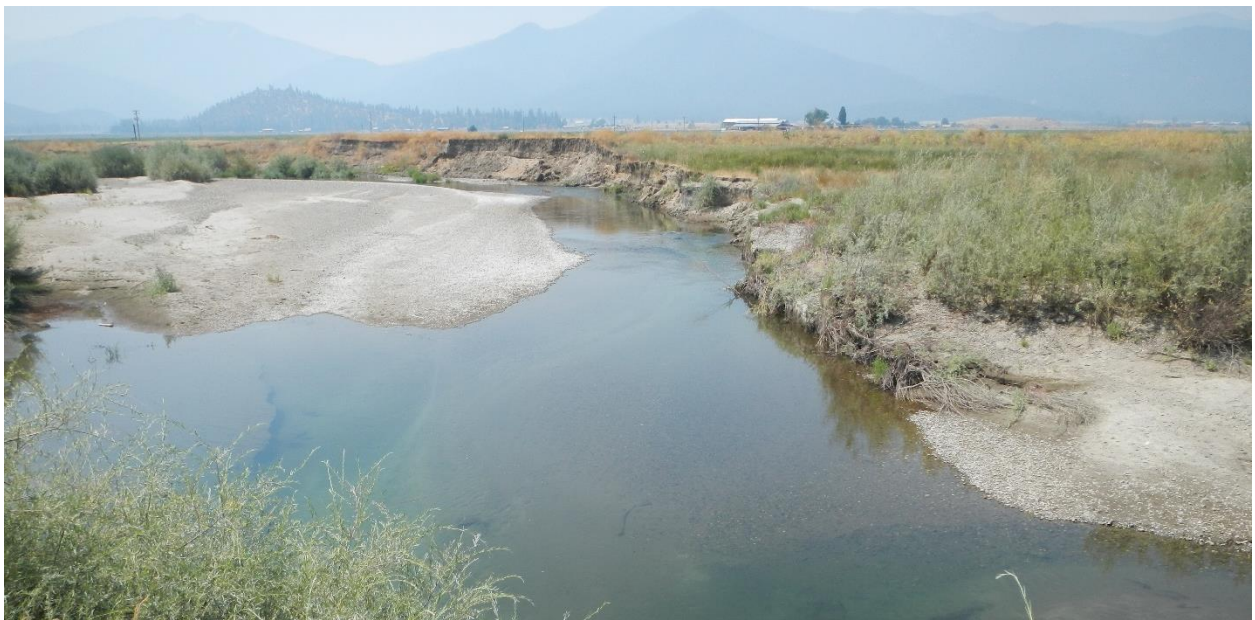
Figure 6. Scott River rkm 67 (western bank), 2017

Scott River rkm 67 (Rancho del Sol): Based on topographic surveys, historic aerial imagery, and the 2010 LiDAR DEM, the SRCD has calculated that the western bank at rkm 67 has lost an area of approximately 0.45 acres from 2013 to 2017 (Figure 35). With an average height of 9.0 feet and “sandy loam, loose” soil composition, a total of 6,840 tons of material have been lost. This correlates to an average of 1,710 tons per year being contributed to the Scott River. The treatment implemented in the fall of 2018 was intended to minimize sediment contributions from this site.

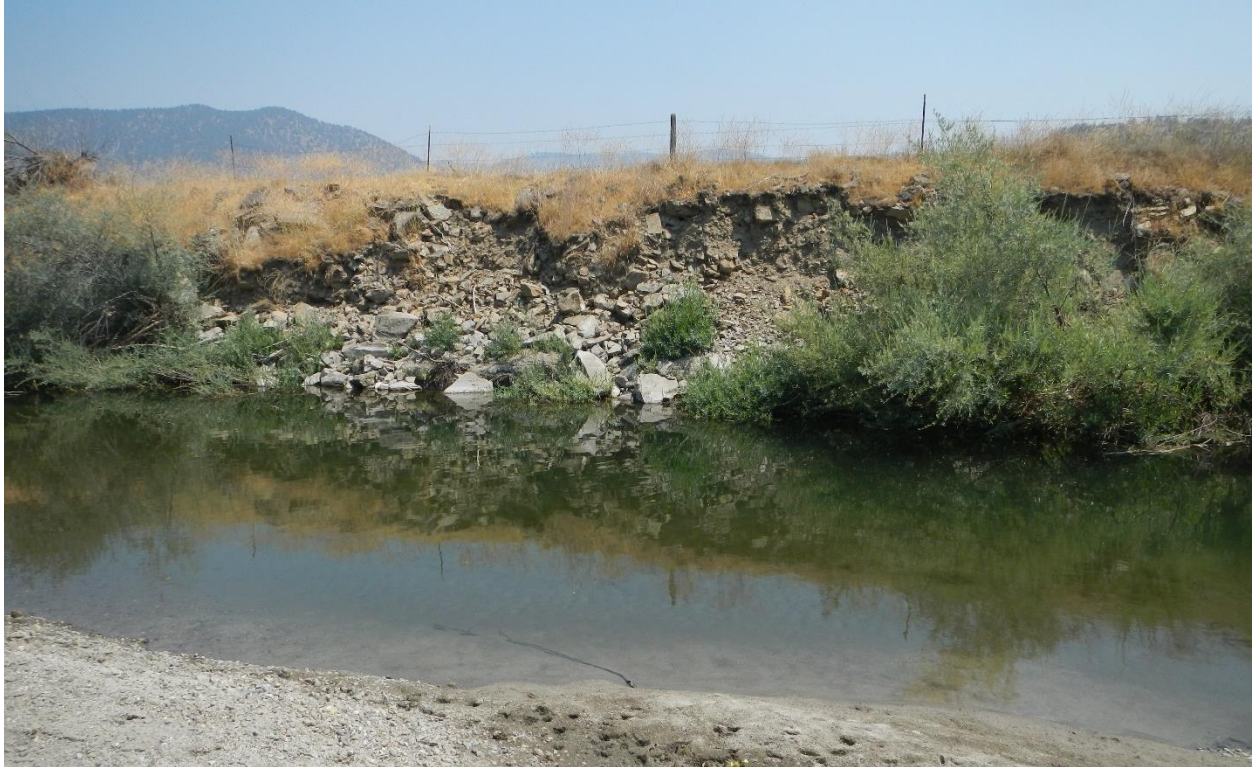
Figure 7. Scott River rkm 67 (eastern bank), 2017

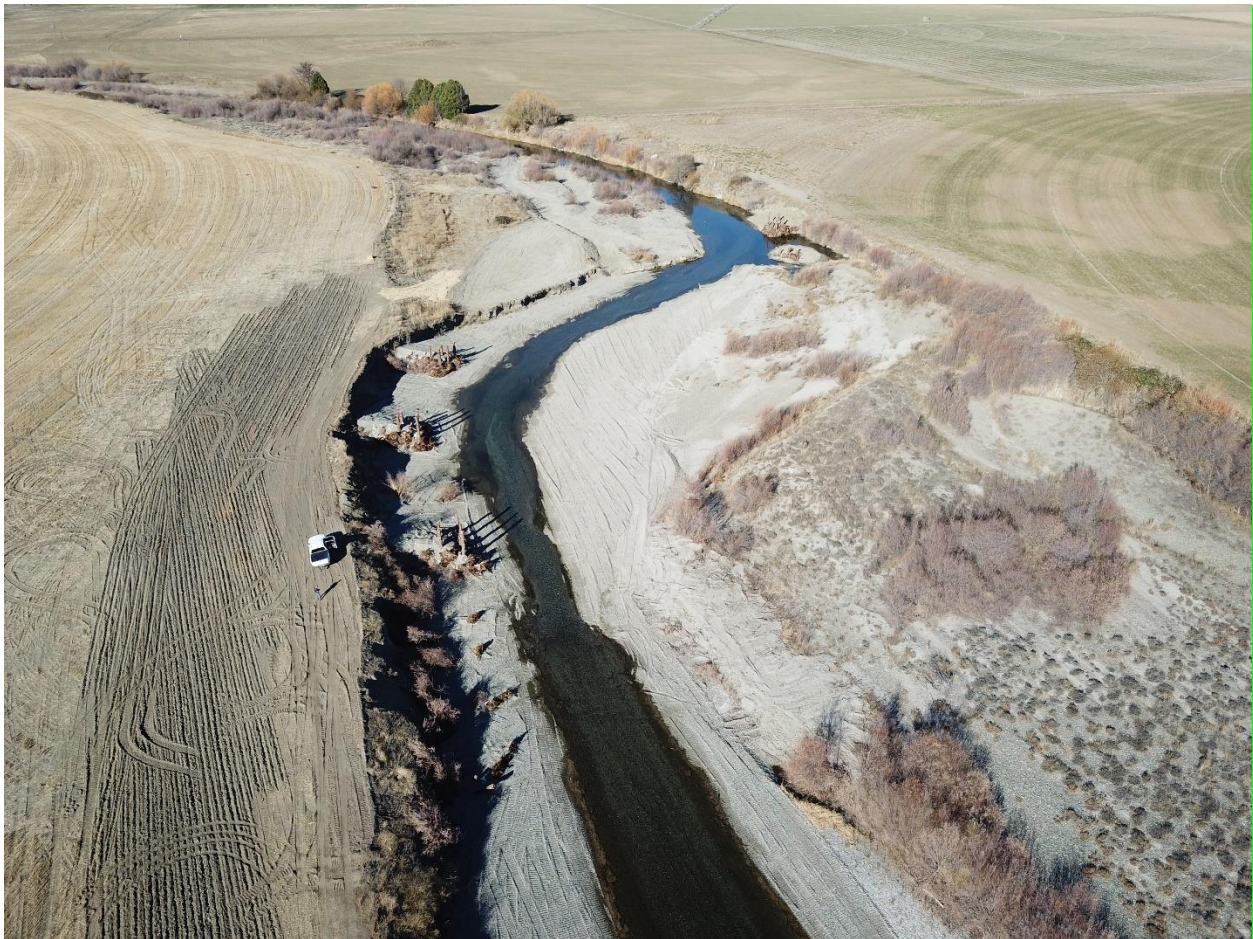
Figure 8. Scott River rkm 67 (looking downstream), 11/5/18.

The introductory section of the treatment area was stabilized with a series of low-profile Engineered Log Jams (ELJs) (Type C) to protect the toe of the slope where erosional forces begin to interface with the western bank and to support any potential slumping that occurs in the future (Figure 9). Type C ELJs consist of ballasted rootwads with transplanted willows installed along the toe of the bank and do not project significantly into the channel. Three Type B ELJs, designed to deflect the thalweg off the bend and reduce water velocities near the bank, were sequentially placed downstream on the western bank (Figure 10). Type B ELJs are larger structures and extend further into the channel than Type C. In order to reduce the subsequent meander curvature and improve flood conveyance, the western terrace and floodplain were recontoured below this point (Figure 12). This process involved 1) excavating a portion of the lower terrace to an elevation similar to the opposite bar 2) enhancing existing flow channels through the floodplain to allow for more frequent access and 3) removing the tip of the gravel bar to provide additional space for flow in the main channel. Extracting material that was promoting the abrupt transition of the channel from

the west to the east (and was positioned for continued erosion) was necessary to initiate stream processes that will reduce pressure (flow, velocity and shear stress) against the banks. Excavation was designed to work with existing topography and minimize disturbance to riparian vegetation. Willow clumps were salvaged from this area for placement elsewhere. The eastern bank was treated with two consecutive ELJs (a Type A, “apex jam” followed by a Type B) to intercept and deflect impinging flows away from the bank (Figure 11). The ELJs installed on both the western and eastern banks also provide cover to aquatic species, sort spawning gravels, and aid natural vegetation recruitment. Additionally, bank swallow nesting habitat was established nearby on the property to mitigate for potential impacts associated with installation of the ELJs. This involved modifying an existing off-channel berm between the agricultural fields and the floodplain into a near vertical slope.

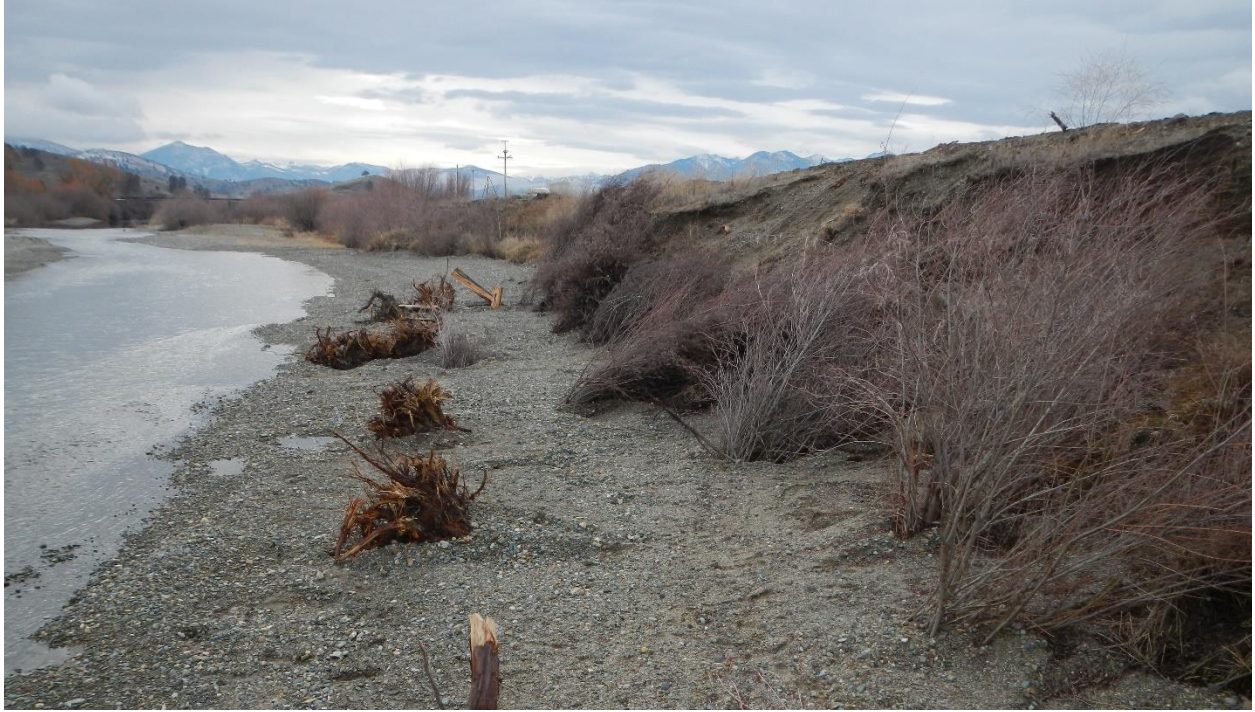
Figure 9. Type C ELJ after construction (western bank), 12/4/18.

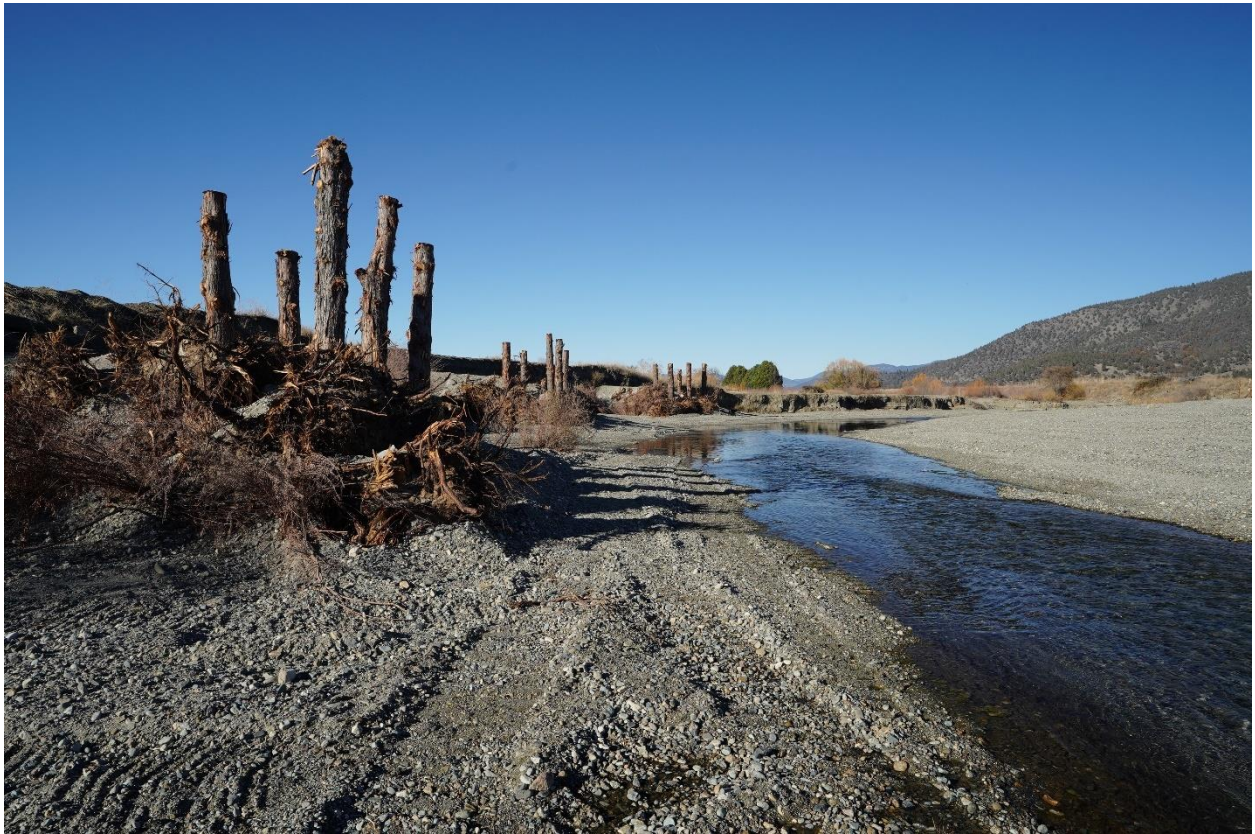
Figure 10. Type B ELJs after construction (western bank), 11/5/18.

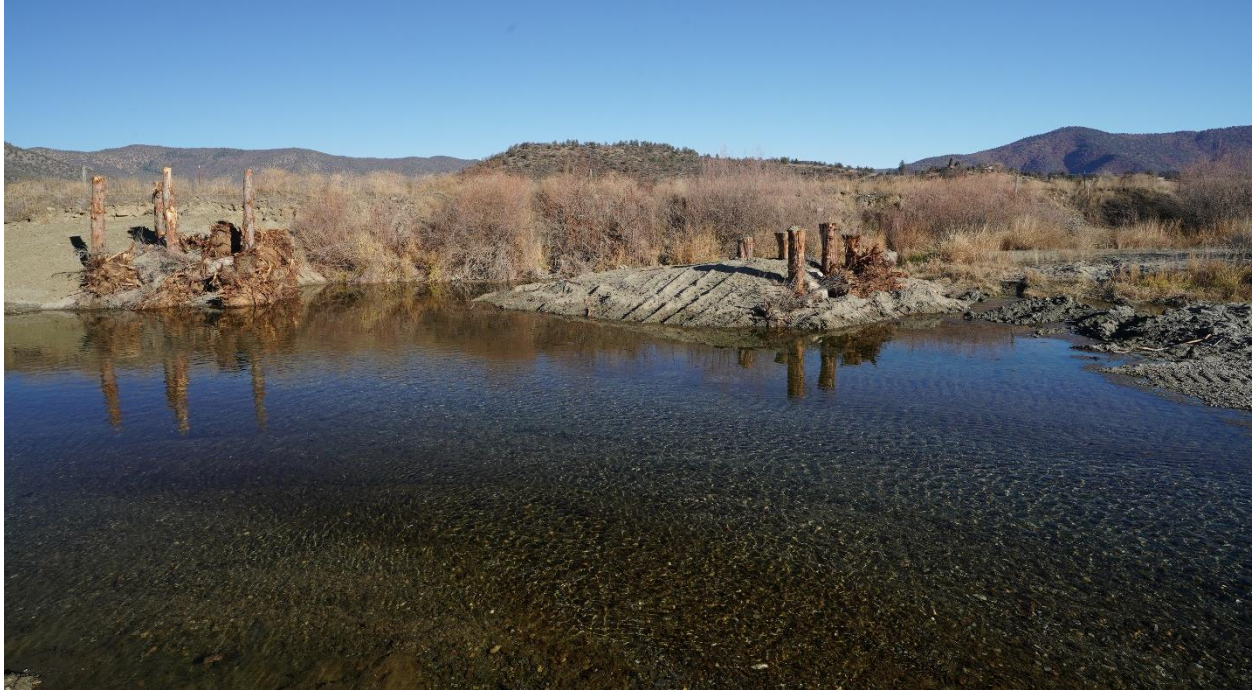
Figure 11. Type B ELJ (left) and Type A ELJ (right) after construction (eastern bank), 11/5/18.

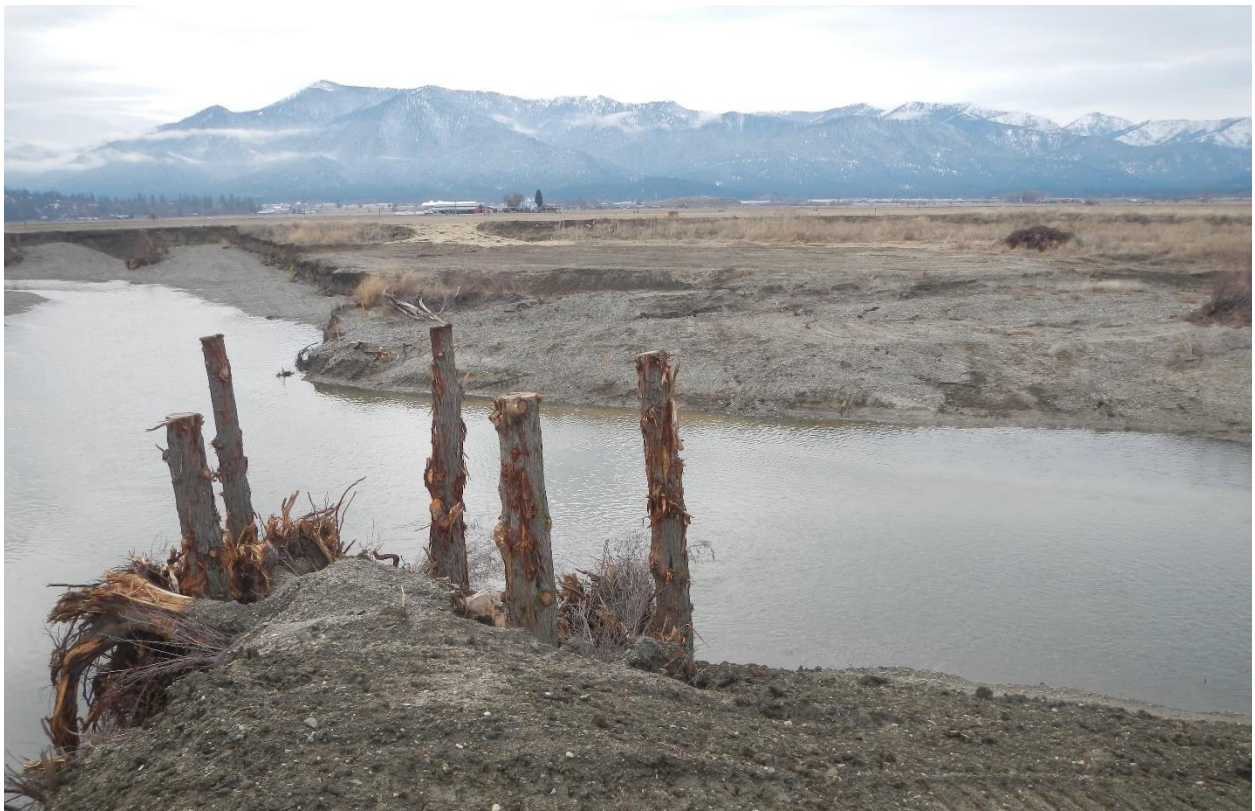
Figure 12. Western terraces and floodplain after re-grading, 12/4/18.

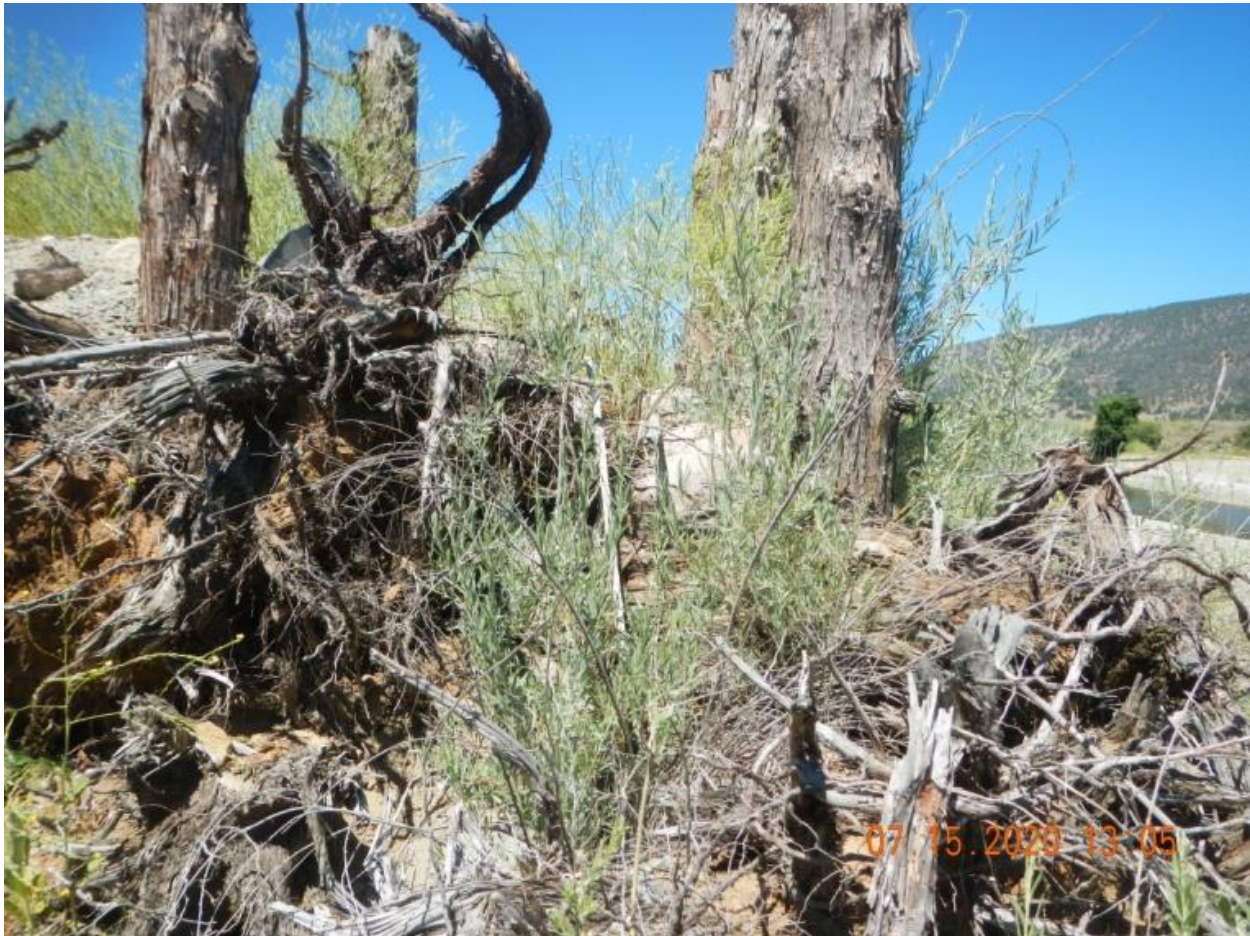
Figure 14. Willow bundles growing within Type B ELJ, 7/15/20.

- Willow bundles were planted within and surrounding all ELJs (Plot 3 and the equivalent on the eastern side of the river) (Figure 14)
- Willow bundles and willow clumps were planted along the toe of eroding bank in association with the river-left constructed toe (ELJ type C) (Plot 3) (Figure 15)

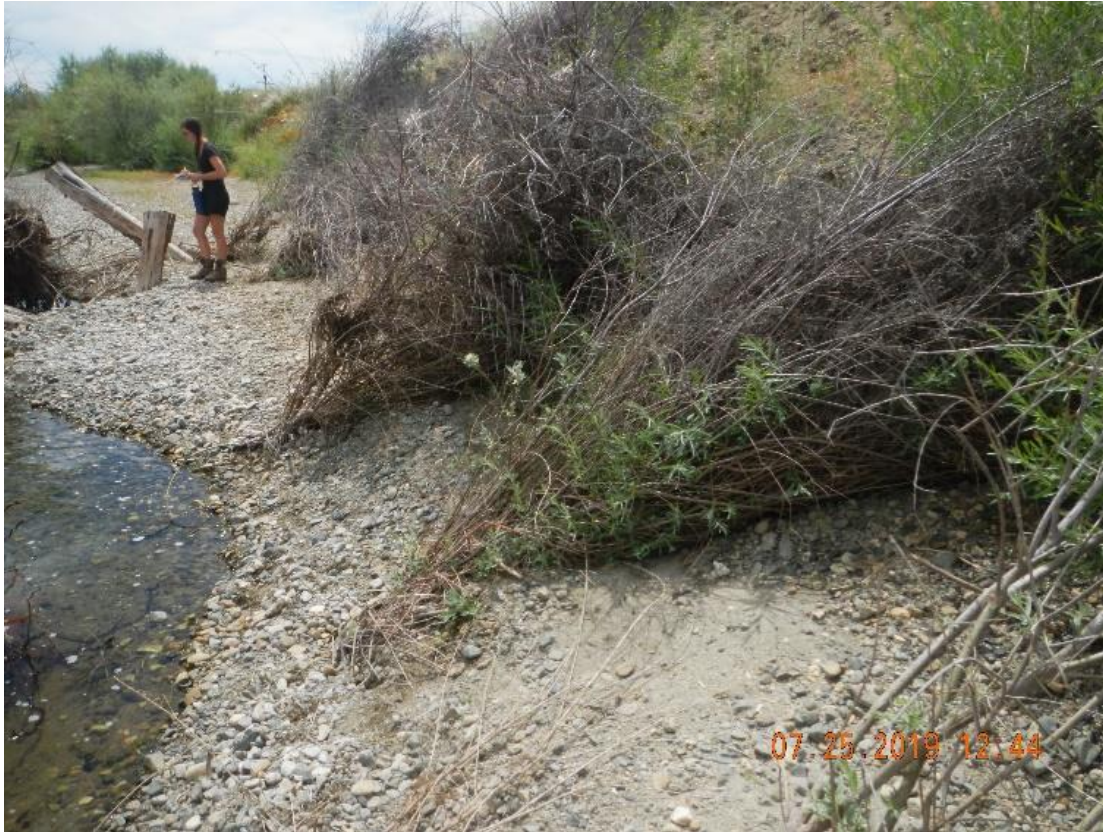
Figure 15. Willow clumps and bundles along the bank in association with the Type C ELJ, 7/25/19.

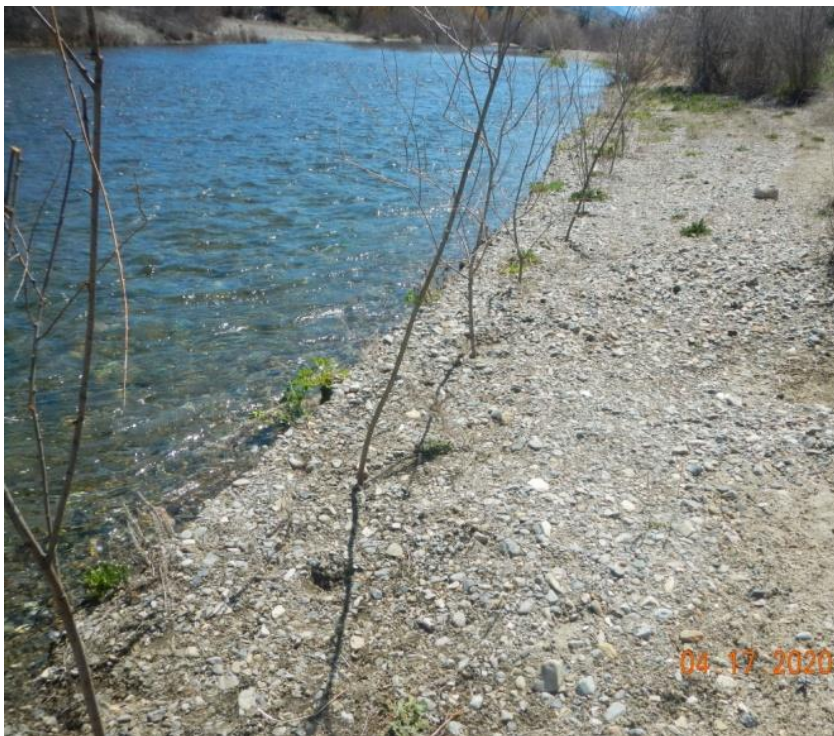
water line, 4/17/20.

Figure 16. Willow whips along the

- Willow whips were planted along the bank and water line through the entire treated area (Plot 3, the equivalent on the eastern side of the river and additional areas) (Figure 16)
- Willow clumps were planted across the newly excavated overflow channels including the re-entrance area near the main channel (Plot 1 and most of the northern salvage area) (Figure 17)
- Cottonwood poles were planted into the lower terraces and floodplain in rows running parallel with the direction of flow (bottom portion of Plot 2 middle terrace, and lower terrace) (Figure 18)
- Willow whips were planted in an eroding cusp on the river left bank upstream from the treatment site (Plot 5)
- Cottonwood poles were planted across the western terrace below the bridge (Plot 7)

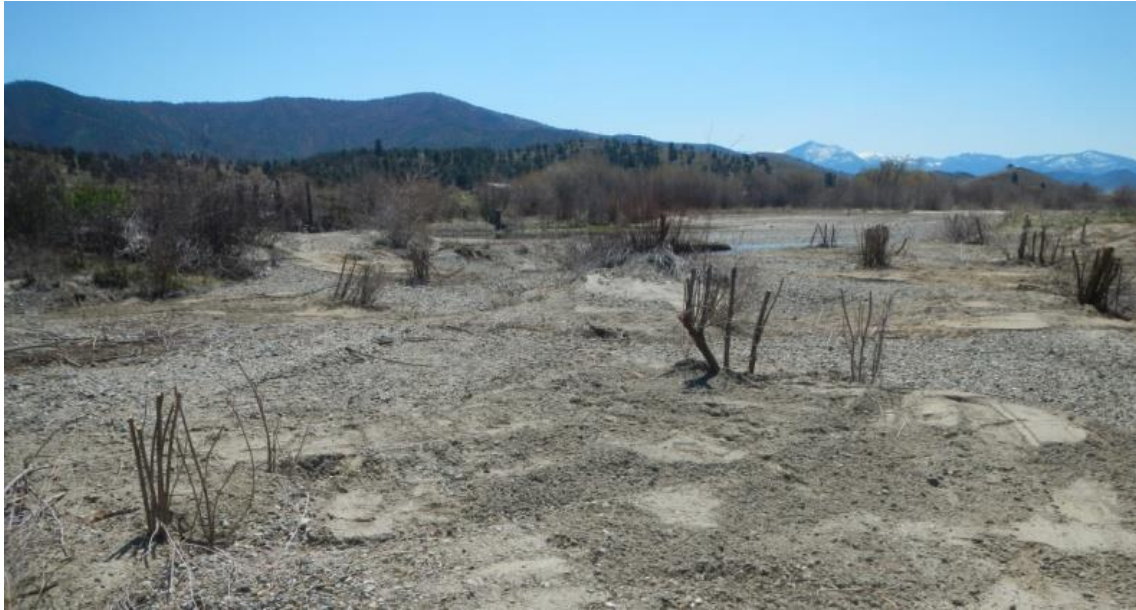
Figure 17. Willow clumps through the excavated overflow channel, 4/11/20.

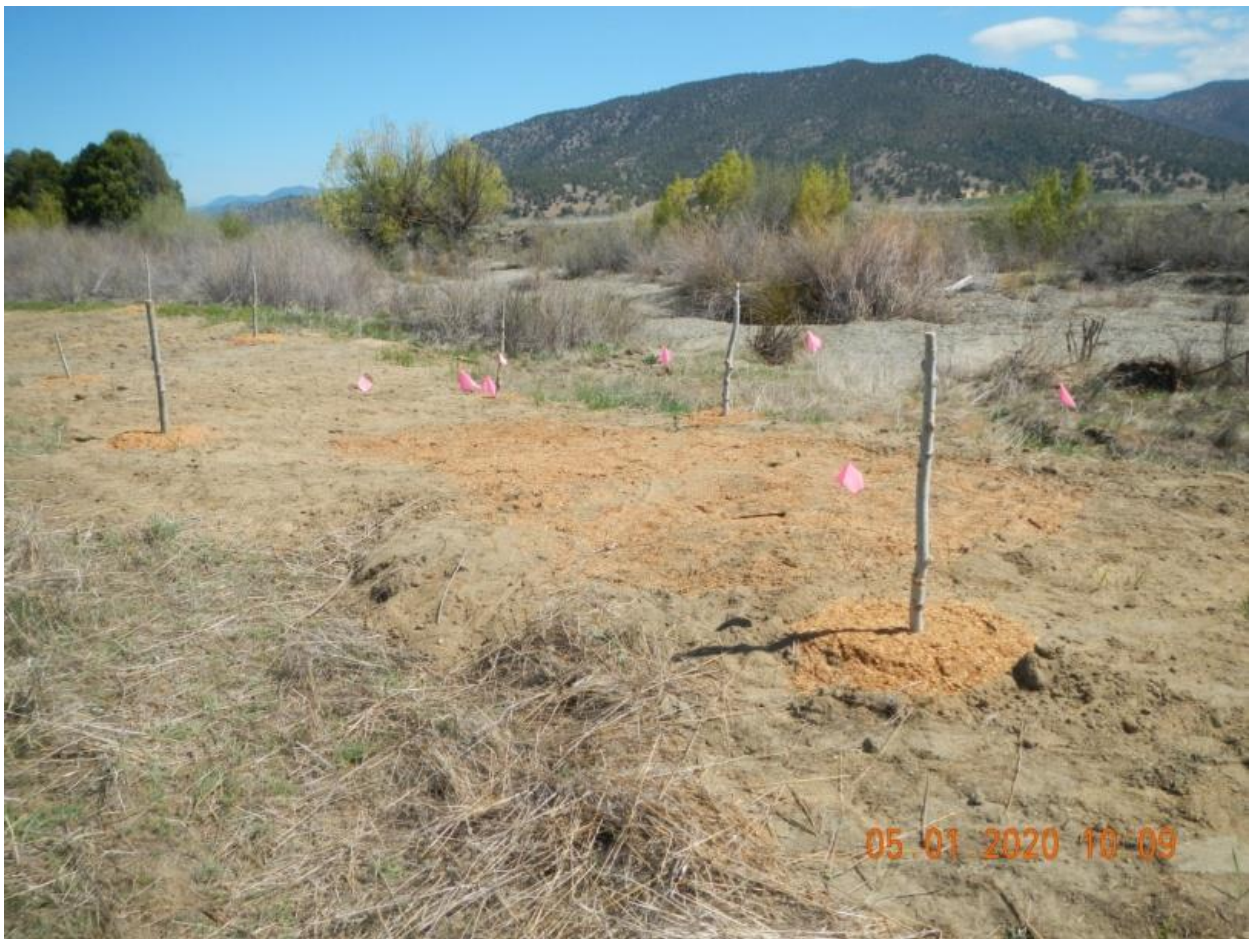
Figure 18. Cottonwood poles through the lower terrace, 5/1/20.

Plantings included black cottonwood (*Populus trichocarpa*) and native willow (*Salix*) species including pacific willow (*S. lucida*) and sandbar willow (*S. exgua*). Cottonwood poles were only sourced off-site from other local areas along the Scott River. Willow cuttings were harvested from dense stands available within the treatment area and elsewhere on the property. The selection of species and planting type for each plot was selected to best promote survival and success given plot characteristics. For example, willow clumps, which have spherical root mass, were planted through low lying areas of the floodplain to facilitate sufficient access to water while cottonwoods were planted on elevated terraces because the poles could be installed deeper. Planting involved excavating a hole or trench and subsequently burying the cutting(s). North Rivers Construction was able to reach the water-table for most but not all of the cottonwood plantings. The landowner organized the procurement of locally produced sawdust for mulch, which was applied around all of the cottonwood poles by the SRCD.

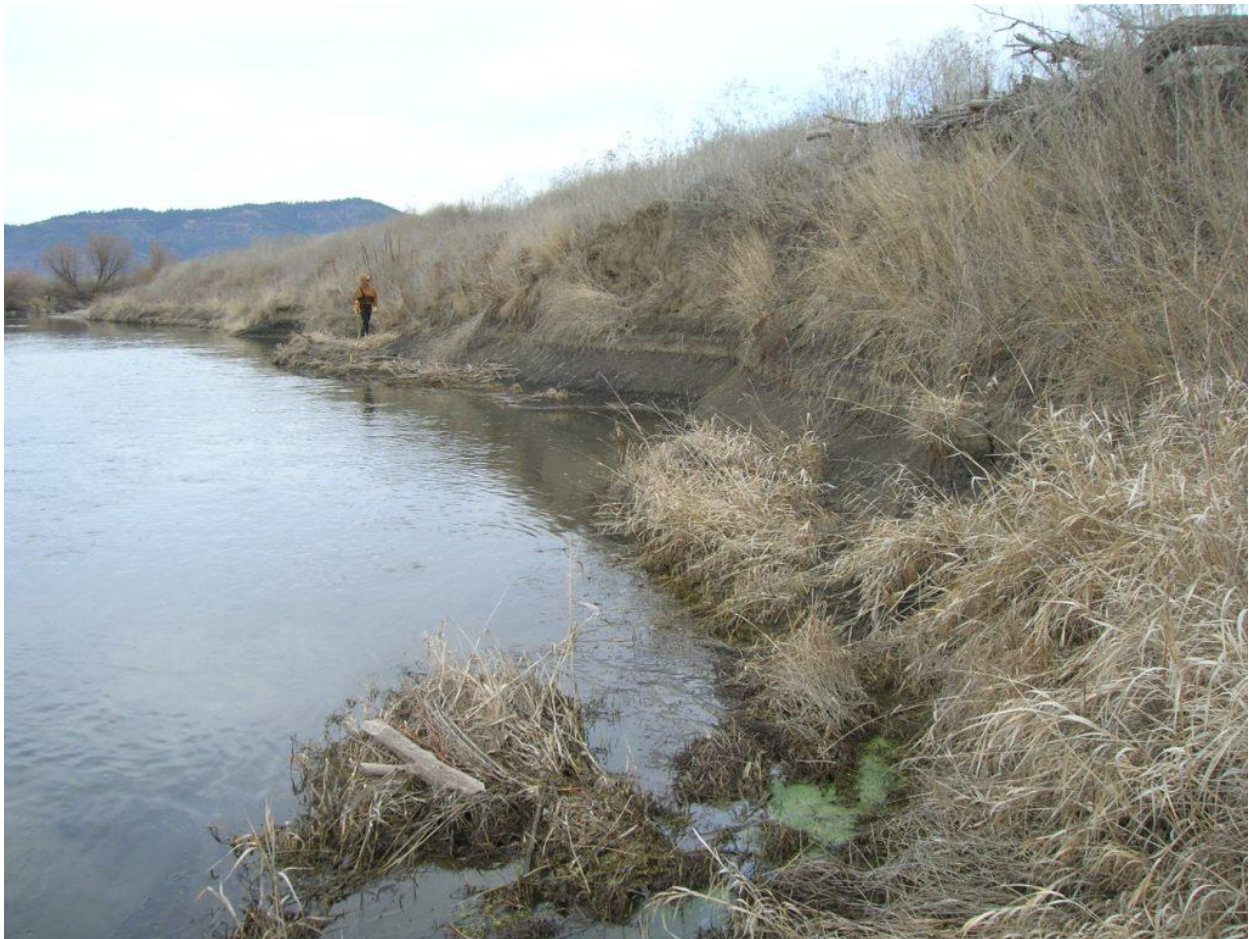
Figure 20. Scott River rkm 60 (eastern bank), 2009

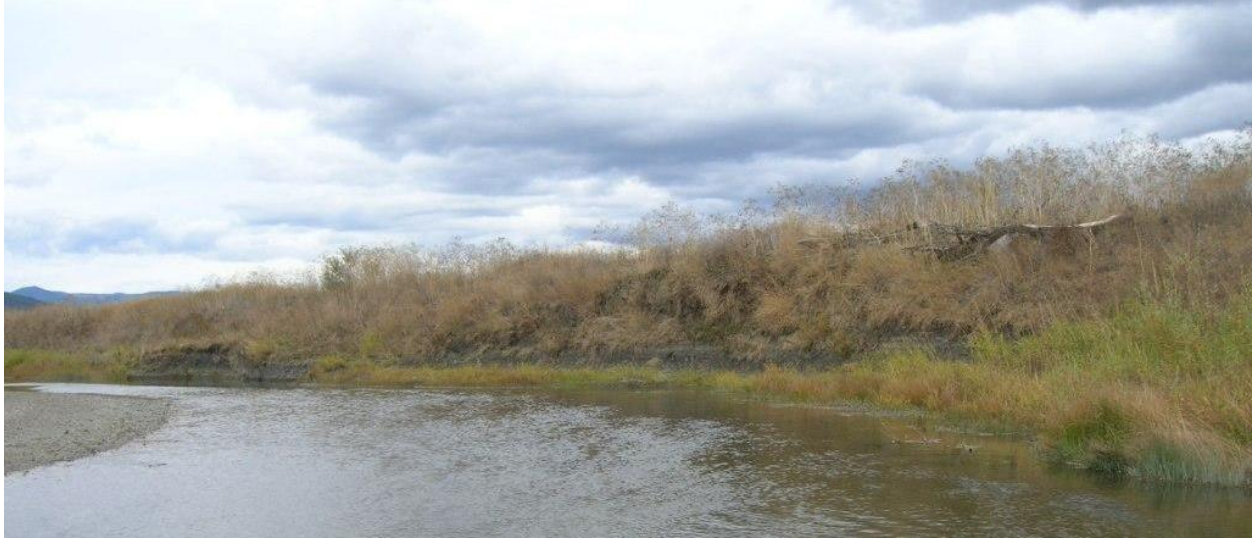
Pollutant Load Reduction, page 45). In 2017, the eroded face of the eastern bank was approximately four times longer than it was in 2010 and was threatening avulsion (Figure 22). Furthermore, these mass wasting events have altered the functional morphology of the eastern bank significantly. A soil horizon lower in the bank profile consists of higher levels of clay, making it relatively cohesive and resistant. Differential erosion patterns led to the development of a distinct concave section and cusp which conveyed water nearly perpendicular across the channel and directly into the western bank (Figure 23). These flow alterations have already undermined the defending riprap and riparian vegetation and led to recent damage of the western bank.

Figure 21. Scott River rkm 60 (eastern bank), 2010

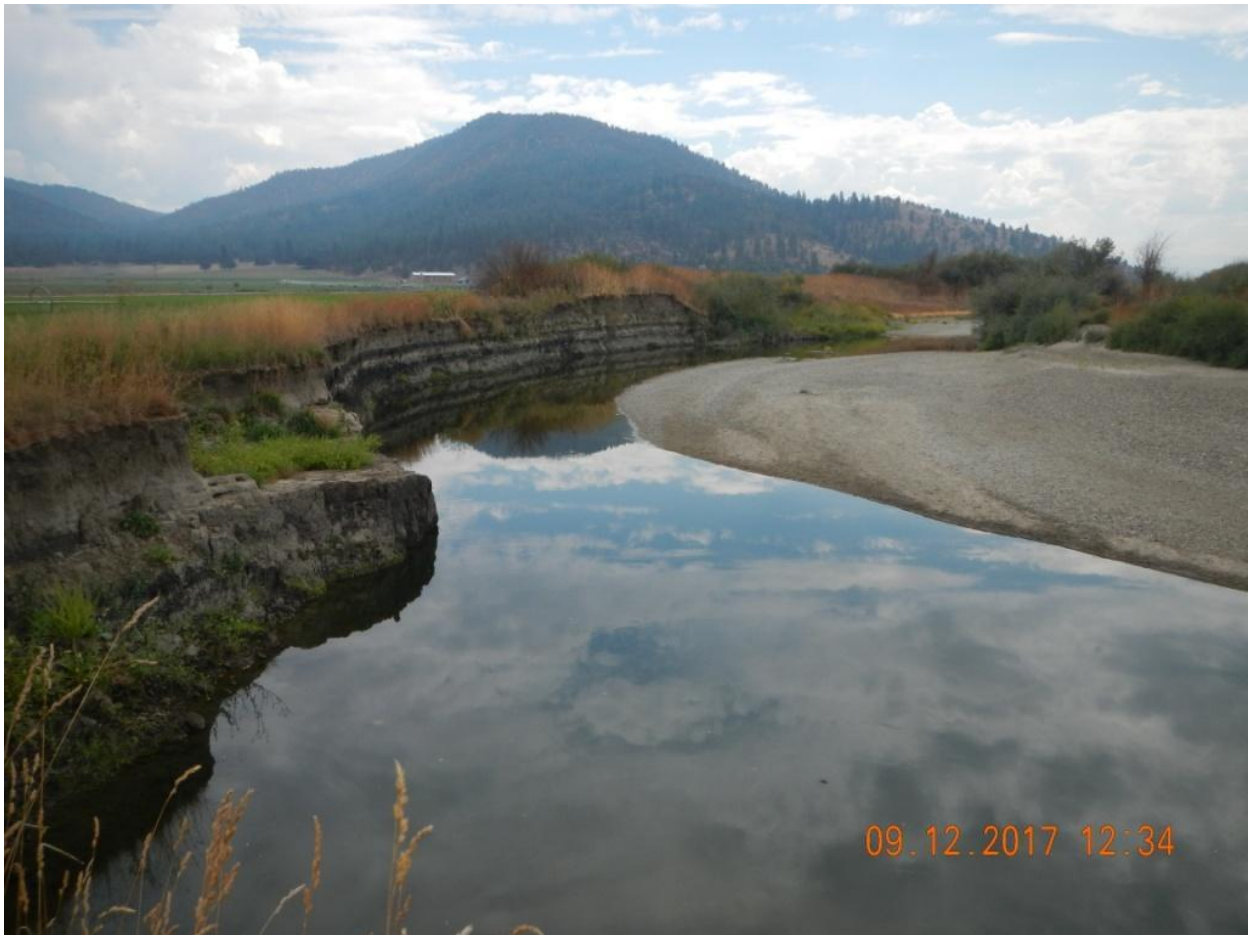
Figure 22. Scott River rkm 60 (eastern bank), 2017

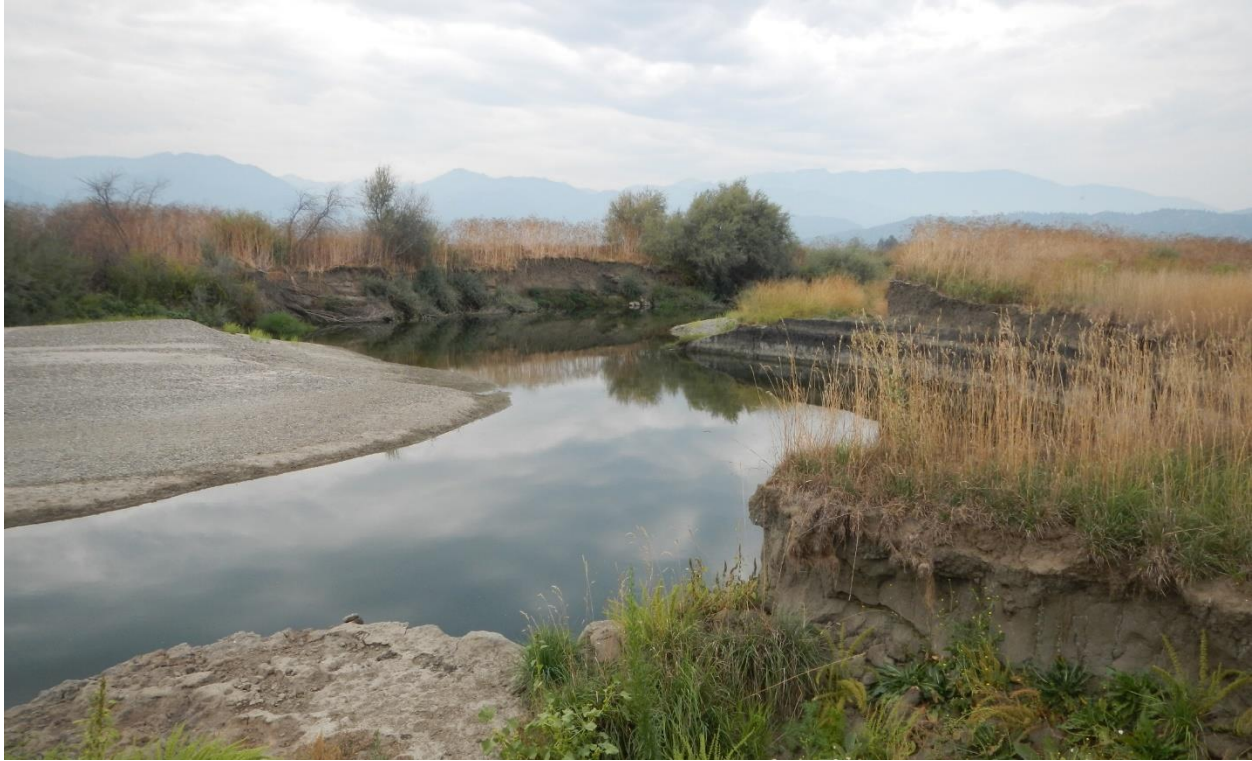
The eastern terrace has been characterized by leveed agricultural land and lacks a riparian buffer. The hydrologic disconnect and extreme erosion along the east bank has damaged and prevented the natural re-establishment of a stable riparian zone. Existing vegetation consists primarily of weeds. The western bank has experienced less erosion than the eastern bank and therefore supports more mature vegetation. Segments of the western bank contain decent stands of riparian shrubs and trees; however, many of them were vulnerable because impinging flows have eroded through the rock slope protection. Without intervention vegetation loss is likely to continue.

Figure 23. Scott River rkm 60 (eastern bank and western banks), 2017

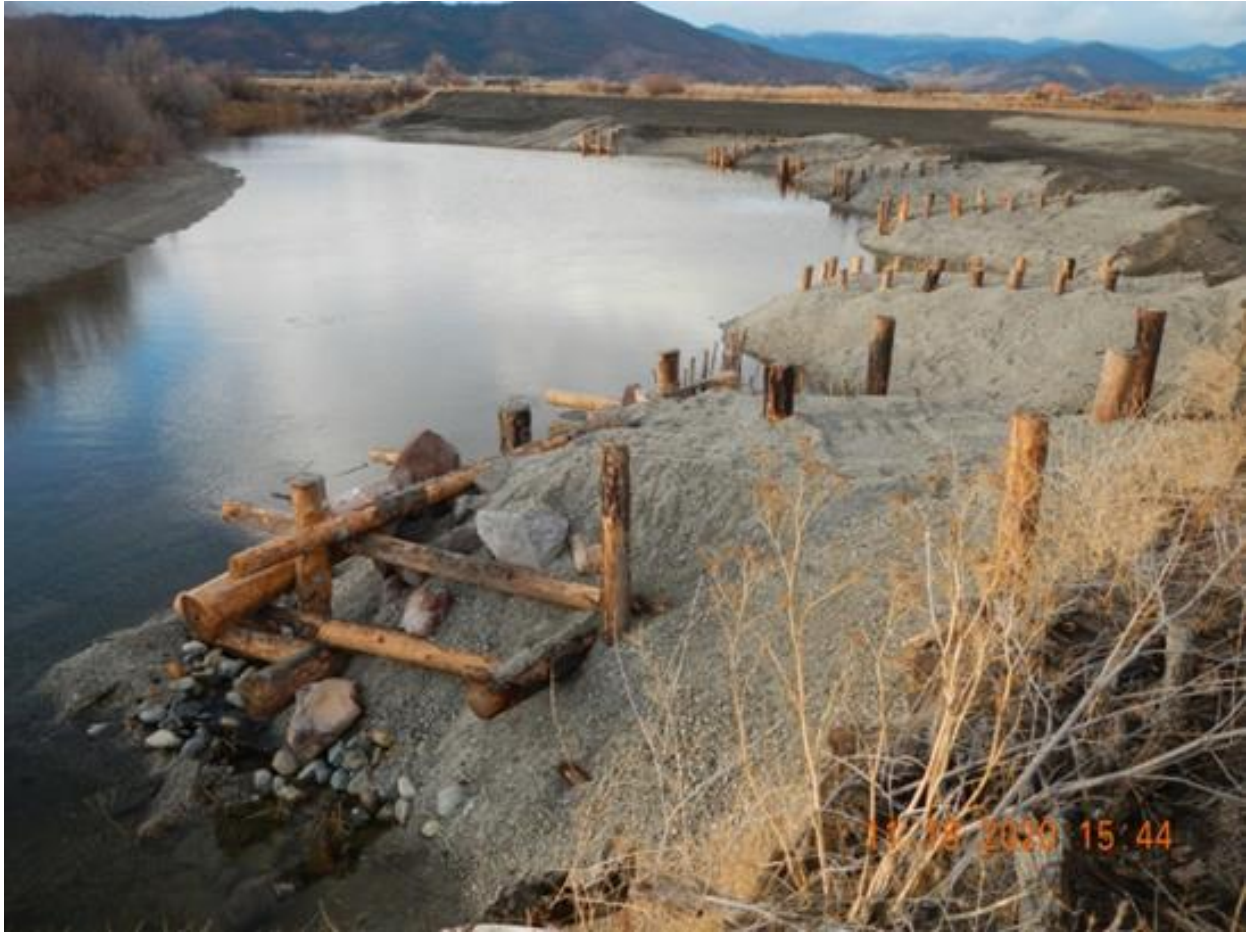
Figure 24. Type B ELJ (front) and all six Type A ELJs after construction (eastern bank), 11/18/20.

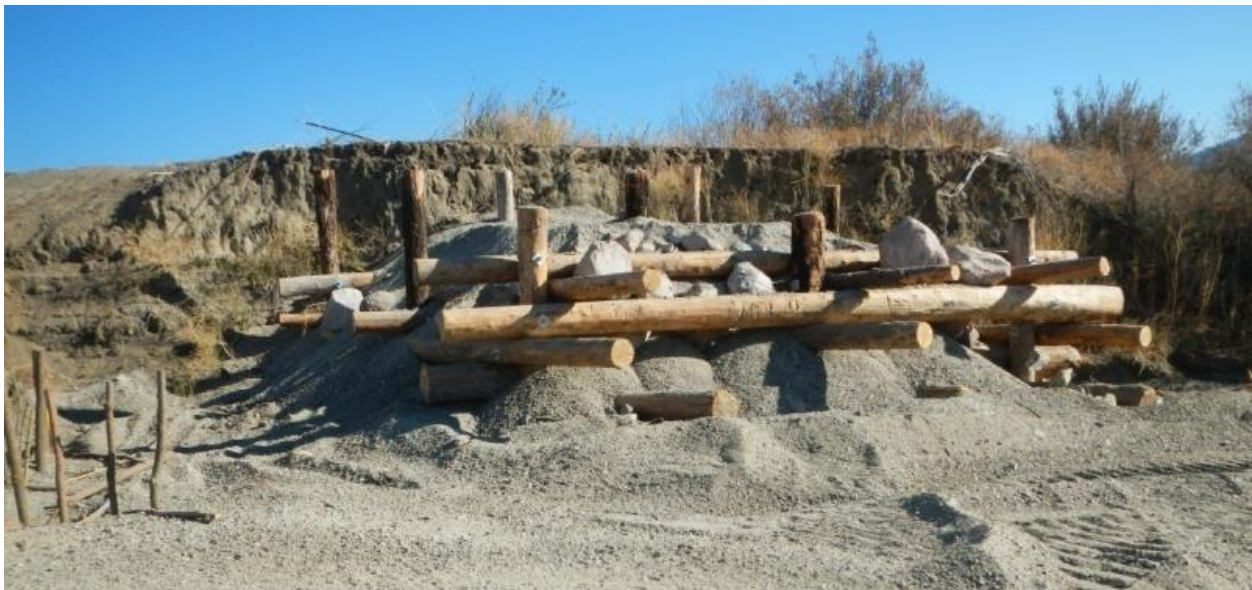
Figure 25. Type B ELJ after construction (eastern bank), 10/30/20.
