SCOTT RIVER STREAM RESTORATION AND SEDIMENT REDUCTION PROGRAM 2017-2021 FINAL REPORT

Siskiyou Resource Conservation District
Scott River Watershed
February 2021

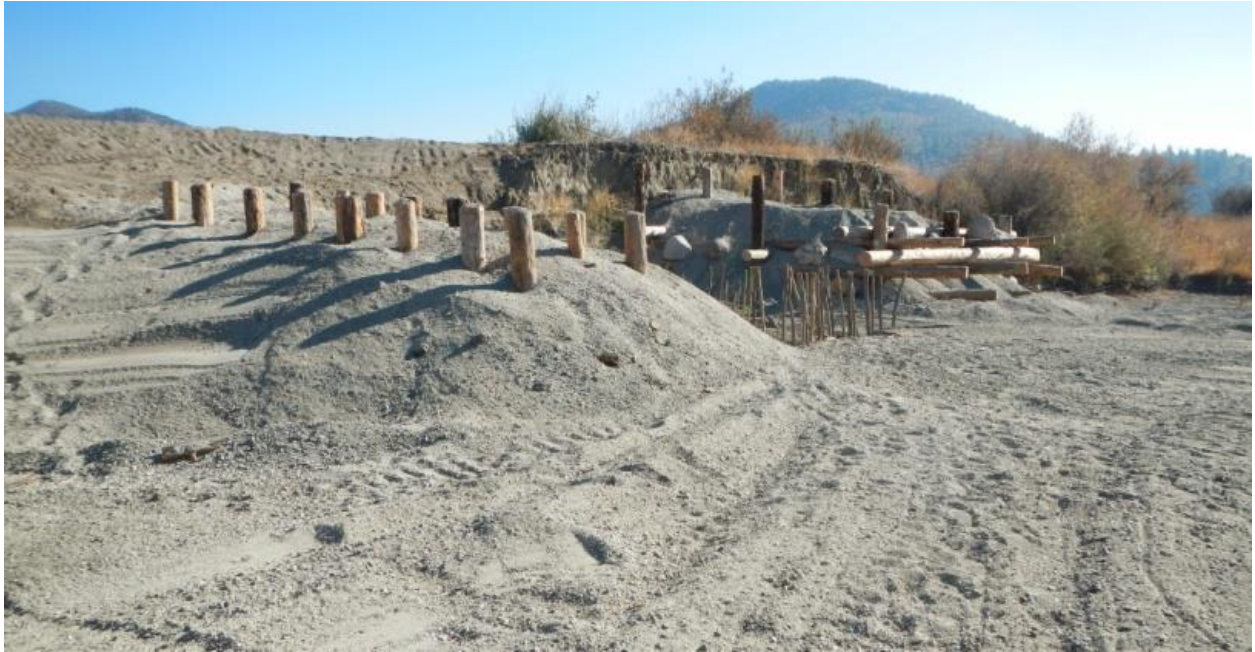
Figure 26. Type A ELJ (left) and Type B ELJ (right) after construction (eastern bank), 10/30/20.

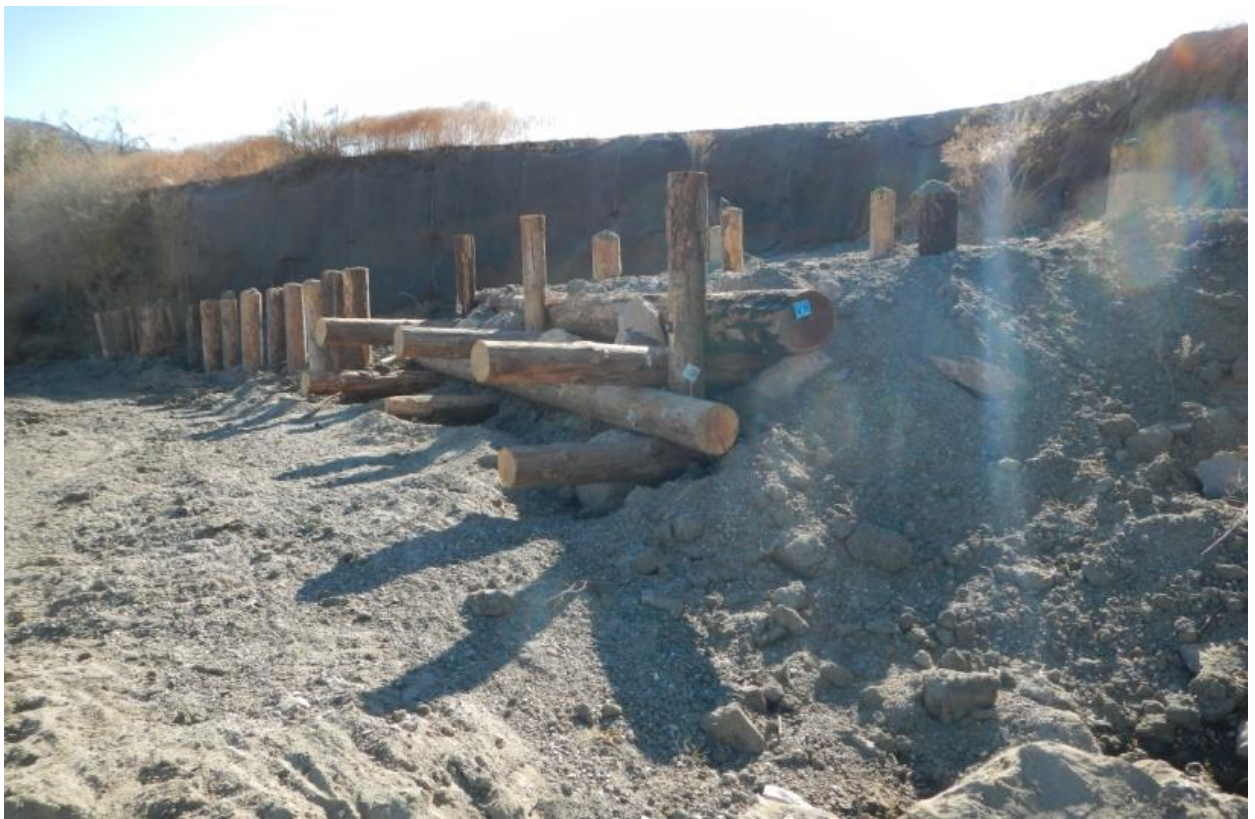
Figure 27. Type B ELJ after construction (western bank), 10/30/20.

The western bank was treated with a single Type B ELJ to intercept impinging flows and protect against erosional damage (Figure 27). Fill for this structure was planned to be sourced from a designated borrow area alongside the river-left access road; however, it was ultimately determined that the material in that area was too fine for this application, so bed load from the gravel bar was used instead. All of the structures are intended to stabilize the streambank, thereby allowing riparian plantings to establish and effectively resist the forces of high flows, while also providing shade, cover, and habitat. Lower velocities along the bank will also allow sediment deposition and promote the natural recruitment of native vegetation to compliment the riparian planting efforts. The utilization of natural and locally available materials is a continued investigation into using softer, vegetation-based methods to address lateral channel migration and encourage riparian re-establishment, as compared to historical practices.

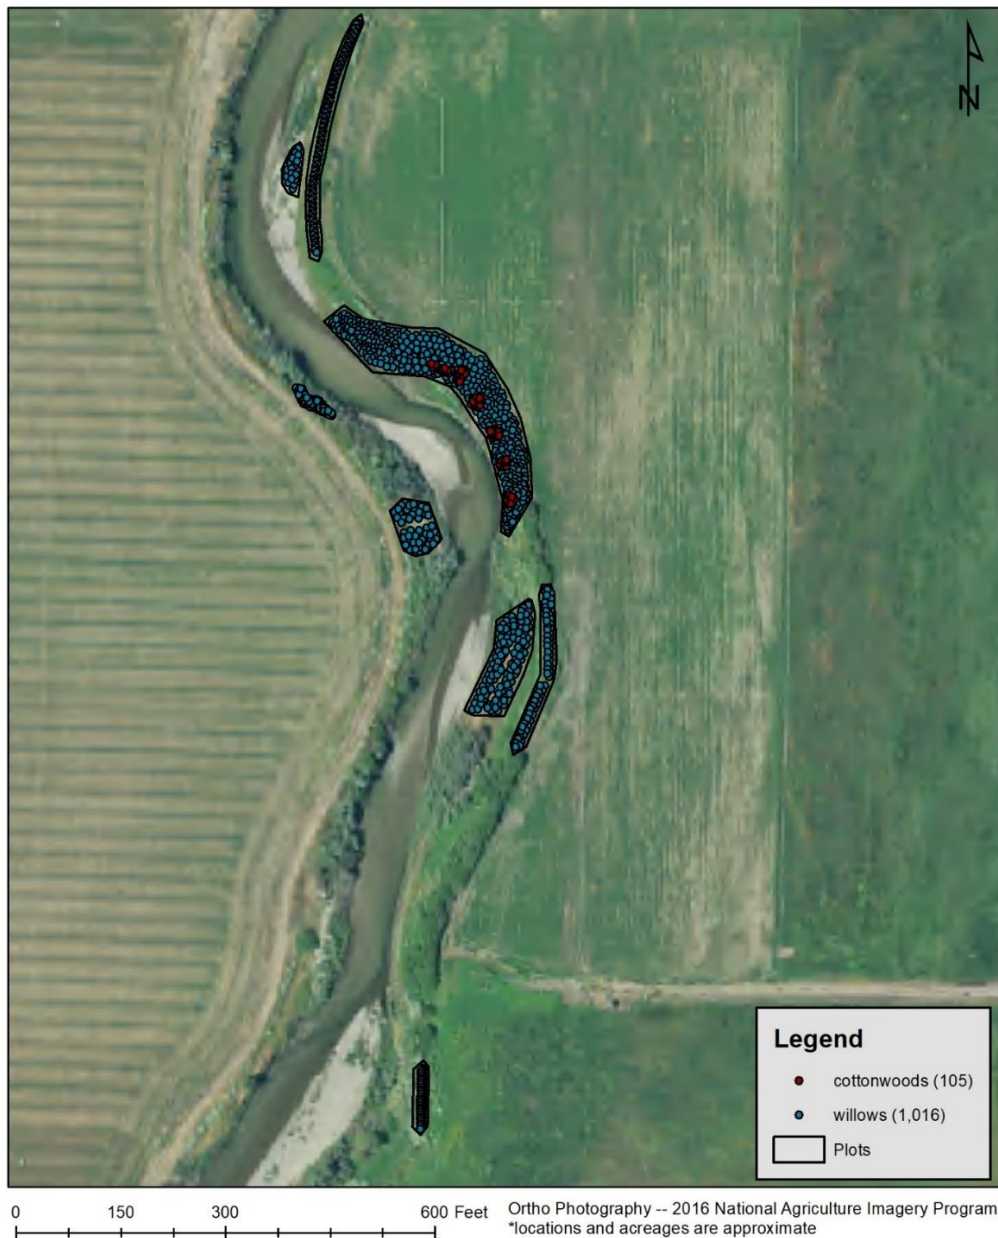
Scarface Cattle Co/Finley Farms -- Fall 2020 Revegetation -- Total Acreage = 1.3

Figure 28. Diagram of planting methods and locations

Again, comprehensive riparian revegetation was an integral component of the treatment plan as vegetation contributes to long-term stability of the banks and development of an ecologically functional riparian corridor. All planting activities were completed during the fall 2020 construction period and covered 1.3 acres of the riparian corridor (Figure 28). Of this acreage, approximately 0.6 acres were planted at high density (>1,000 plants per acre) and approximately 0.7 acres were planted at medium density (around 500 plants per acre). A total of 105 cottonwood poles and 1,016 willow poles were installed through plots covering bare areas of the terraces, the re-sloped bank and berm, surrounding the stabilizing structures, along the water line and other nearby areas.

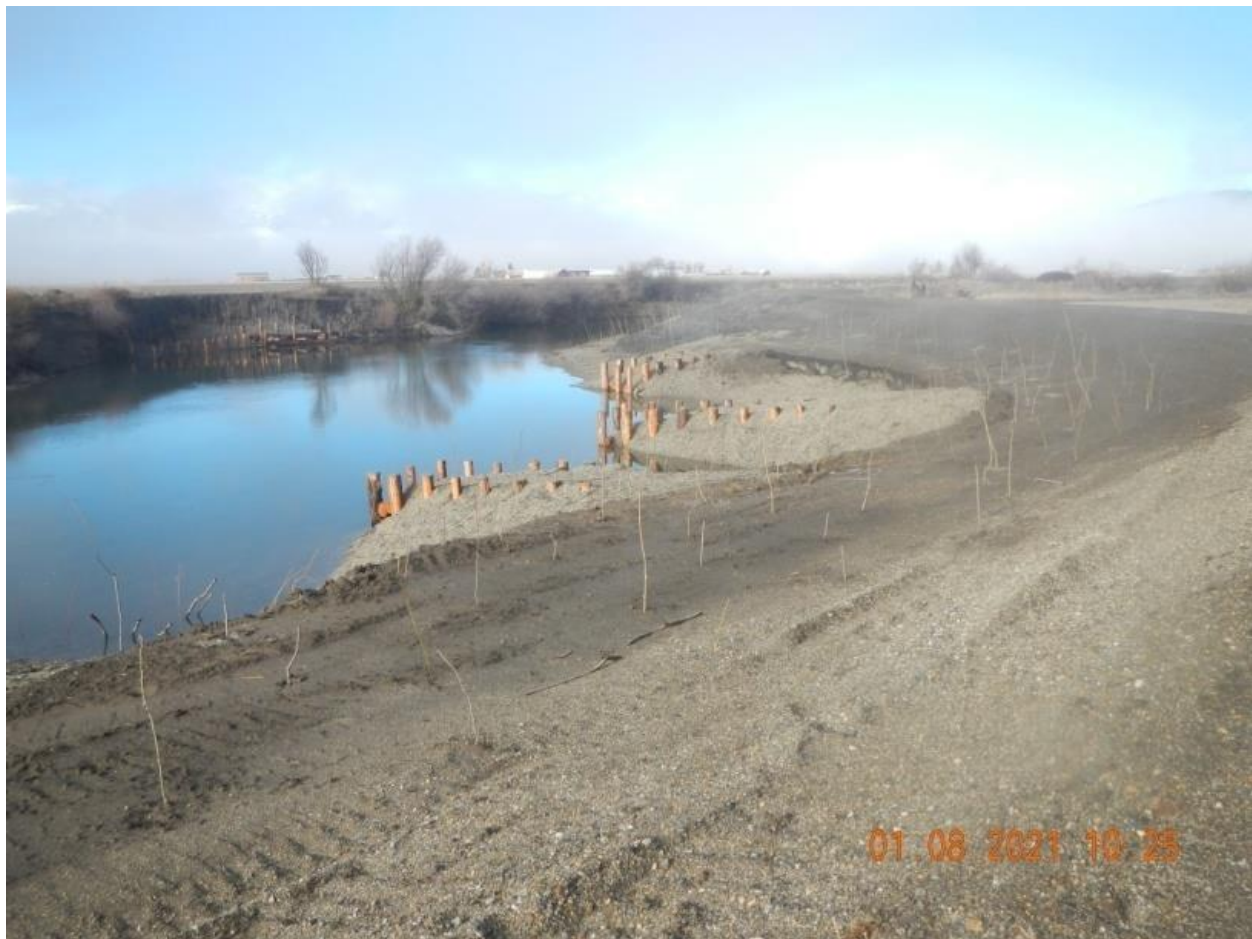
Figure 29. Willow poles and whips planted across the entire disturbed area of the eastern bank, 1/8/21.

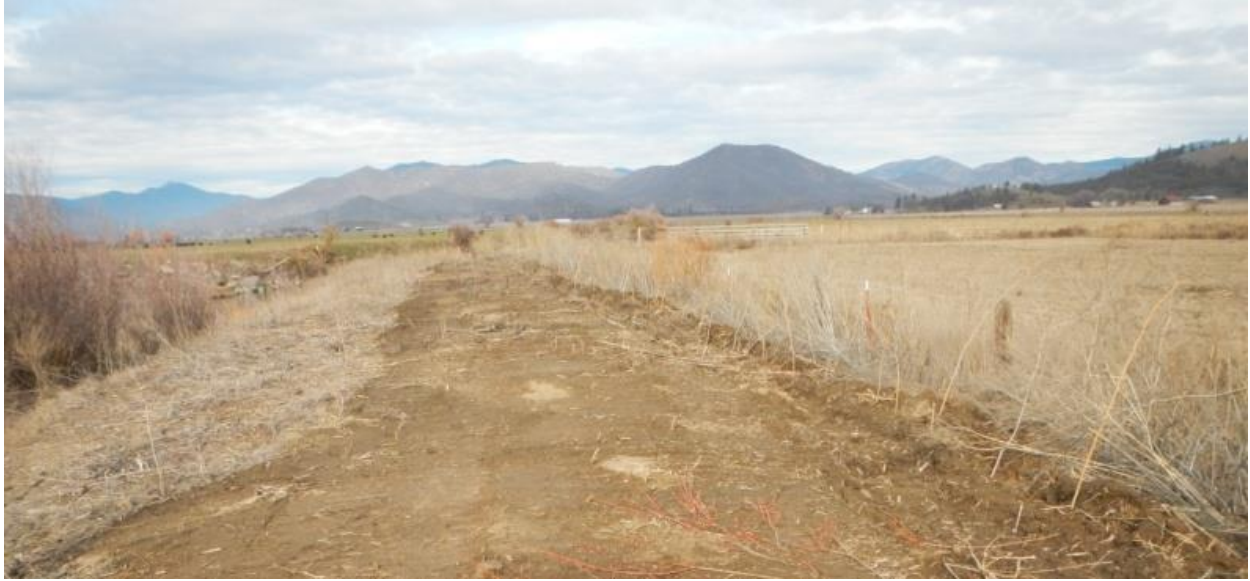
Figure 30. Willow planted through the eastern upper terrace along the fence line (Plot 1), 1/21/21.

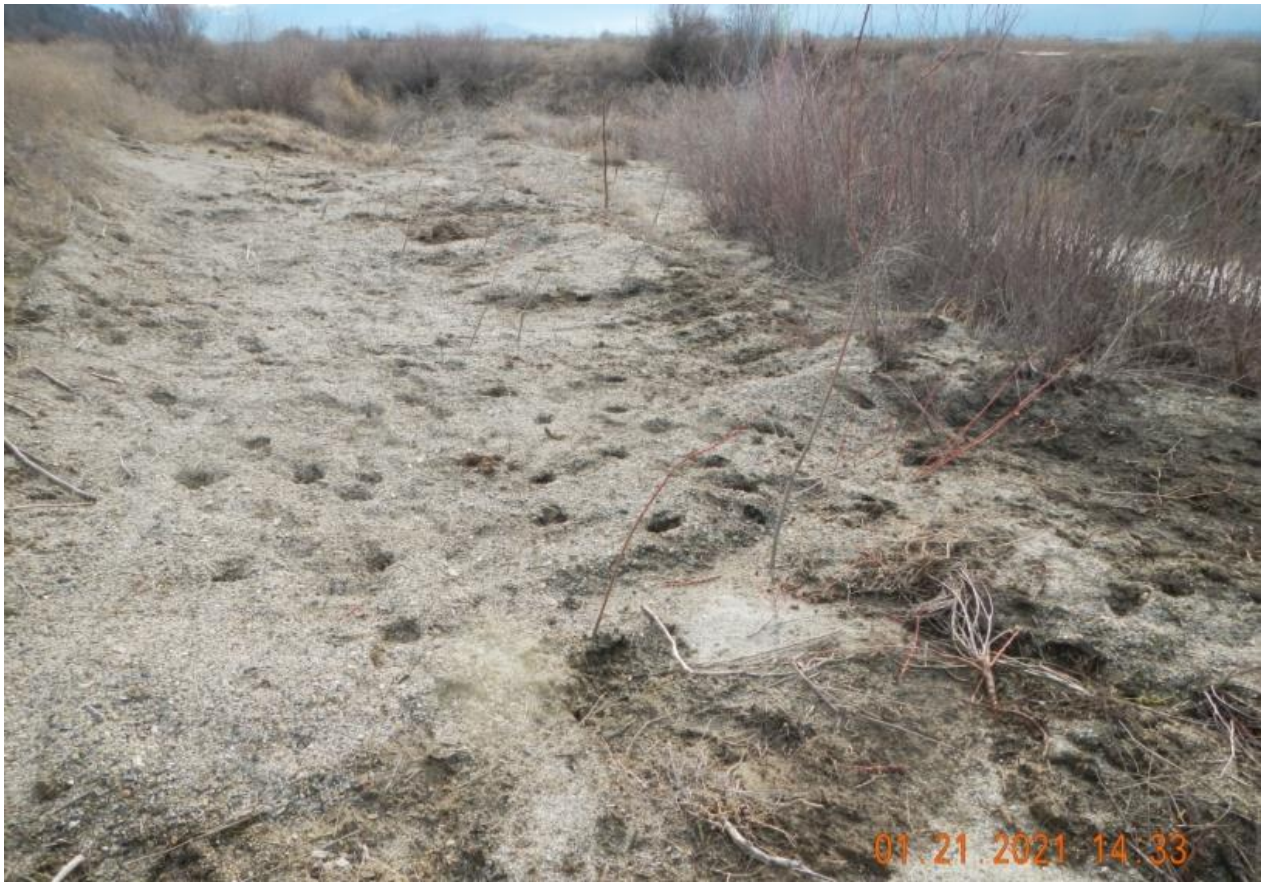
Figure 31. Willow planted through the eastern lower terrace (Plot 1), 1/21/21.

- Willow poles and whips were planted through bare areas within the middle and lower terraces of the eastern side of the river in rows running parallel with the direction of flow (bottom portion of Plot 4 and bottom portion of Plot 1) (Figure 31, 33)

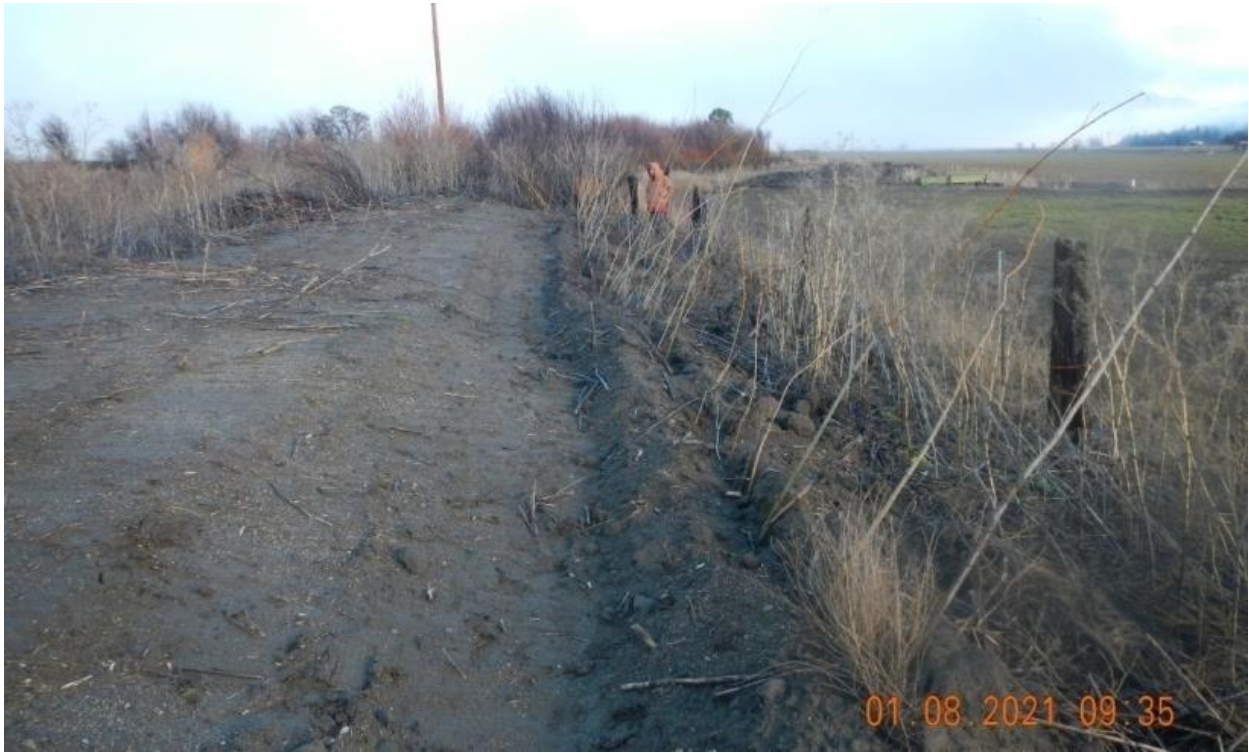
Figure 32. Willow planted through the eastern upper terrace along the fence line (Plot 5), 1/8/21.

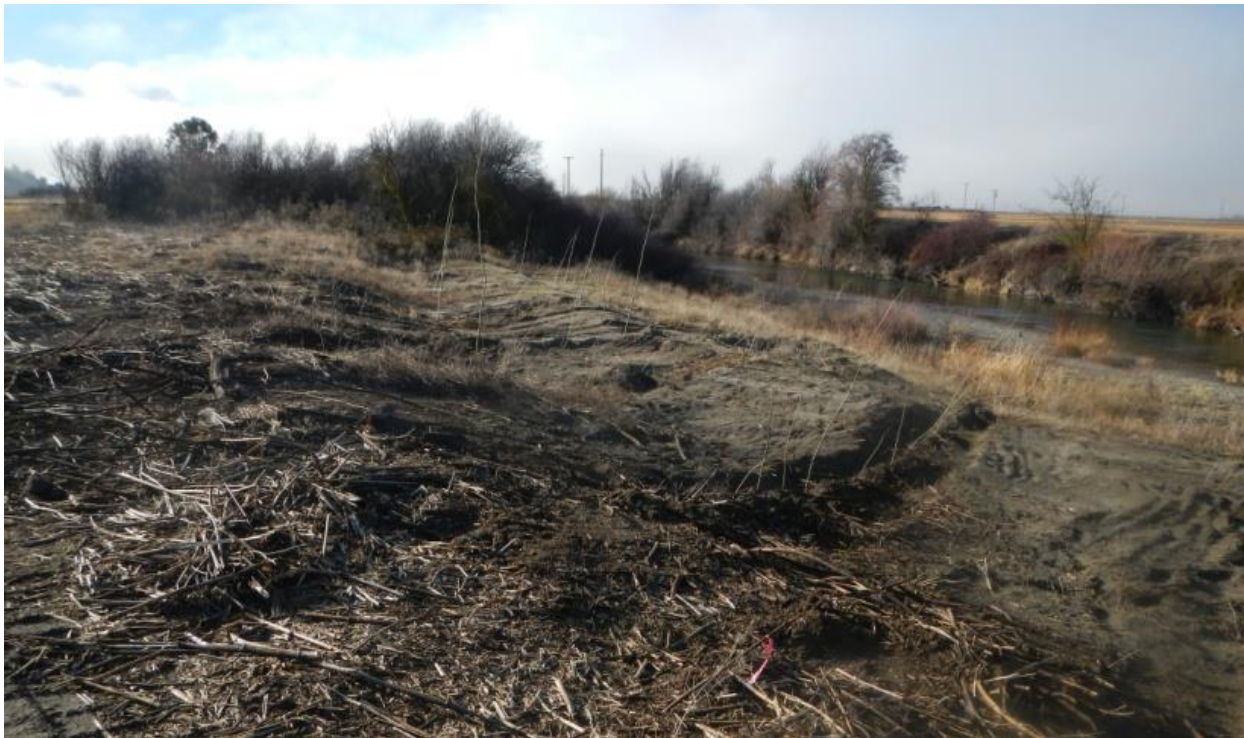
Figure 33. Willow planted through the eastern middle and lower terraces (Plot 4), 1/8/21.

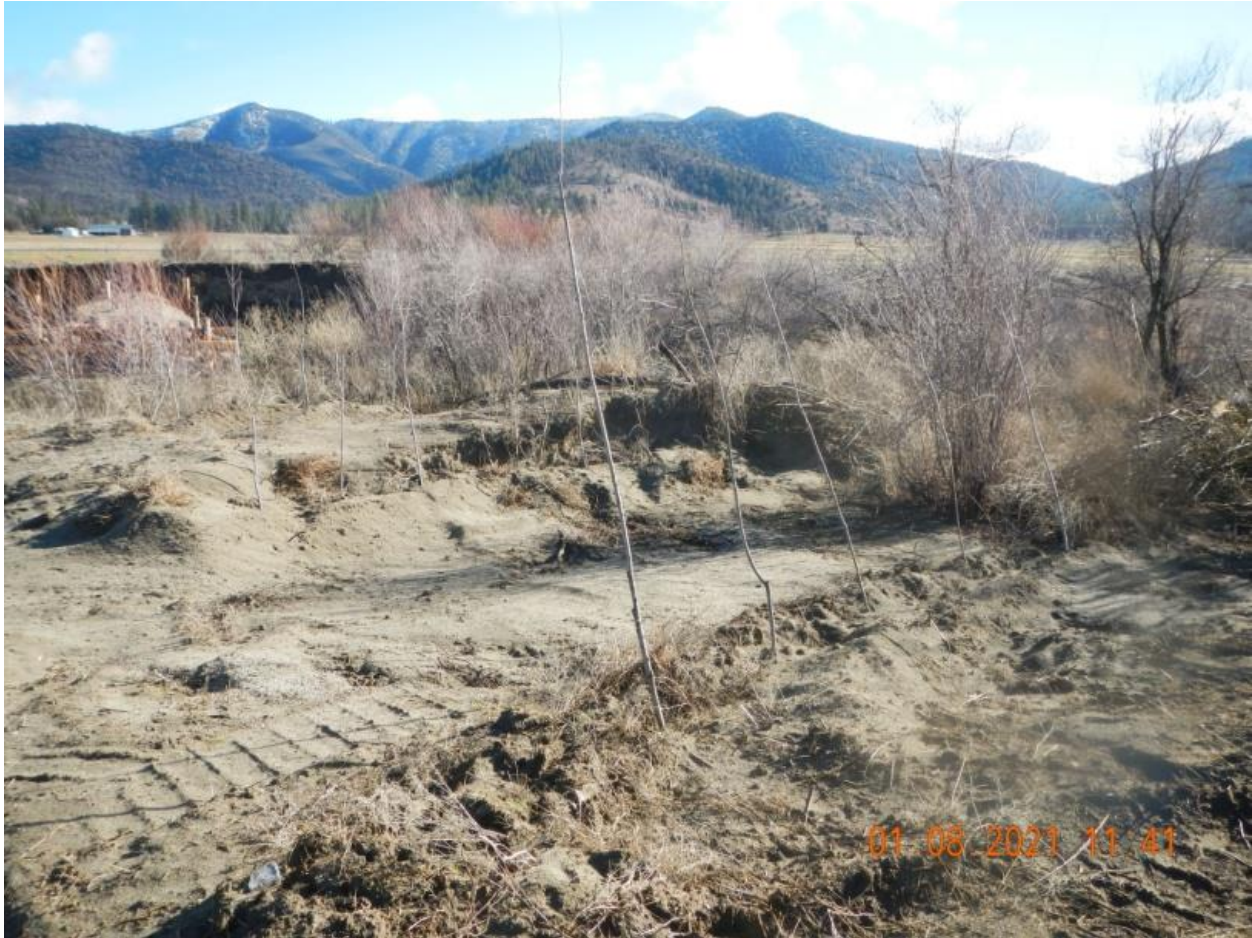
Figure 34. Willow planted through the western access road (Plot 3), 1/8/21.

- Willow poles and whips were planted through the access road on the western side of the river (Plot 3) (Figure 34)

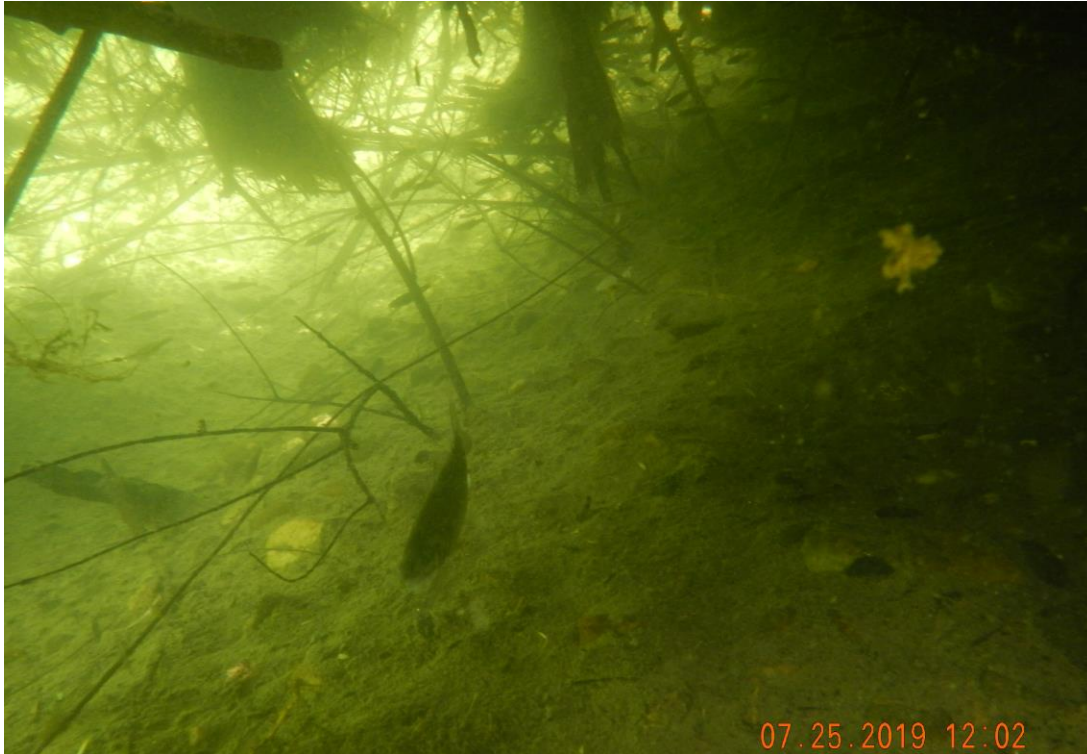
Figure 37. Steelhead trout occupying sheltered habitat created by Type B ELJ on western bank, 7/25/19.

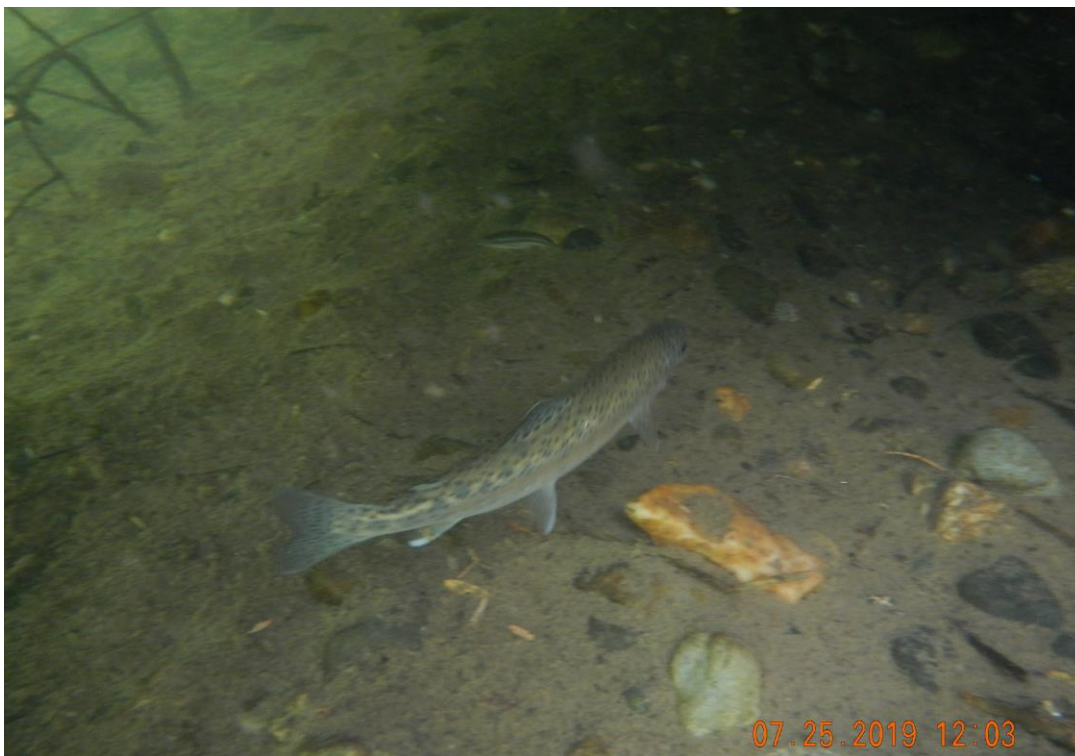
Figure 38. Steelhead trout underneath woody debris of Type B ELJ on western bank, 7/25/19.

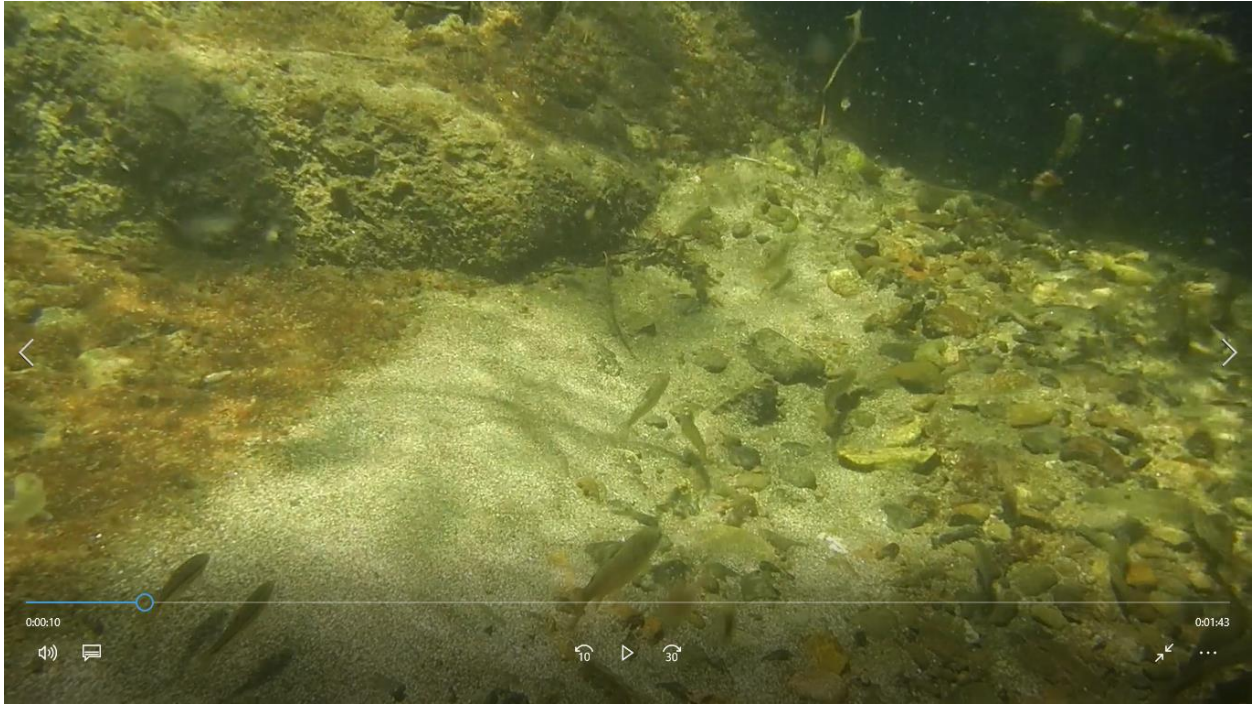
Figure 39. Scour pools surrounding Type C ELJ with different age classes of rainbow trout, 6/19/20.

A snorkel survey conducted in late July 2019, discovered only a few salmonids within the rkm 67 project area. Water quality conditions this time of year often prompt salmonids to complete their seasonal migration into cold water tributaries or down river towards the ocean. However, several juvenile coho salmon, rainbow trout, and adult steelhead were documented occupying the scour pools and backwater eddies of the Type C and Type B ELJs on the western bank (Figures 37-38). The following year, a snorkel survey was conducted a month earlier in mid-June 2020 and discovered a decent population of rainbow trout throughout the project area. These fish were found mainly in deeper areas where complex cover elements such as undercut banks, riprap, submerged woody debris, or overhanging terrestrial vegetation were available. This included the scour pools and backwater eddies of all the ELJs. A total of 628 rainbow trout were counted occupying the habitat formed by the constructed features (Figures 39-41).

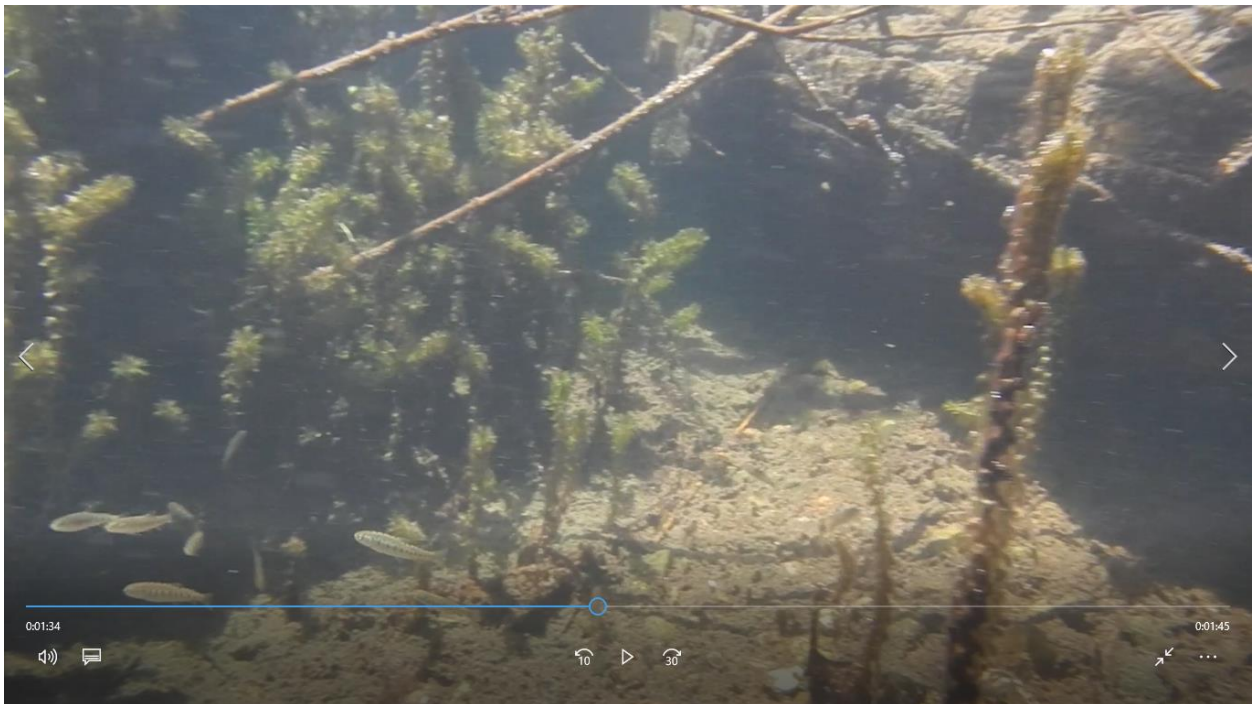
Figure 40. Juvenile rainbow trout in scour pool surrounding Type B ELJ on western bank, 6/19/20.

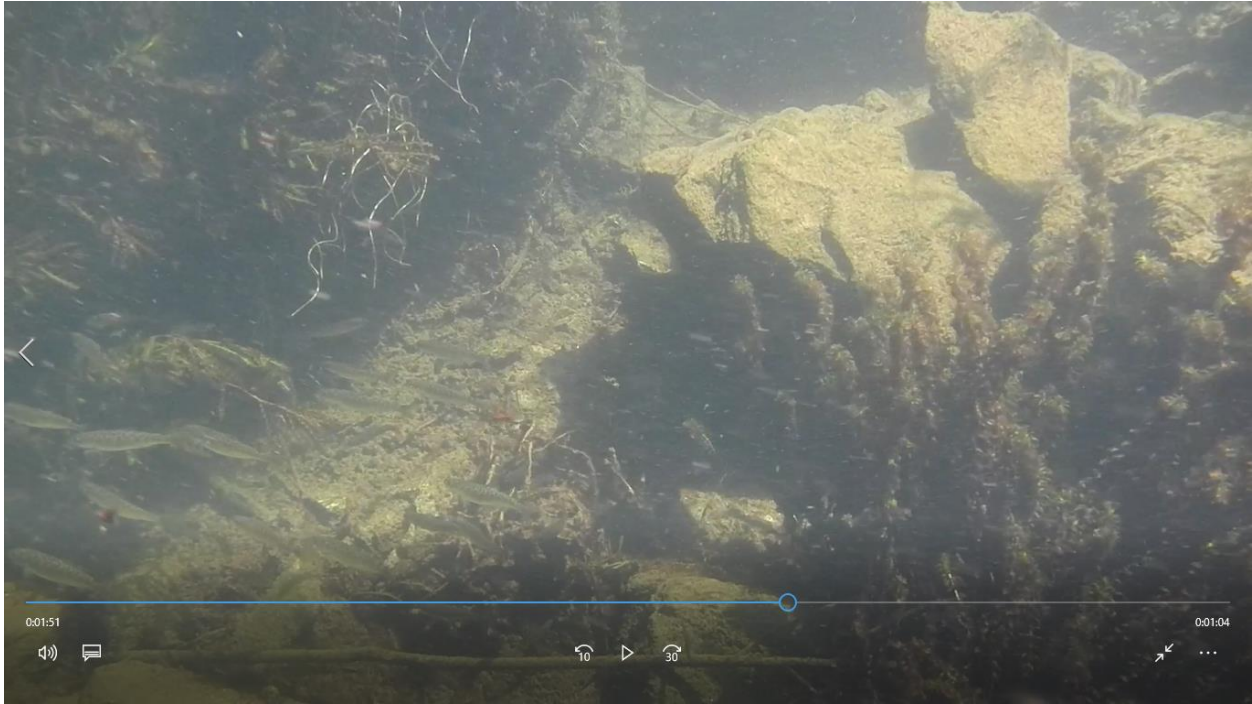
Figure 41. Juvenile rainbow trout in scour pool surrounding Type B ELJ on eastern bank, 6/19/20.
