Scott River Riparian Restoration Analysis

Prepared by the Siskiyou RCD

For the United States Fish and Wildlife Service

Sept 2009

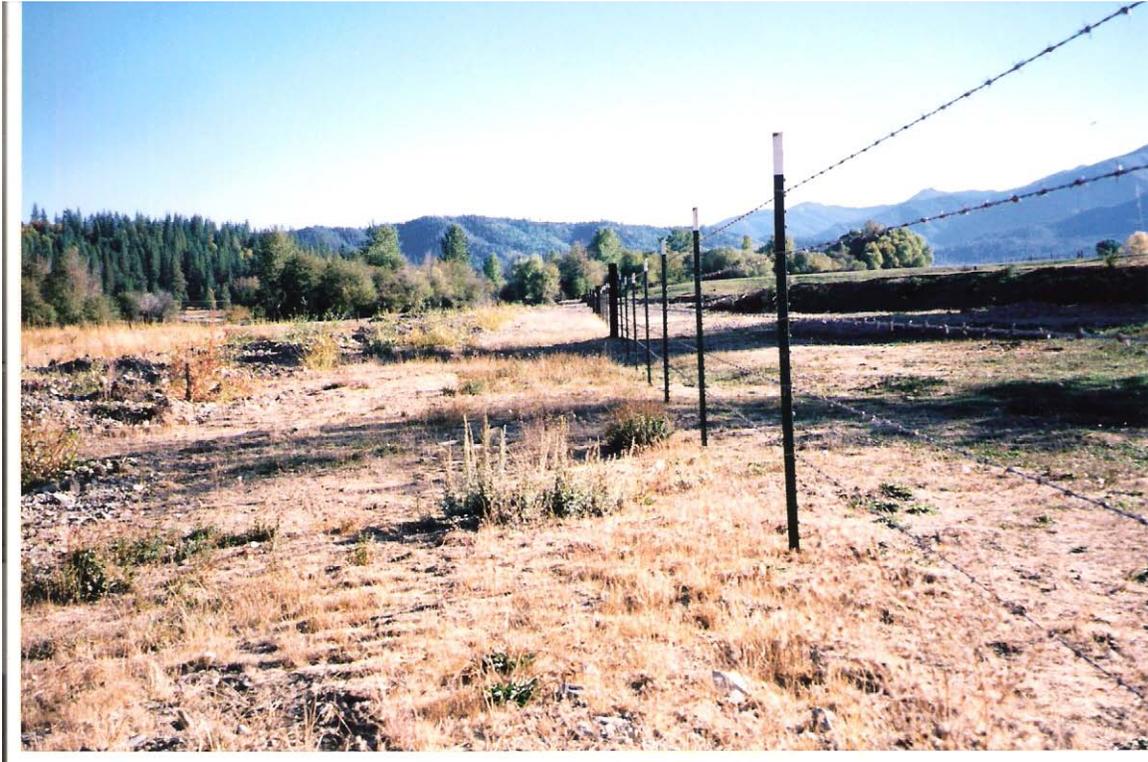
Figure 6 This picture shows the completed fencing and riparian planting in 1999 - Mill Creek on left

The success of this site is attributed to combination of the cattle exclusion fencing in a reach with a stable year-round water table and the existence of a source riparian seeds above and within the reach.

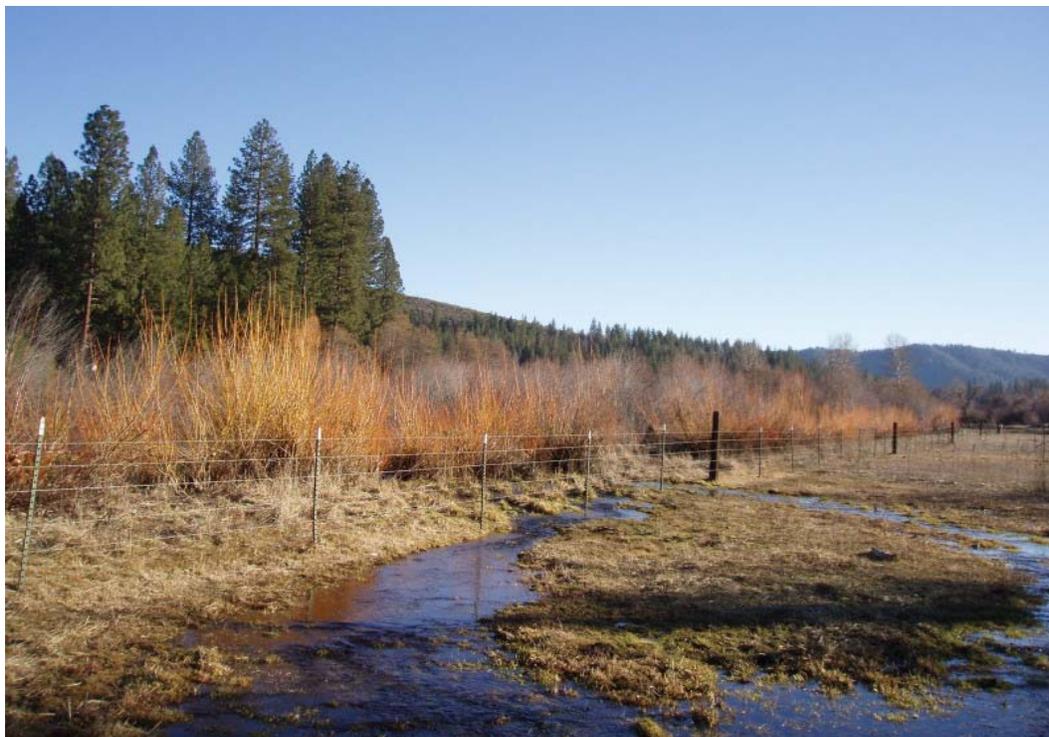
The image above clearly illustrates the current (2005) extent of riparian vegetation in the project reach in contrast to the almost denuded state of the channel’s banks and floodplain in 1993. A beaver dam and significant impoundment currently exists in the upstream portion of this reach.

No indication of beaver presence is observable from the 1993 aerial photograph. It is hypothesized that the increased riparian vegetation allowed the beaver to create a dam that impounds the creek effectively increasing the water table in the area and supporting further riparian growth. Besides the positive effect on riparian vegetation the beaver dam's impoundment has been documented to provide habitat for rearing juvenile coho salmon and rainbow trout.

Figure 7 This picture shows the same exclusion fence on Mill Creek, December 2008 - Mill Creek on left – overflow from beaver impoundment in foreground

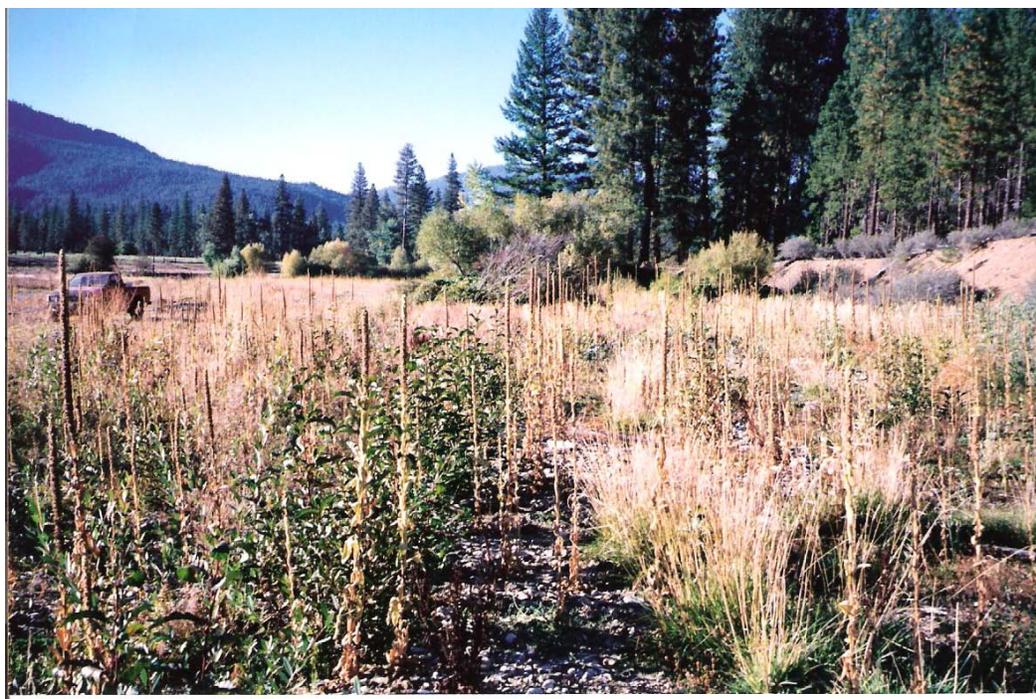
Figure 8 This picture shows natural vegetation within the fenced riparian area after 10 months - 1999

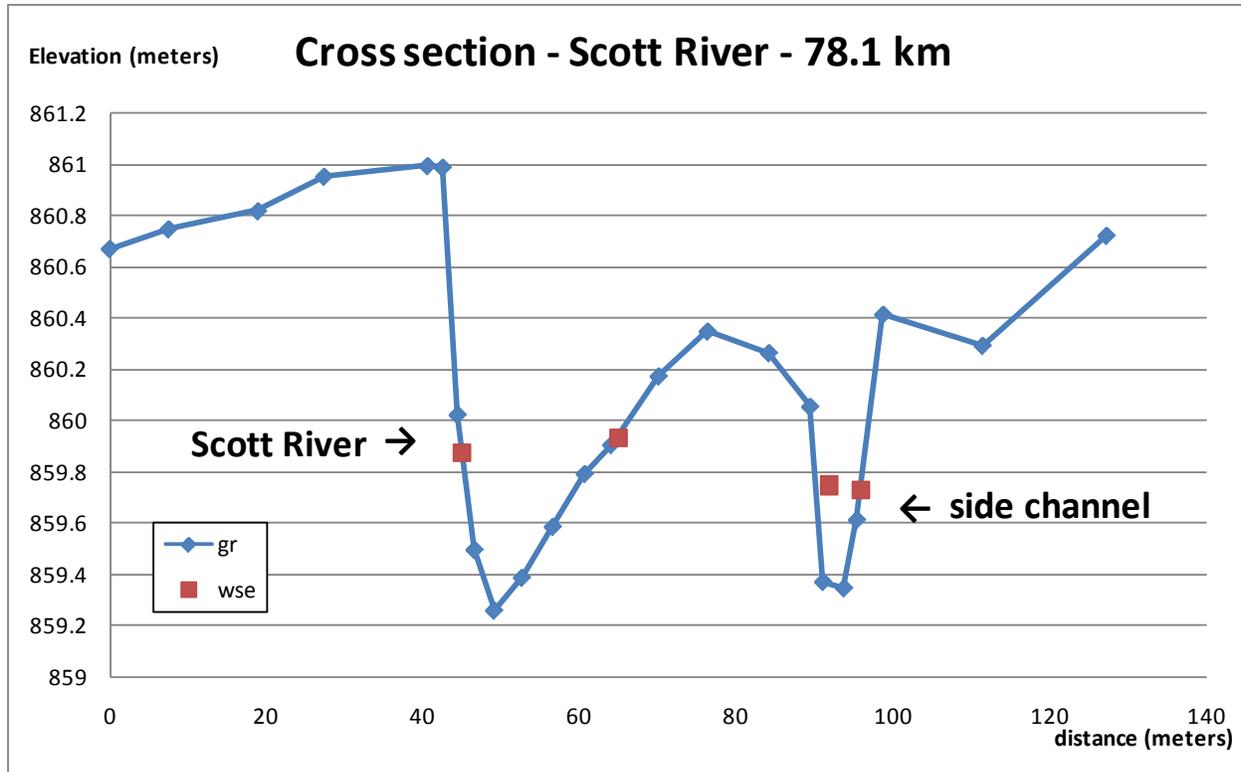
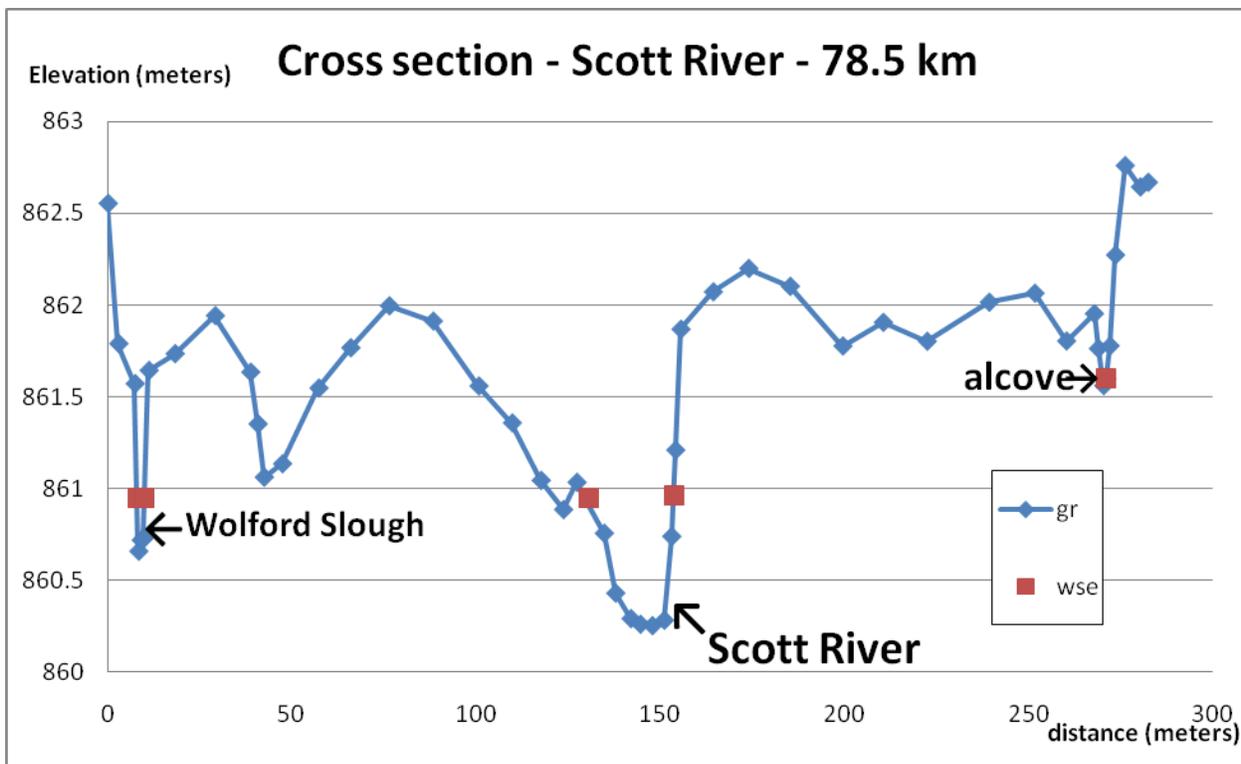
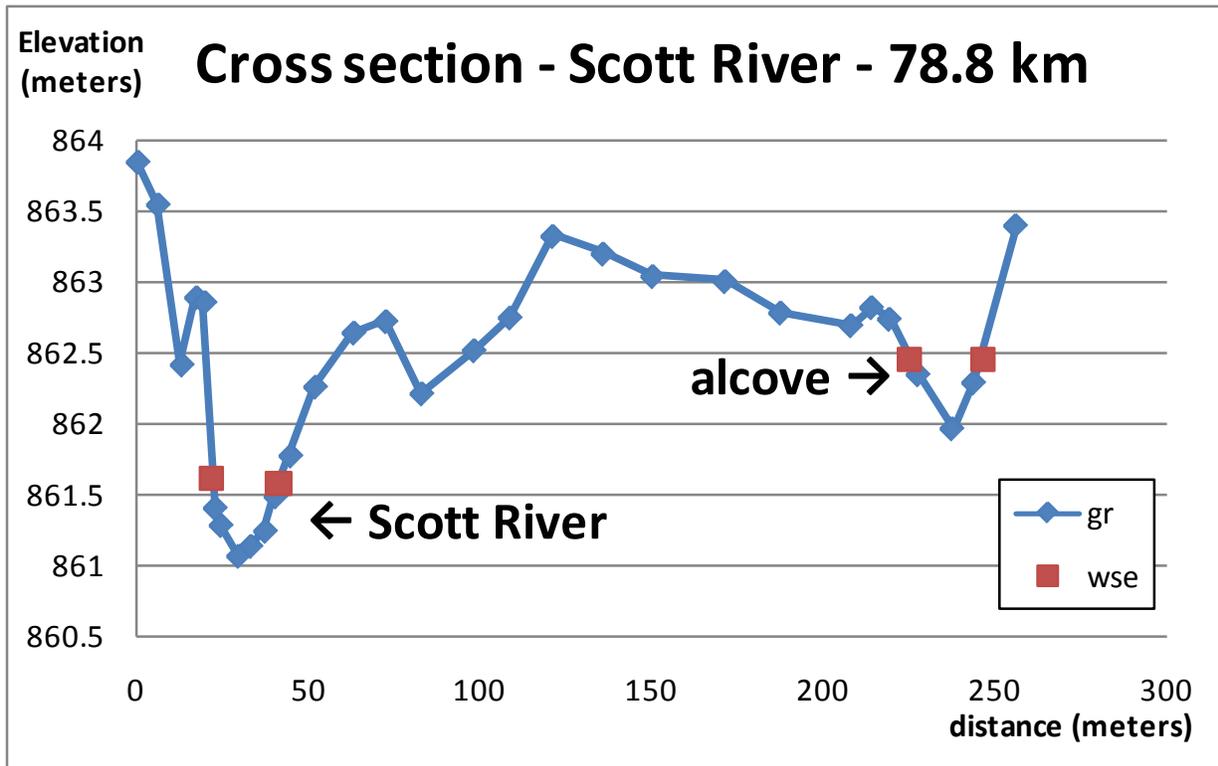
Figure 12 – Cross section of Scott River at RKM – 78.1 with water surface elevation (wse)

Figure 13 - Cross section of Scott River at RKM – 78.5 with water surface elevation (wse)

Figure 14 - Cross section of Scott River at RKM – 78.8 with water surface elevation (wse)

The downstream portion of the study reach is characterized by cross sections performed at RKM 78.1, 78.5 and 78.8 - Figures 12, 13 & 14, respectively. Wolford Slough is on the west side and a side channel (historic channel) is on the east side of the Scott River. Significant bars with maximum widths of approximately 100 meters (300 ft.) on which plantings were performed in the late 1990's separate these water features. Riparian vegetation is relatively dense along both Wolford Slough and the side channel with more limited vegetation across the bars (Figure 16). Analysis of the cross sections and water surface demonstrates that the elevations of the land adjacent to the water courses are less than those on the gravel bar. These water courses offer both surface water and land that is closer to the water table potentially increasing the survival and natural recruitment of riparian plants.

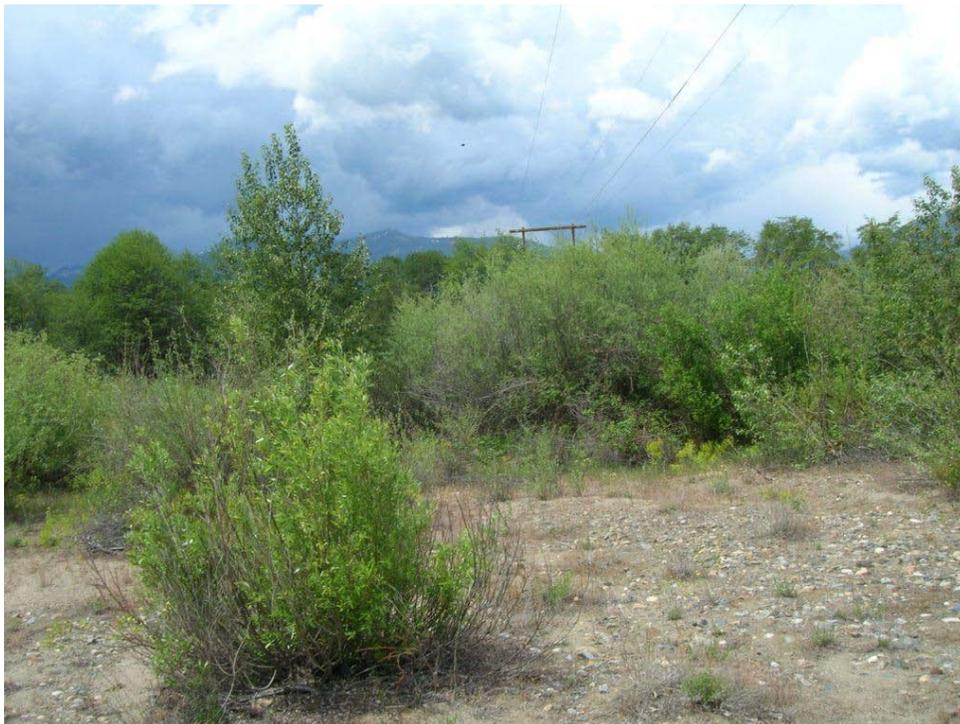
Figure 16 – Denser riparian vegetation in the background is associated with Wolford Slough

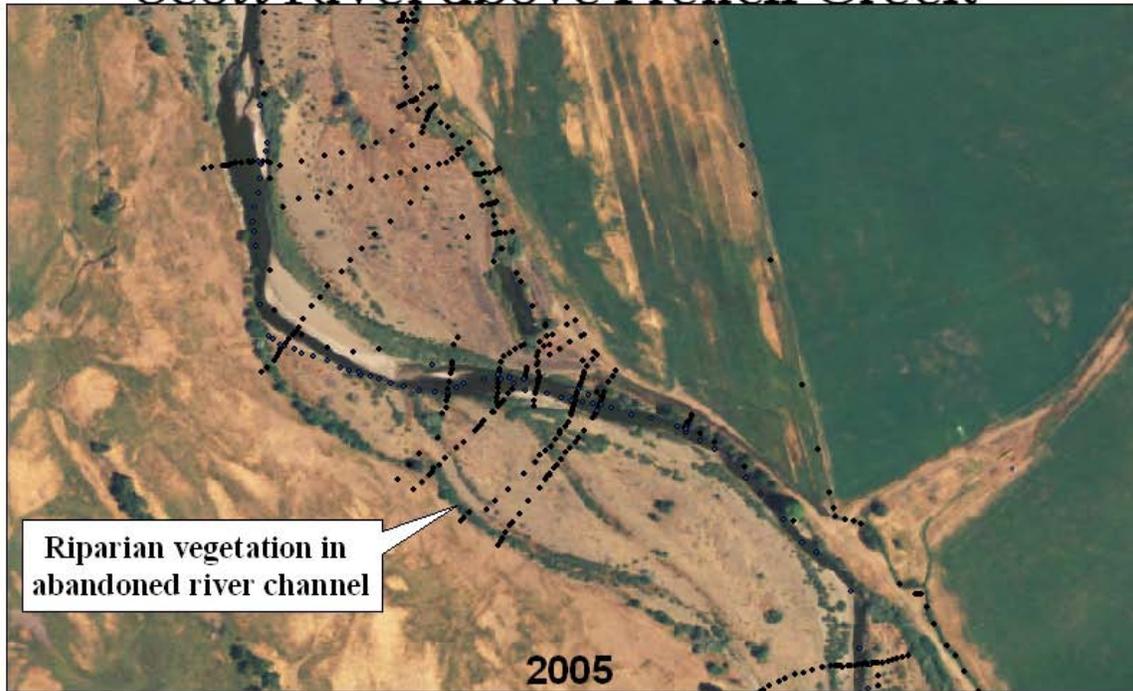
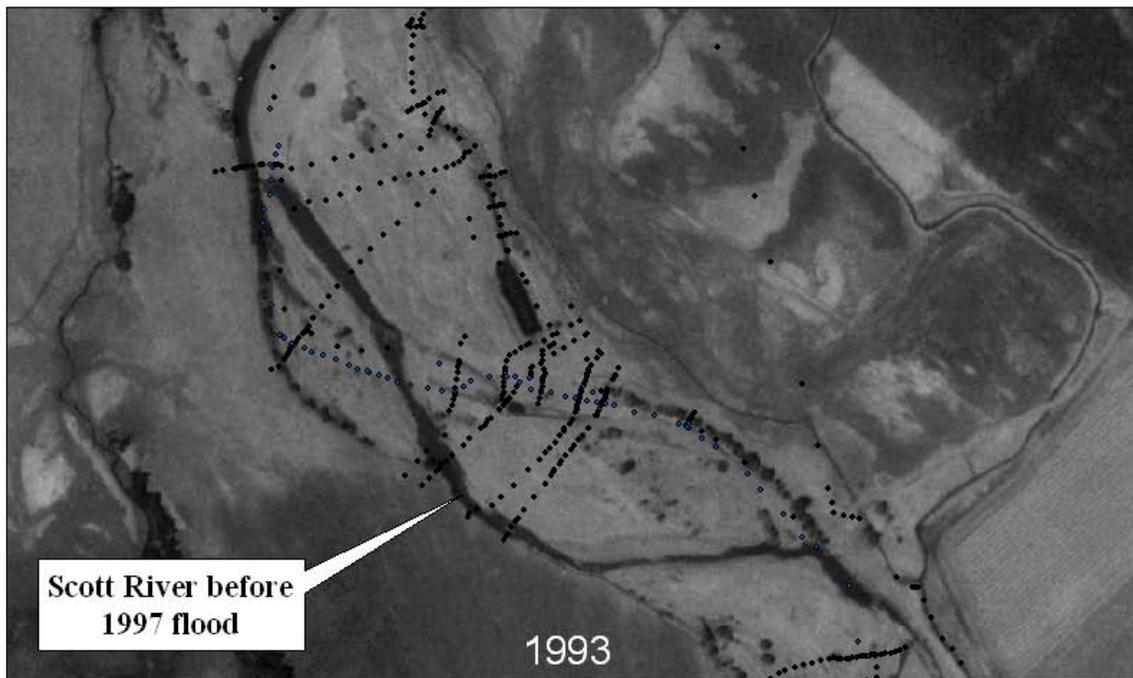
The cross section performed at RKM – 79.0 (Figure 15) shows a low elevation “trough” at the western edge (Left Bank). Analysis of the 2005 aerial photograph shows this trough is occupied by a strip of riparian vegetation in an area otherwise sparsely vegetated. Analysis of the aerial photograph captured in 1993 shows this area with lower elevation was occupied by the Scott River’s channel previous to the 1997 flood (Figure 17). Though the channel has migrated, the former location has significantly lower elevation than the surrounding gravel bar creating an area with a depth to water table that is less than the depths on the adjacent gravel bar. The occurrence of riparian vegetation in this corridor with access to a “higher” water table indicates the importance of the water table’s elevation in respect to the land in the success of riparian vegetation establishment.

Figure 17 – Aerial images of study reach in 2005 (above) and 1993 (below)

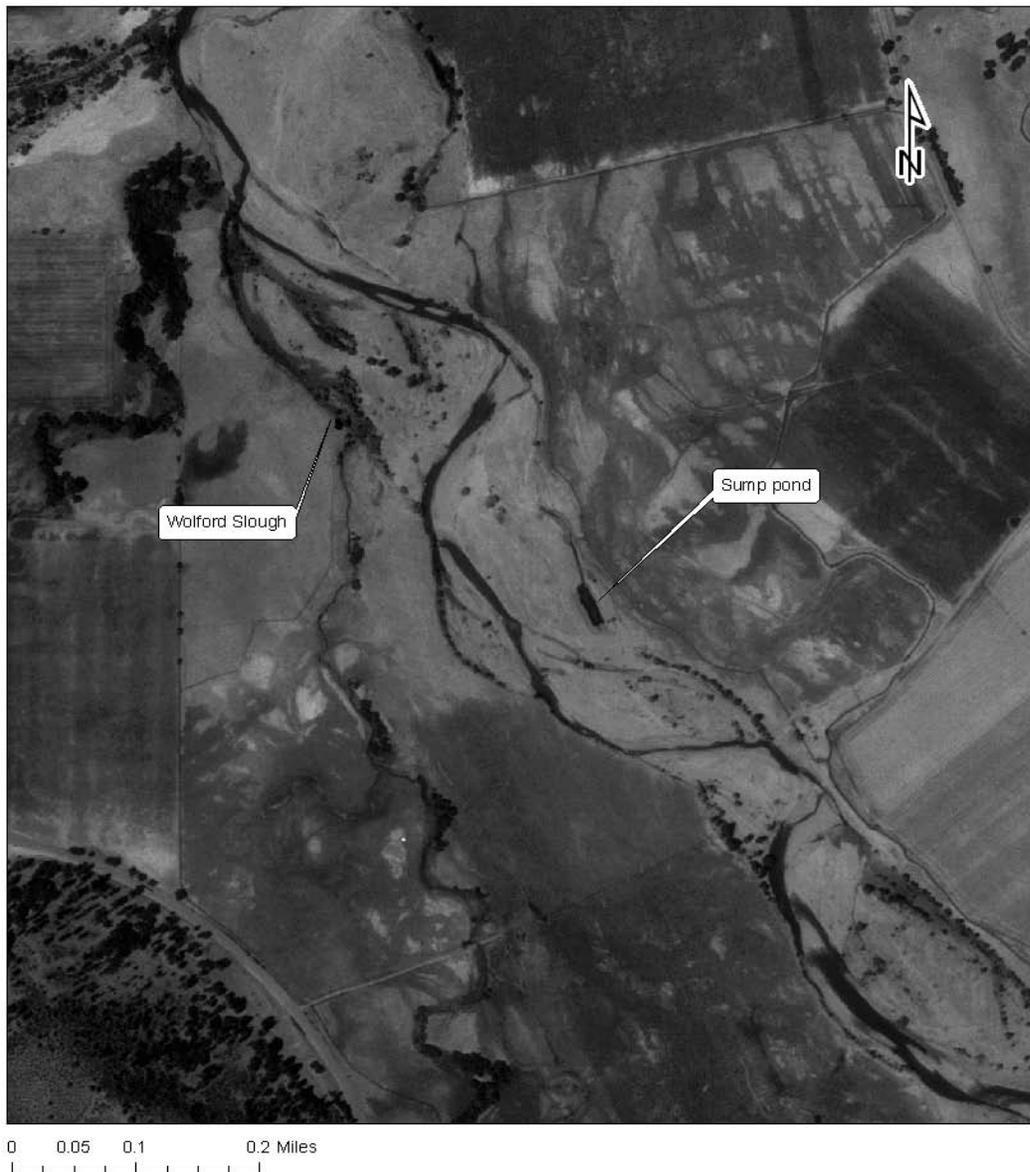
Further analysis of the aerial images from 1993 and 2005 demonstrates multiple locations of channel alteration attributable to the 1997 flood in this reach (Figures 18a and 18b). Many of these abandoned channels are characterized by strips of riparian vegetation in the 2005 image. The reach from the bottom of the tailing pile to Youngs Dam does not have the significant elevation difference between the stream bed and adjacent lands that is observed in the leveed areas of the Scott River below Youngs Dam.

Figure 18a - Aerial image of study reach 1993

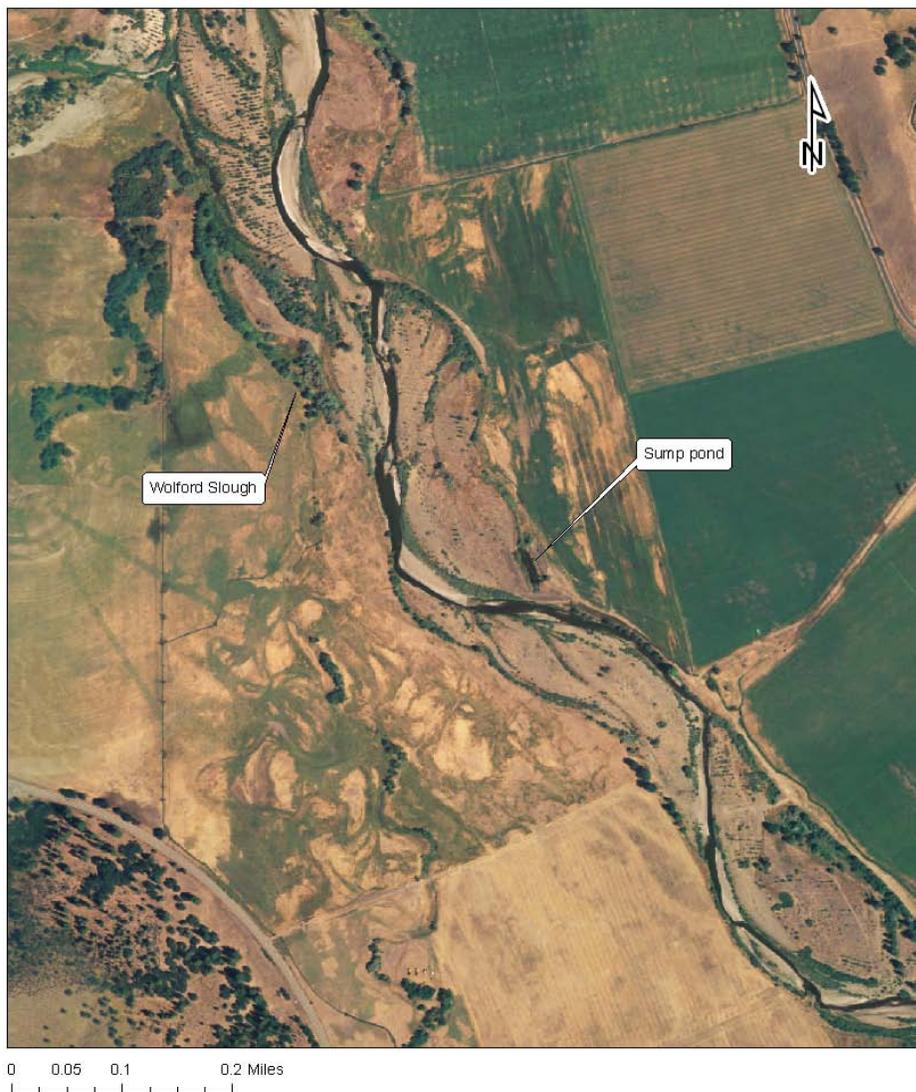
Figure 18b – aerial image of study reach 2005

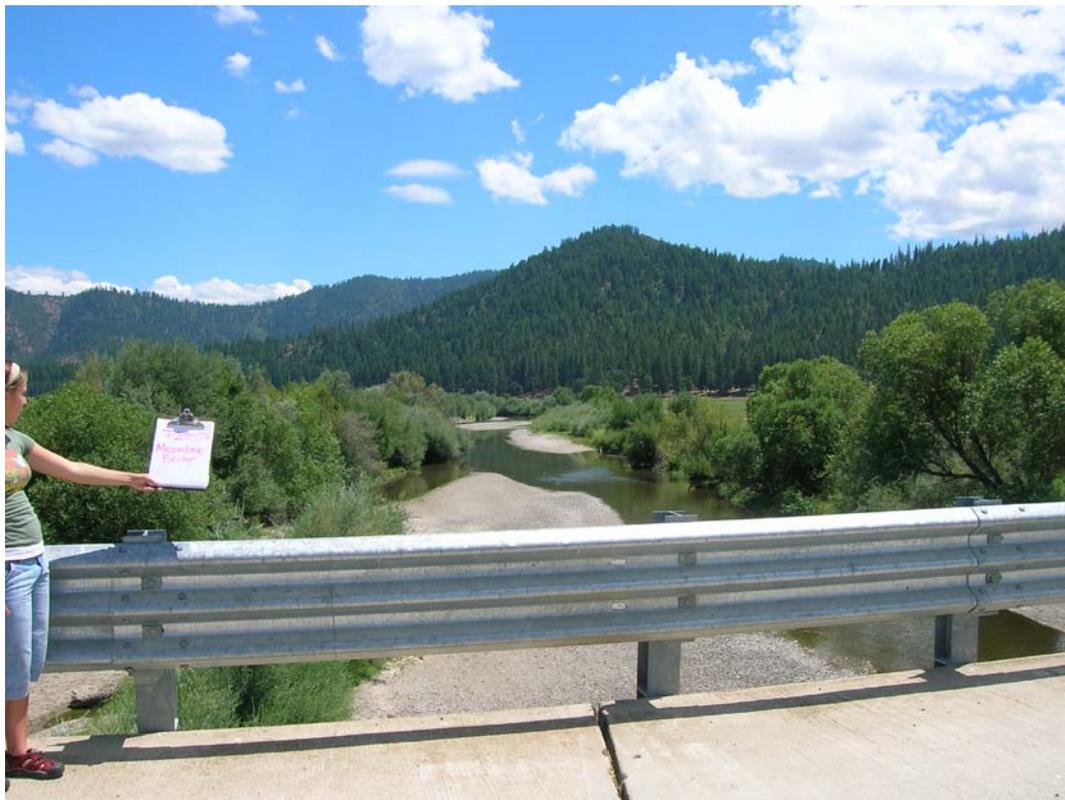
Figure 23- Scott River at Meamber Bridge looking upstream

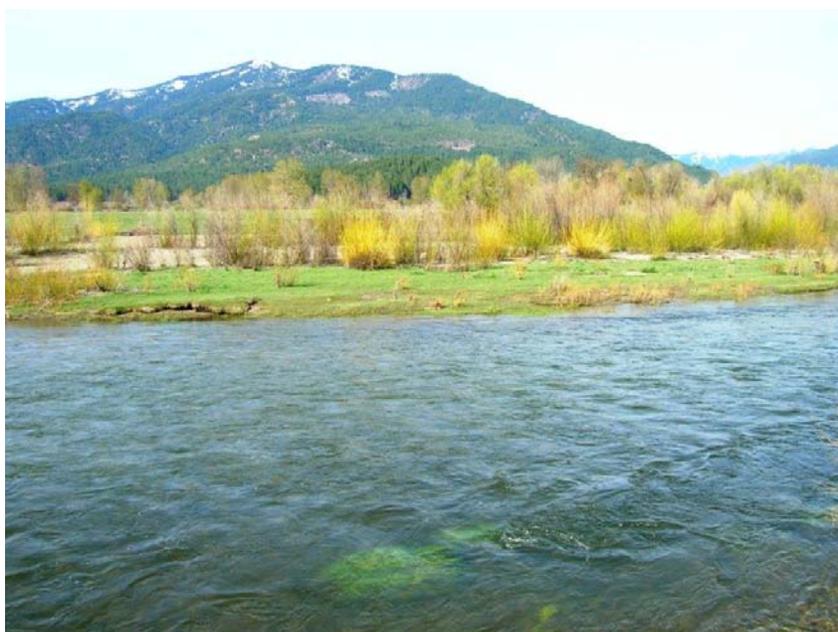
Figure 24 – representative stream bank above Shackleford Creek
