# **Assessment of Juvenile Salmonid Passage at the Young's Dam Fish Ladder, Scott River, Siskiyou County, CA**

Siskiyou County Resource Conservation District

Dr. Christopher Adams, Fish Wiz LLC

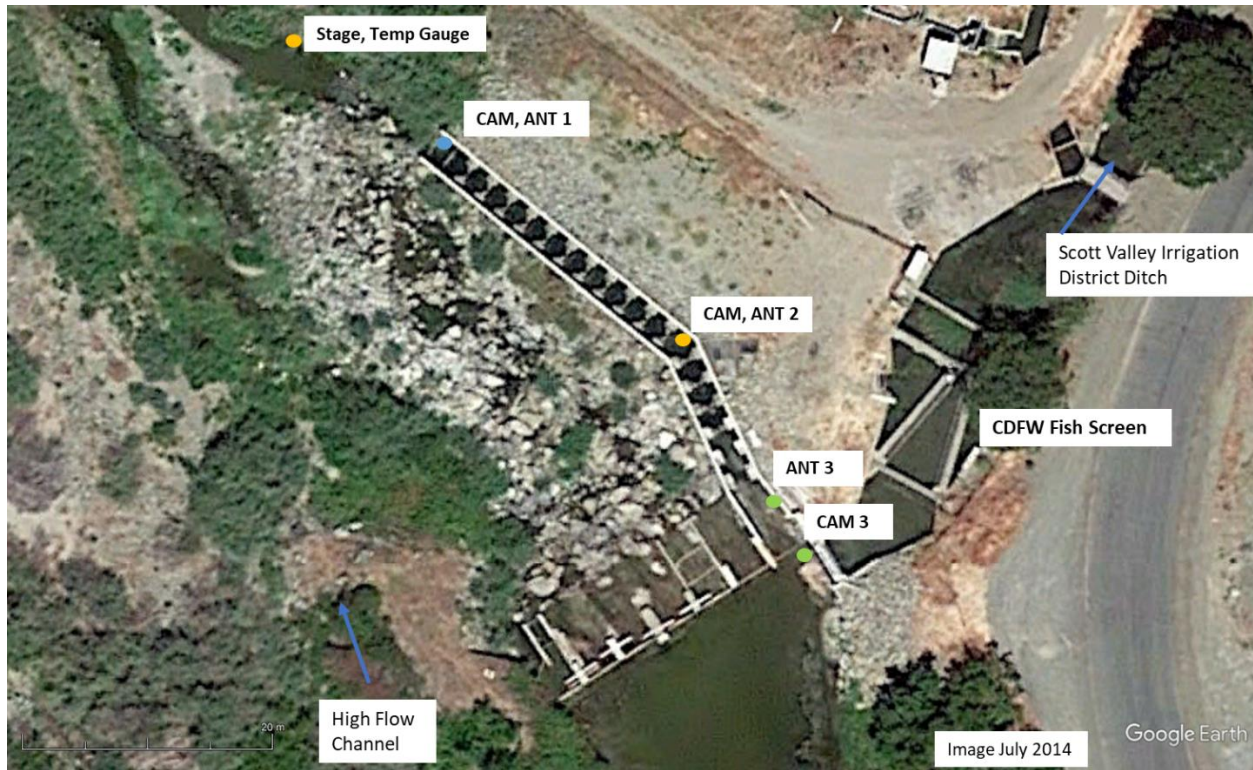
Young's Dam (Figure 1) is located at River Kilometer (RKM) 75.1 and is the diversion site for Scot Valley Irrigation District (SVID), which flows from the east bank. A fish ladder was built by the California Department of Fish and Wildlife (CDFW) in 2006 and is situated along the east bank just downstream of the SVID diversion downstream extending approximately 50 meters downstream (Photo 1). The ladder is an approximately 3-meter-wide concrete channel with 17 v-notched iron baffles seated in concrete sills in a downstream angle (Photo 2). Dam boards may be added at both the upstream and downstream ends to manipulate flow through the ladder and depth in the downstream bay. A fish screen exists at the upstream end of the SVID diversion, with the return flow entering the Scott River just downstream of the fish ladder. A concrete apron and flashboard dam spans the remainder of the mainstem channel, consisting of 6 bays in which dam boards may be added to manipulate flow into the ladder and diversion. A high-water channel exists on the west side.

Figure 1. Aerial image of Young' Dam. Image date July 2014, which provides the best unobstructed view of structures.

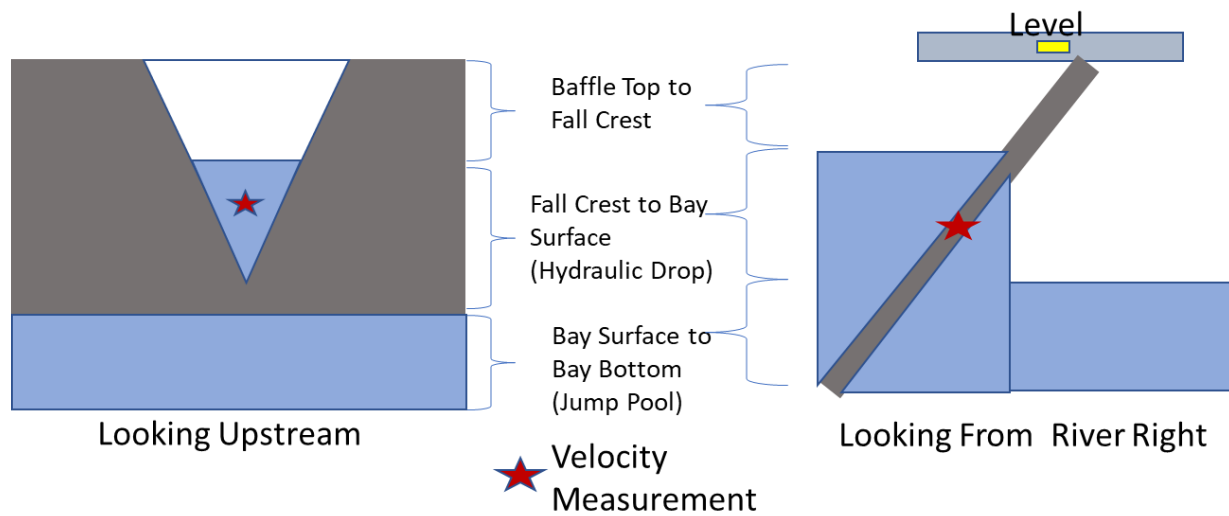
Water velocity, hydraulic drop, and jump pool depth were measured during three discharge levels in the ladder on 7/1/2023 by manipulating dam boards at the upstream end of the ladder (Figure 12). Velocity and height/depth was measured in the V notch of the upstream and downstream-most baffles using an OTT MF Pro Water Flow Meter on 7/1/2023 (Figure 12, Photo 10, Photo 11). Three discharge levels were measured, controlled by number of dam boards in the upstream end of the ladder (no boards, one board, and 2 boards, photo 12). Discharge through the ladder was calculated for each scenario and three- or four-point velocity measurements were made at each location at each discharge, and averages were calculated (Table 4). Velocities and hydraulic drop were higher than recommended for juvenile fish passage by the National Marine Fisheries Service (1 foot per second velocity and 6-inch hydraulic drop) at all measured flows, which includes the minimum flow allowable through the ladder on the date measured (1.85 cfs).

Figure 12. Illustration of velocity, hydraulic drop, and jump pool measurements.

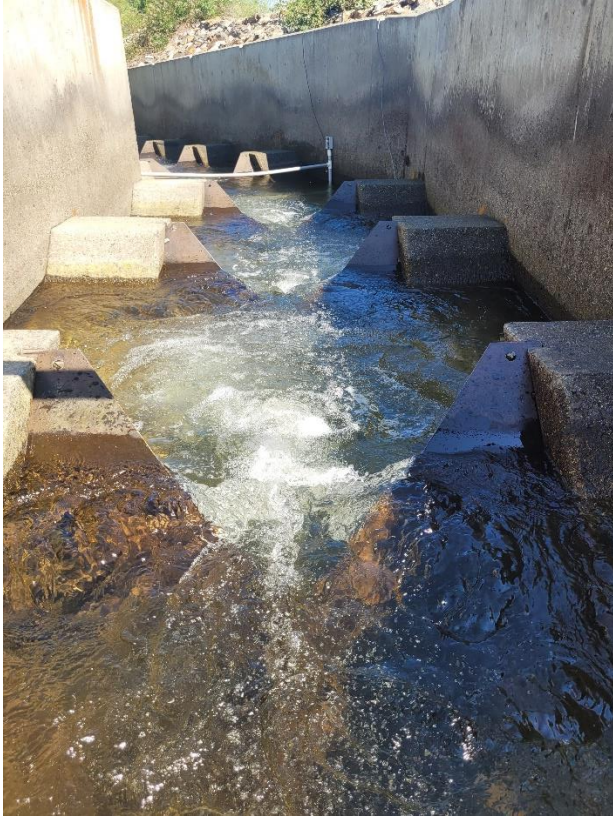
Photo 9. PIT tag antenna in bay 12.
