Avian Resources Report
for the
Scott River Streambank Bioengineering Project
Lead Agency: Siskiyou Resource Conservation District

I. Introduction

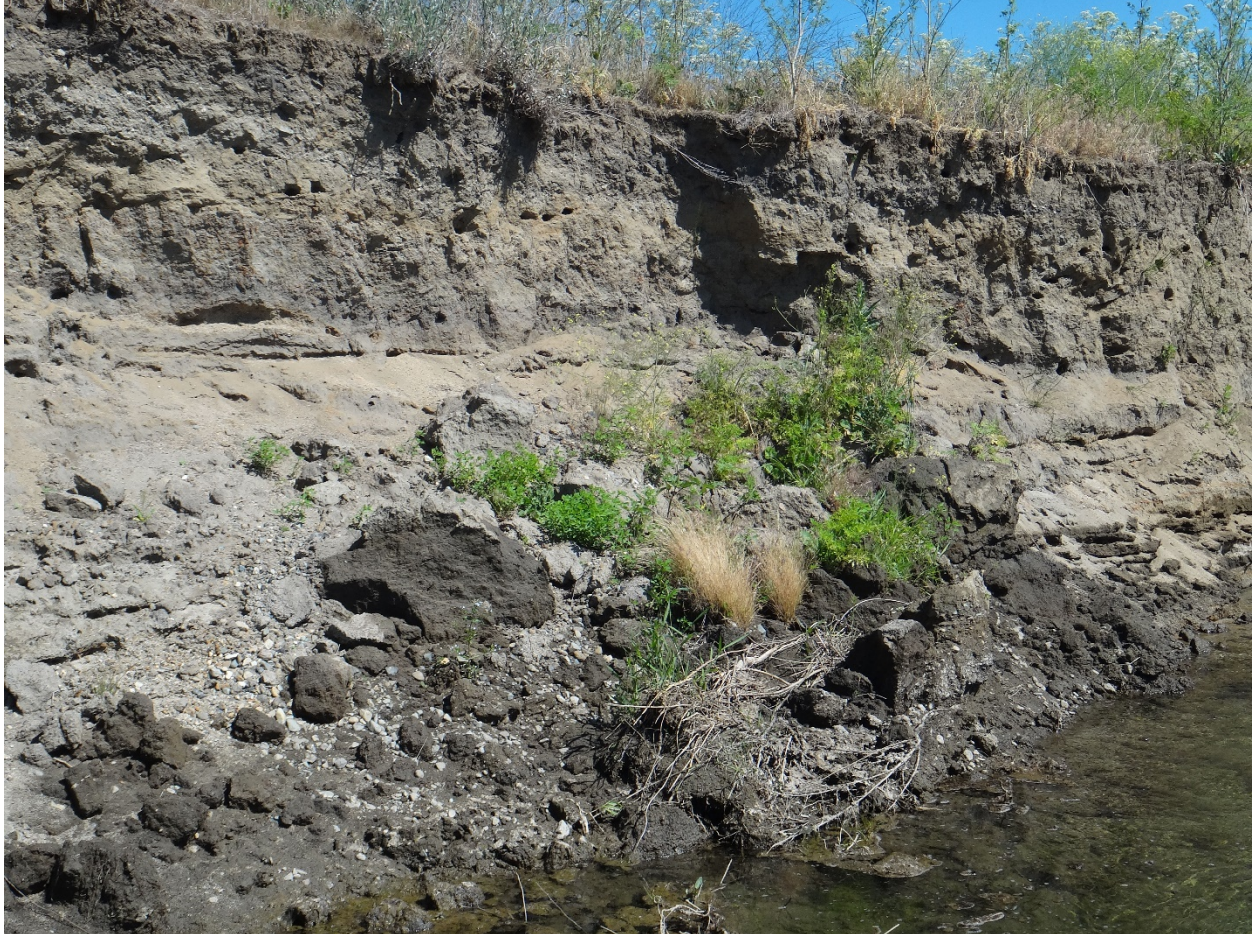
Photo 1.

Photos 1 and 2. Examples of suitable nesting habitat within the Scott River Streambank Bioengineering Project reach. Sites are characterized by vertical slopes of ≥ 2 meters, friable soils, and little or no accumulation of aggregate materials at the base of the bank.

For the purpose of this report suitable nesting habitat for Bank Swallows is defined as vertical banks ≥ 1 meter in height, with little or no accumulation of aggregate material at the bank toe, friable soils, and minimal or no vegetation (Photos 1 and 2). Unsuitable nesting habitat is defined as areas lacking vertical banks, vertical banks < 1 meter in height with aggregate material at the bank toe, heavily vegetated banks, or banks with unstable soils (Photos 3 and 4). Suitable nesting habitat for Willow Flycatchers is defined as dense willow thickets of ≥ 0.5 acres in size.

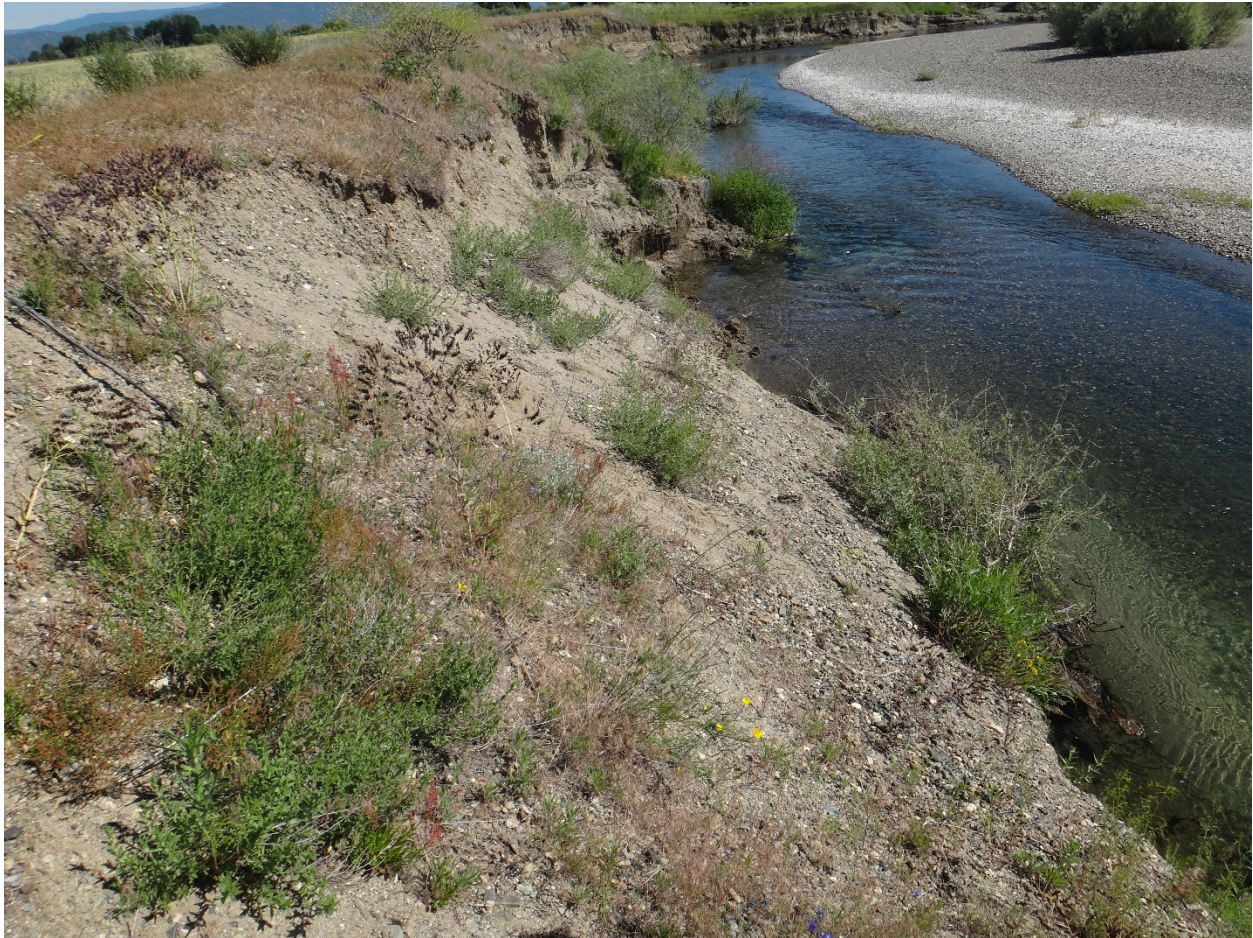
Photo 3.

Photos 3 and 4. Examples of unsuitable nesting habitat within the Scott River Streambank Bioengineering Project reach. Sites are characterized by lack of vertical slopes, vertical slopes of < 1 meter, significant accumulation of aggregate materials at the base of the bank, and/or dense vegetation.

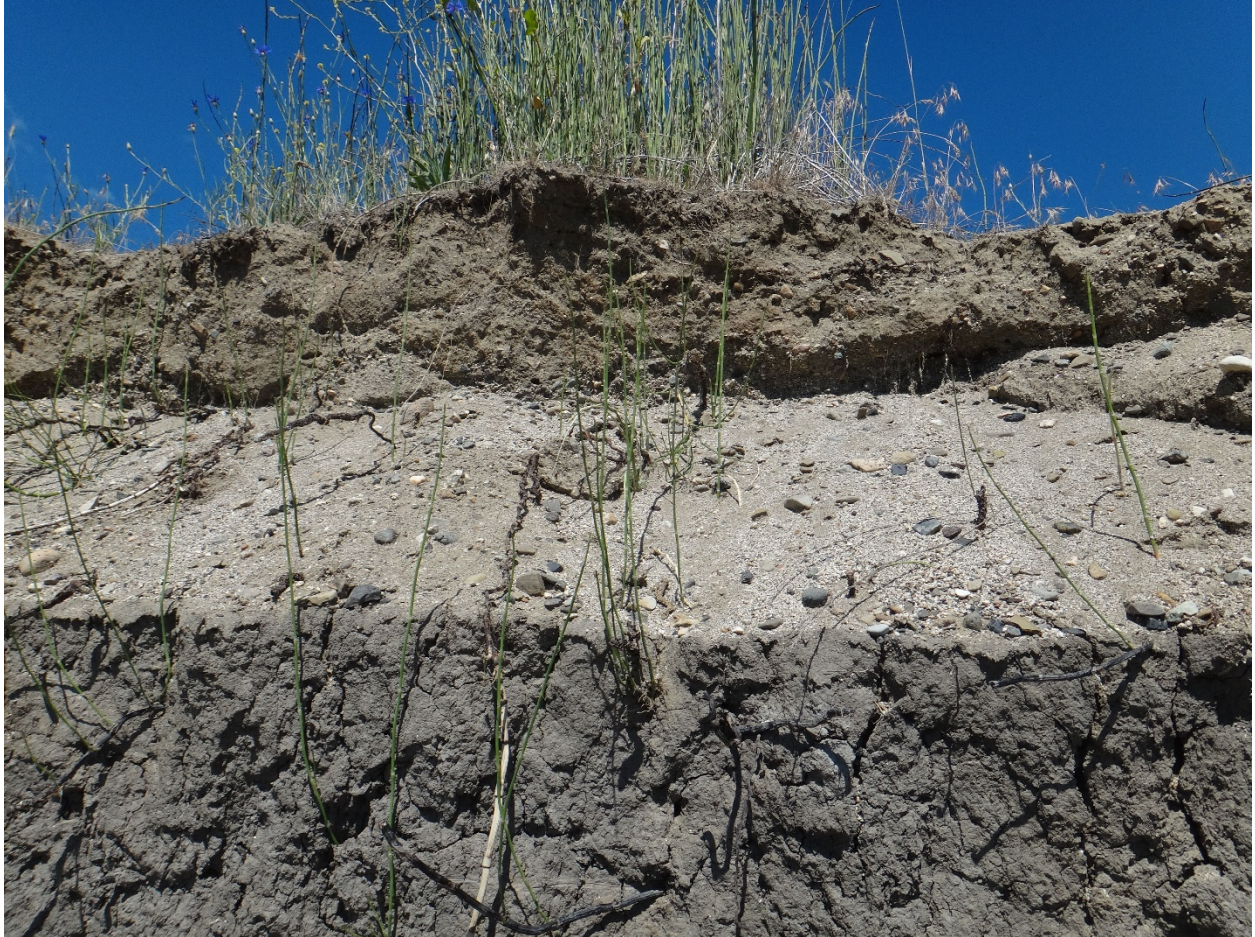
Photos 5. Example of the depositional layer on the floodplain terrace within the Scott River Streambank Bioengineering Project reach. The top layer consists of coarse gravel and sand that is unstable and not suitable nesting habitat for bank swallows.

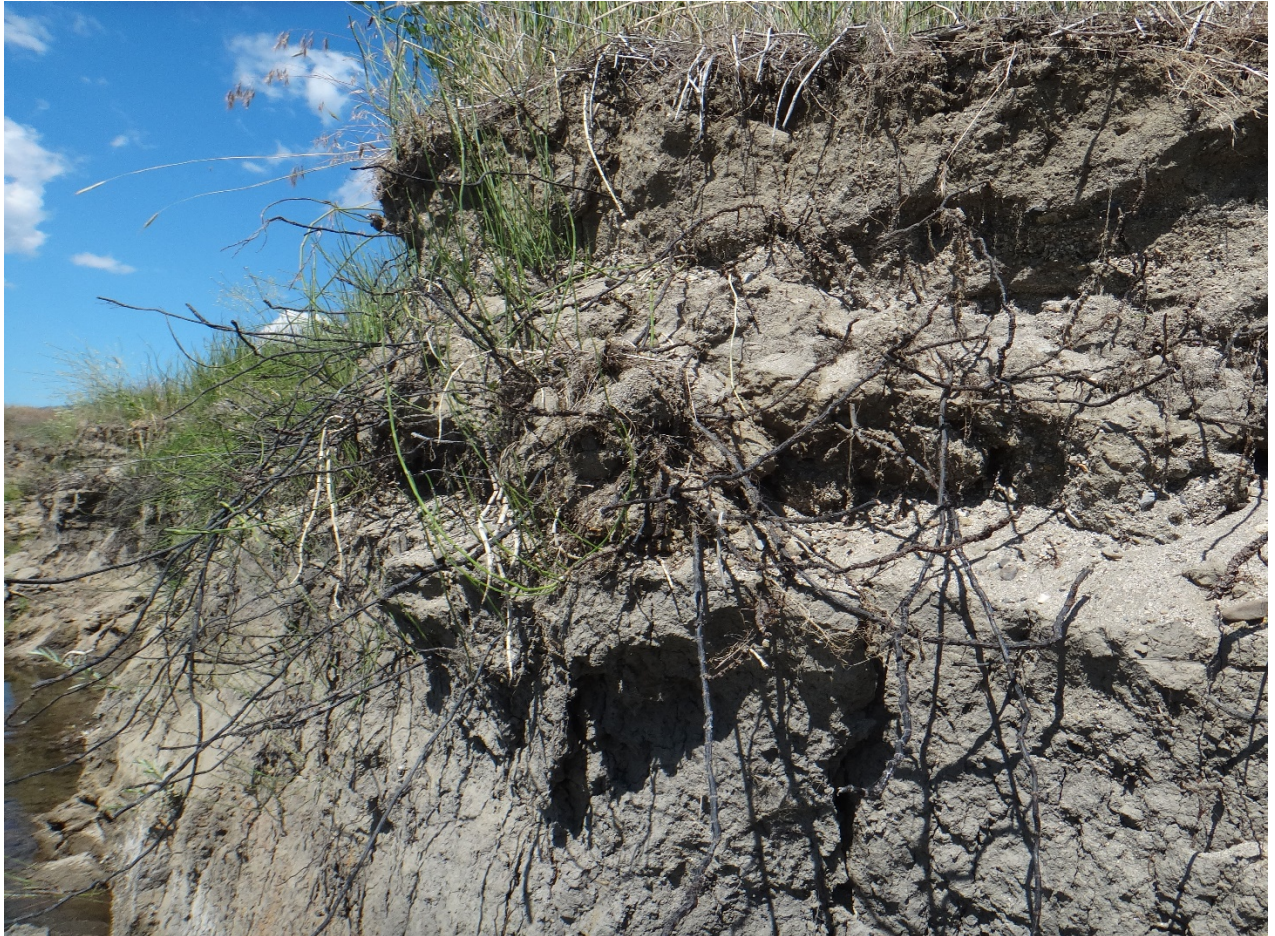
Photo 6. Example of the depositional layer on the floodplain terrace within the Scott River Streambank Bioengineering Project reach. Much of the depositional layer is characterized by dense roots from the vegetation growing on top of the terrace.
